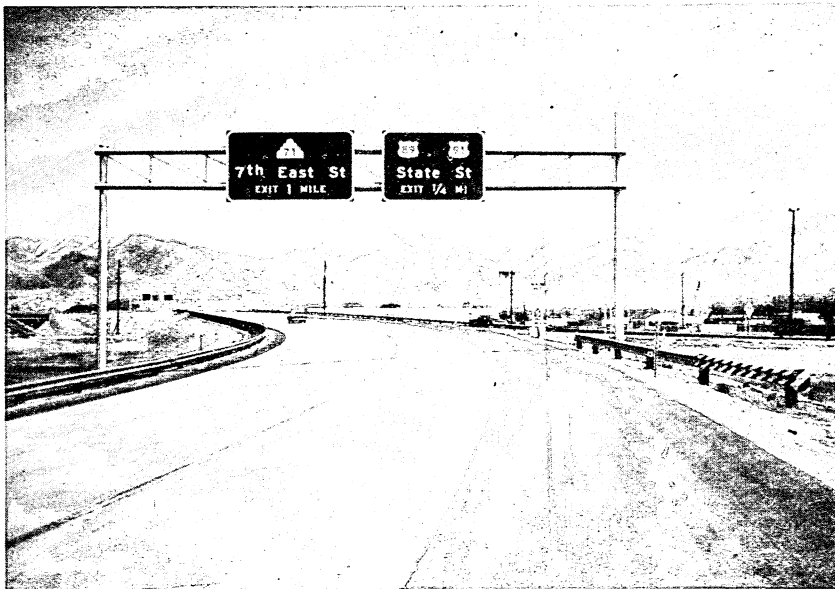
Moving on now, we find then, in the same project, a guardrail which is placed in line, and not buried.

The end, as you see here, is distinguished by the fact it is striped, black and white, for that last 12-foot, 6-inch section. But this portion of it is at the full height, and anyone who went off the roadway on that curve might have difficulty if he struck that. I am almost certain he would.

This is an installation, quite obviously, for the sign bridge. But if you look in the background of the picture, you will see a couple of sign footings here which are pretty big hazards by themselves; the rail stops short of those.
