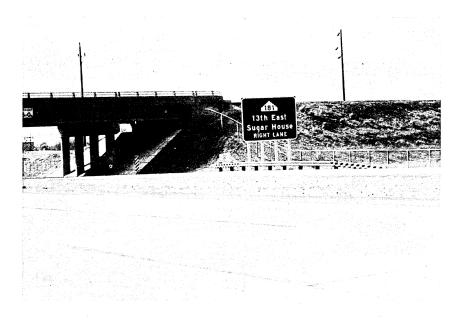
Here you see again about the same kind of situation, rather short run of rail around the sign; no consideration of the hazard presented by these side piers in this case.

Mr. Constandy. It appears a greater hazard. They are unprotected, but the sign which has four steel posts supporting it does have a guardrail in front of it.

Mr. Constandy. That is right, Mr. Prisk. Note there, too, when the rail was installed for the roadway, the State followed one design standard, and by the time they came to letting the contract for installation of signs, they upgraded the design standard for the guardrail, hence we have roadway guardrail on this project not blocked out, and the guardrail protecting the motorist from the sign is of a higher design. One thing, it is blocked out.

Mr. Constandy. So we see some improvement within the same project, even though the protection of the motorist is handled entirely separately when it involves a sign as it does here.
