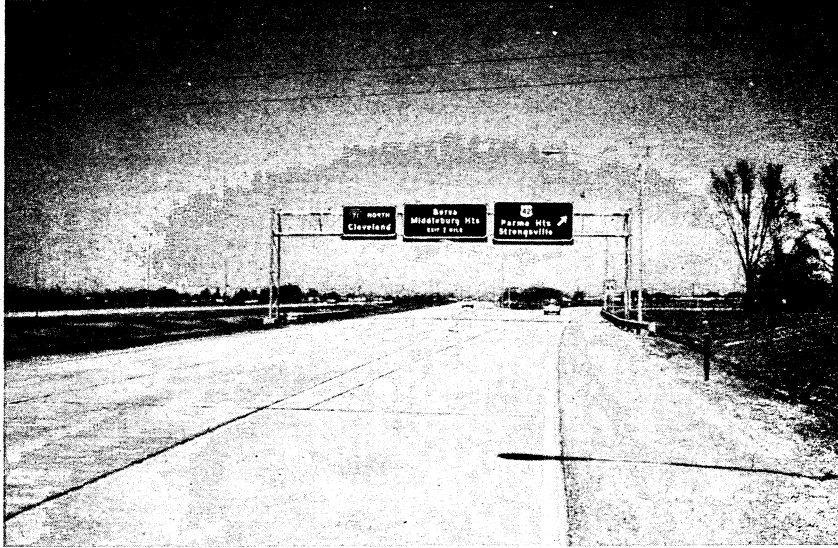
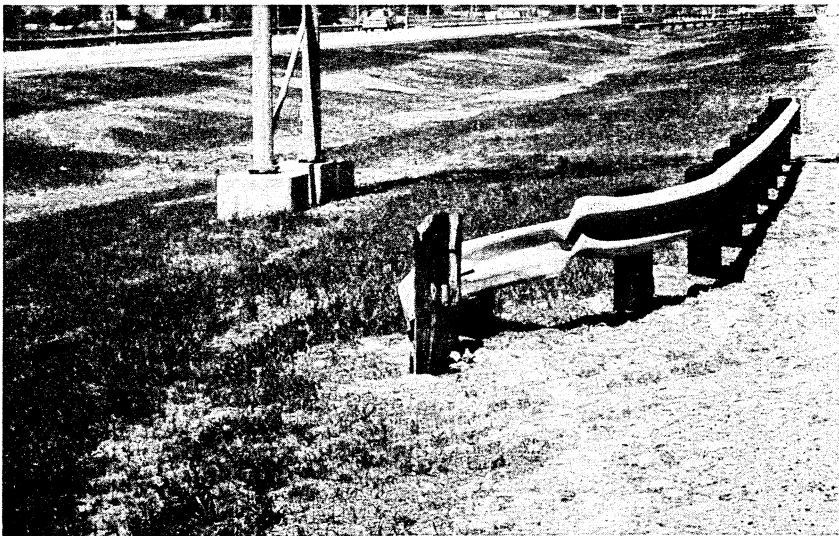
Here is an installation we passed en route to the subject job. This is on I-71, near Cleveland, where there is a guardrail installation at an overhead sign bridge and it is rather short and moving up close to it you see what happened on the median side. This guardrail without the washers, as I said, was torn off the post.
