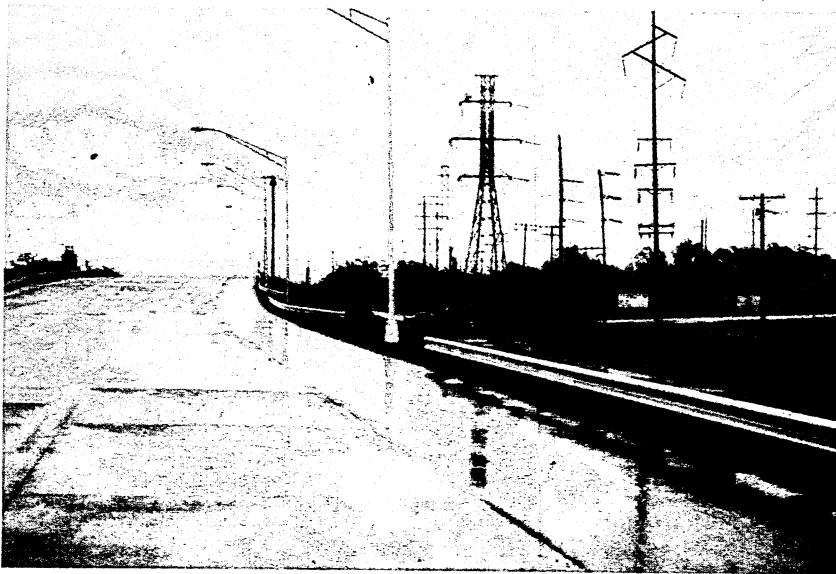
This rail—look at it a little bit farther—here is an installation where there are some light poles involved. The one that you see first, beyond the end of this rail, has a frangible base, transformer base in there. This one is a steel pole and so are the others behind the guardrail.

During the course of the work, the contract was changed to introduce these frangible bases in those places where the light poles were exposed.

One thing that you will notice is that there is a separate guardrail around each post installation and some of the other places, and that, again, begins to bring some concern about the continuity of the rail and desirability of closing up gaps that we see there.
