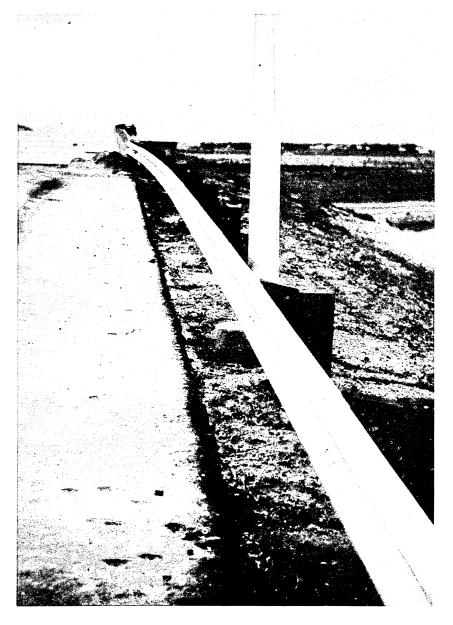
Mr. Prisk. Here now is another view of the guardrail installation on new work, showing the flareback. There is no indication of any

on new work, snowing the hareback. There is no indication of any rail being buried here at all, carrying on up to this bridge structure. That light pole, of course, would be a steel light pole behind the rail. And here is the way it looks close up. You will find when you get there that you have the light pole mounted on a concrete footing, and some of these footings get very close to projecting in front of the rail. Some of them actually did.
