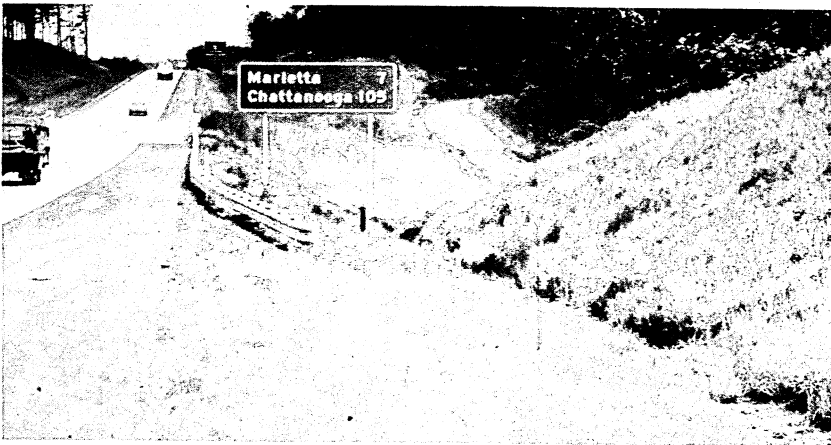
Mr. PRISK. Here is another installation that was carried out the same way; blocks on the rail up to the point of the sign and then you fade back into the rail mounted directly on the post going into the structure.

Mr. WILSON. I know we are not talking about signs right now, but if that sign were moved about 100 feet ahead, just beyond the end of the bridge rail or just at the end of the bridge rail, then all this protection on this end would be unnecessary and the sign itself would not be able to be hit.

Mr. CONSTANDY. Of course, without a guardrail installation, it would be possible for an automobile to go behind.
