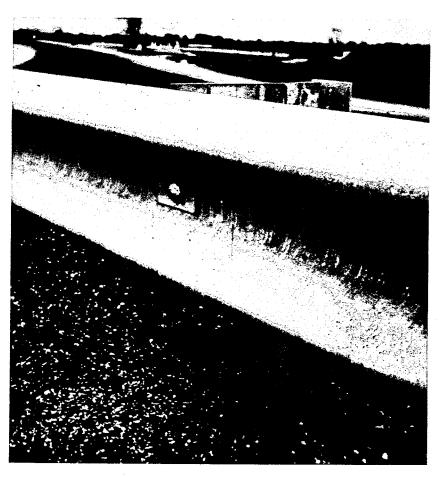
Mr. Prisk. It would be pretty hard to fault them on this kind of an installation. The washer is there and it is blocked out and the height was about 26 inches.

As we take another look at this first bridge which was equipped with rail, we find this approach rail on the right pretty well buried in line with the edge of the paved shoulder, as I am pointing out here [indicating], and on the left just about the same kind of treatment.

If anything, this may be a little bit short, but otherwise it looks fairly good as far as that part of it goes.

Now, this is a dual bridge and you must remember there is a hole

down there [indicating].
