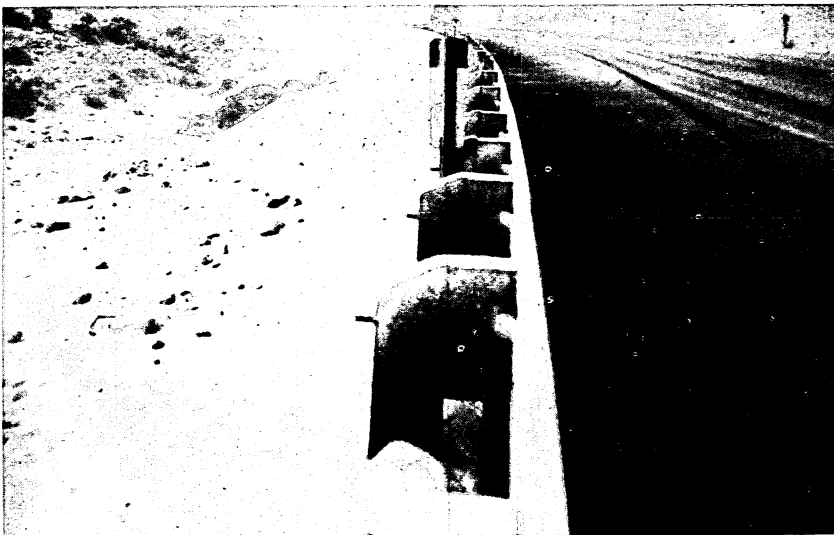
Now we are moving to Nevada and Interstate 80. This is a section we hit in bad weather. Actually we went from bright sunshine to a snowstorm that day. But here they have blocked-out rail and wood posts, as you see, in a fairly good-looking installation. This is typical, again, of what you find in that State.

Mr. PRISK. The post spacing in Nevada is 6 feet 3 near the end of the run, 12 feet 6 normally.

They paint the rail white there and avoid the cost of galvanize. This matches up nicely with the snow.

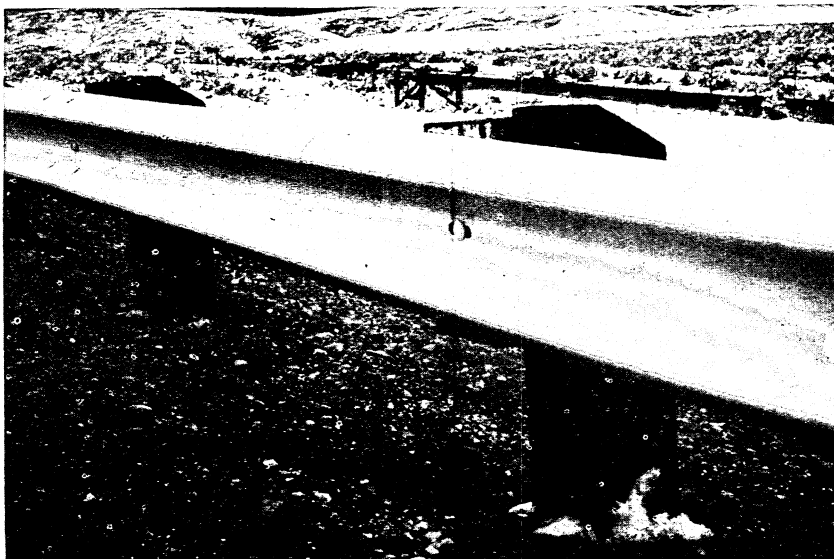
Mr. SKEELS. No washers.

Mr. PRISK. There are no washers.
