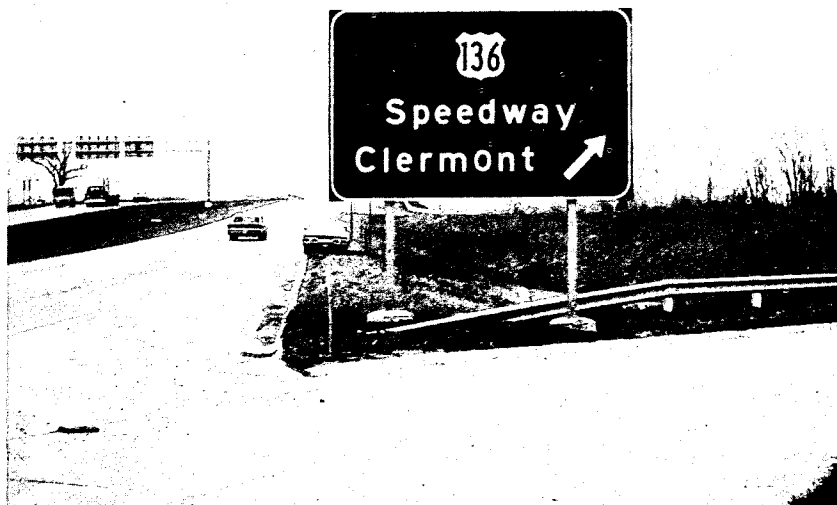
But the guardrail actually projected before the improvement started between the posts here, the I-beam supports, which if I recall correctly are 8-inch I-beams. And so you ran a chance of being impaled on the guardrail or hitting the I-beam, either one or both.

Mr. PRISK. This is a part of a major improvement and this is precisely what has been done at such a location as we saw in the previous slide. This has been pulled down so that you have a buried rail here at this point and your choice now is only running into these 8-inch I-beams.

Mr. CONSTANDY. More than the rail is going to be buried there.

Now this is what has been done as a part of a multi—I was going to say multimillion-dollar project. It is not quite that much money.

Mr. CONSTANDY. The project for a number of improvements relating to guardrail is approximately \$800,000.

Mr. CONSTANDY. Some 24 miles of this circumferential. It includes treating the ends as well as the installation of some new guardrail and installation of guardrail leading to the bridges.
