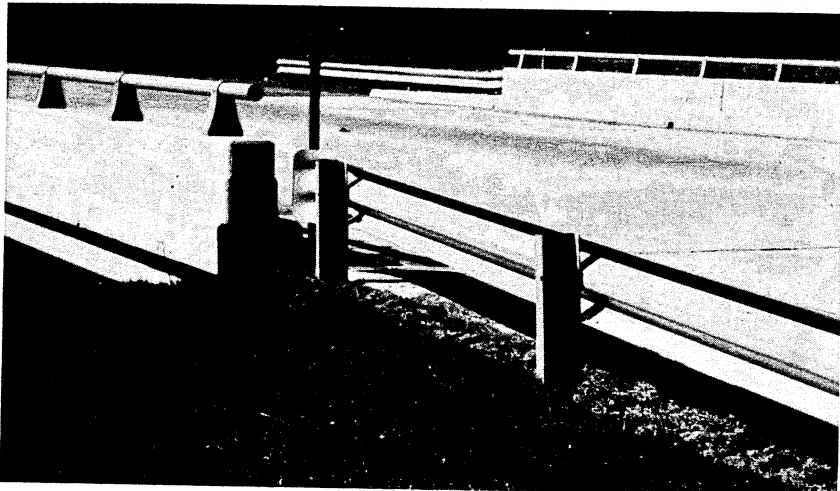
reaches the end of the parapet wall on the bridge structure. Any deflection of this rail, being struck on the approach to the bridge, would cause a car to stop at this point, and of course this is pretty much an immovable object, and collision here gets pretty violent.

Mr. PRISK. Yes. This is typical of Indiana, and a good many of the other States that we will see.

Mr. PRISK. I think it would be necessary to conclude that. We have no post support in the picture for a very considerable distance, and there is a 12-foot-6 spacing on the post. An additional post in this area would help somewhat to reinforce that guardrail against lateral deflection.

As it stands, this could rather easily be moved back by the impact of a car, and the car would collide with the structures.

Mr. WILKES. Could I point to another undesirable feature, and that is the end of that bridge rail, which is obviously an ornamental feature.

Mr. SKEELS. I was simply going to add one comment. On this very short bridge it is doubtful in my mind that the rail is justified at all.

Mr. SKEELS. The metal rail installed on top of the concrete.

Mr. WILKES. Even with the parapet extended to protect the end of that, to keep the rail from hitting the driver or occupant in some cases, the rail could be turned down.

Mr. CONSTANDY. We saw that same point in Utah yesterday. In that instance it was turned down and that round part that we see at the end was curved down to where it meets the top of the parapet, making it a smooth curve.
