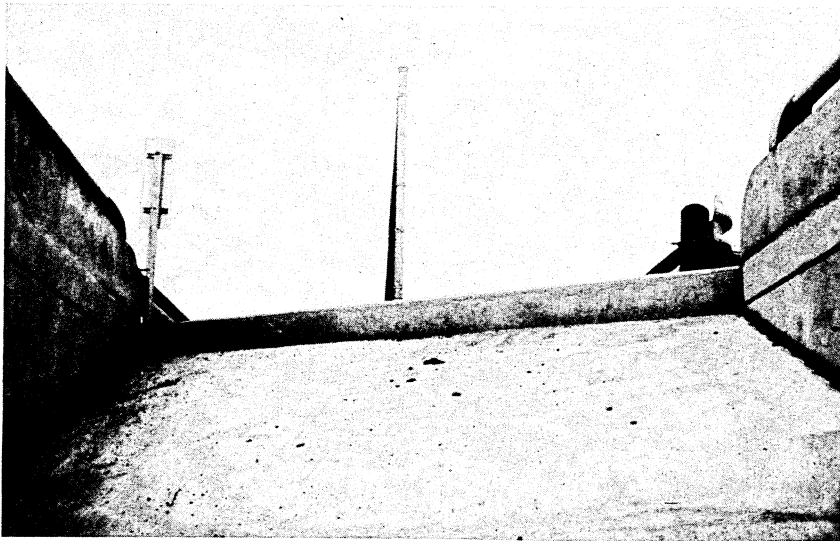
Here is the type of hole that you drop into at this particular location. You can see the fence, anchor fence, up here at the top, and the ends of the two rails, with the daylight between all the way around.

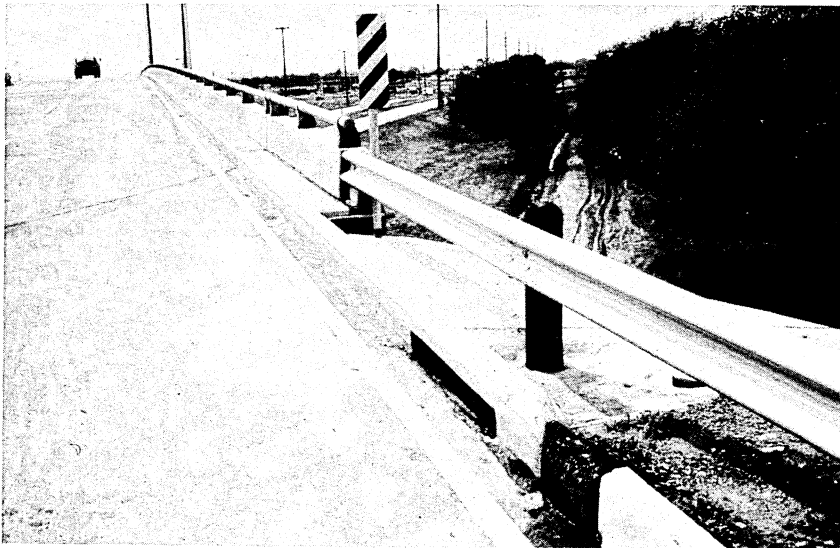
This is another structure showing the attempt here at anchorage. This is the one I thought I had before. But in this case, the rail
