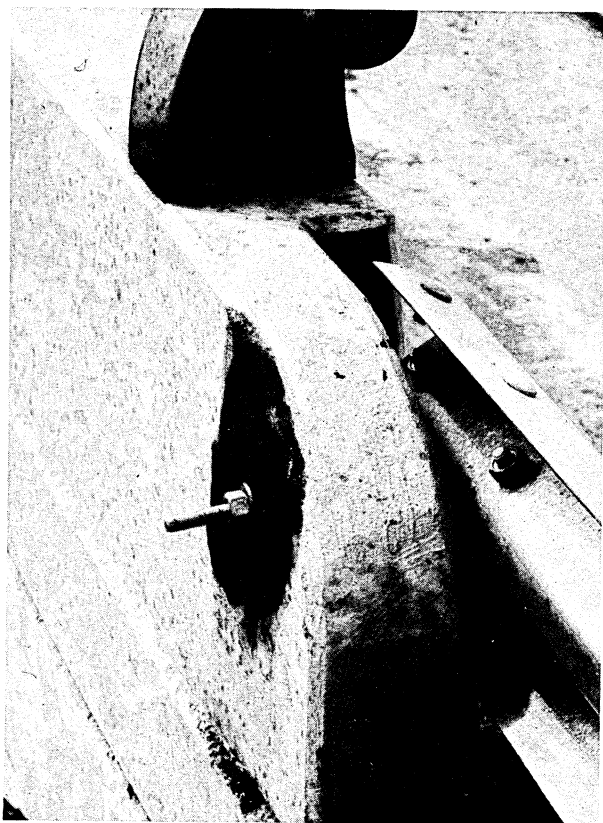
Mr. PRISK. These apparently are not working out too well because this is not a sufficiently strong anchorage to forestall the contraction and expansion stresses that develop in the rail itself. Some of these, as we saw, pulled away or cracked the end of the concrete here.

Mr. PRISK. This particular structure that we found with these anchorage points on it, this gives the detail of what has been done here.
