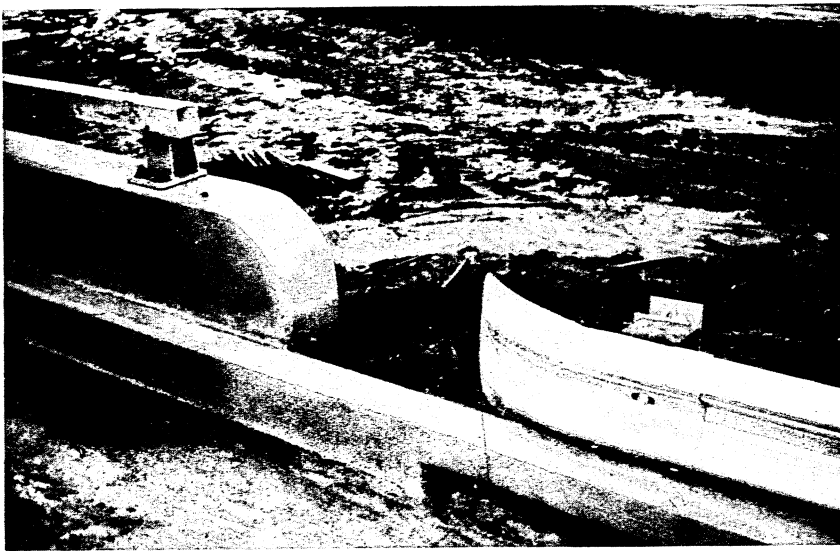
And here is the detail of that. The rail is blocked out. They use a steel post as an end post with a woodblock at this point; this gap is still with us [indicating].

Mr. CONSTANDY. The new work has the same deficiency we have seen on the old.
