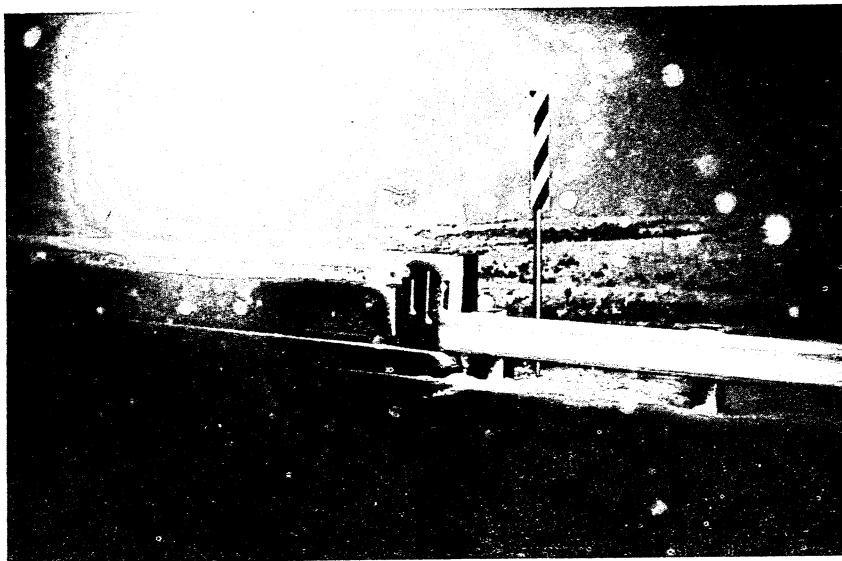
Another approach on that same bridge where there is a slight overlap, 6-foot, 3-inch post spacing used here indicating there is recogni-

tion of the need for stronger rail support in this area. This again is a commendable step.
