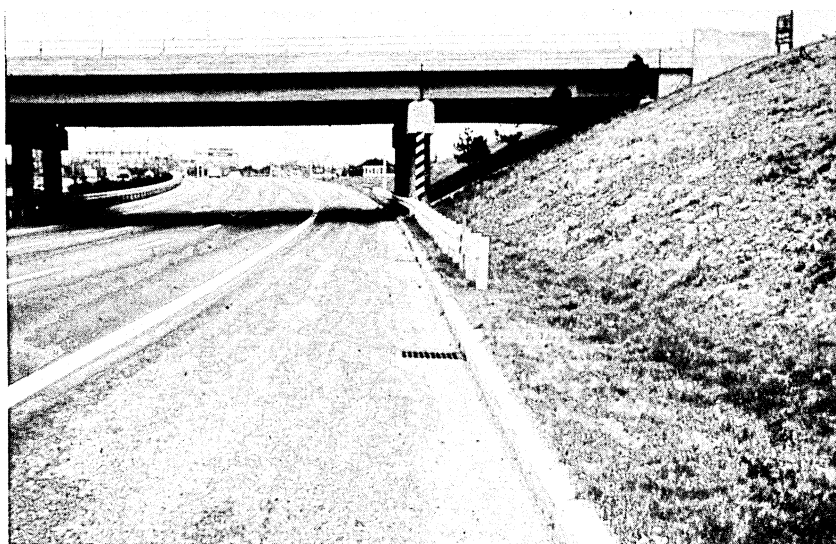
Now we move to the Providence, R.I., area, and find this kind of a situation where guardrail improvements are still underway. Looking at the structure, you of course have here very evident side piers, a foot and a half or 2 feet behind the face of this curb, 10-foot shoulder.

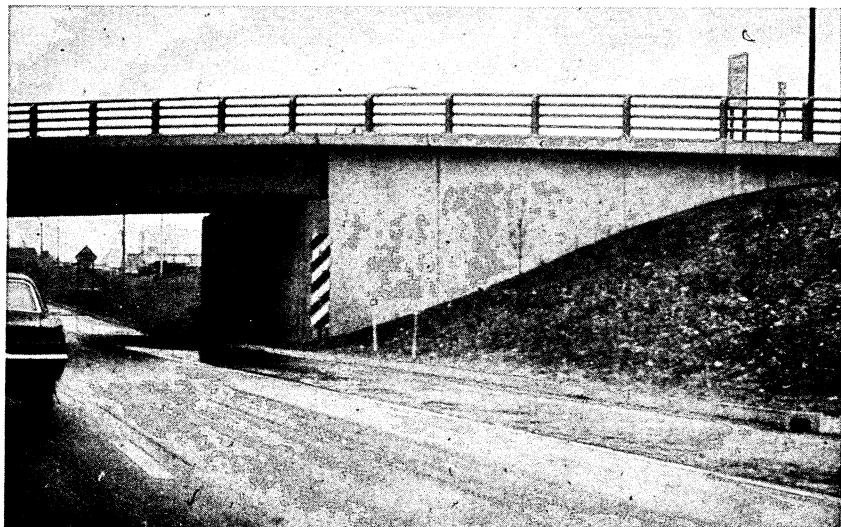
Move up closer, some of these structures are not guarded at all except with black and white striped panel board, such as appears in this picture. This is a pretty good target area. Of course, you do have this slope working for you to turn cars back onto the roadway if anyone got off at that point.
