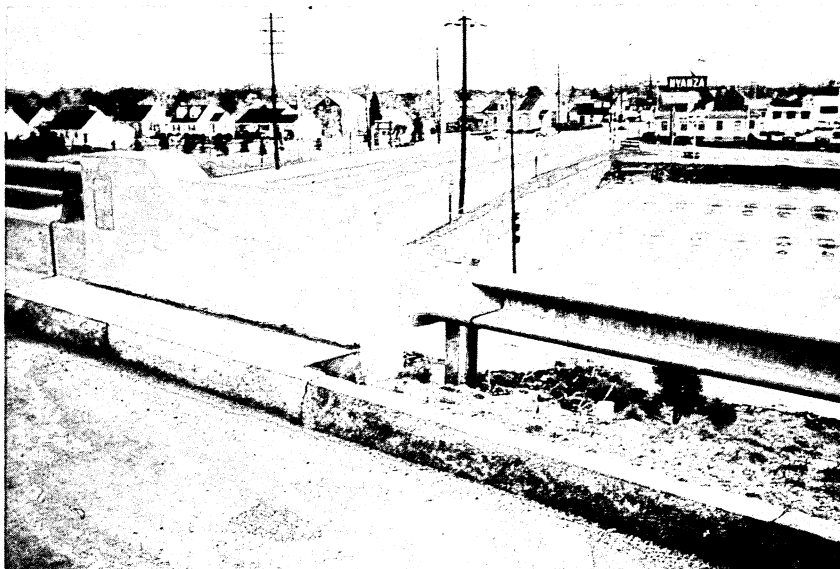
We see here one completely without any anchorage. This is overpassing a more local street.
