So that is the Rhode Island installation we are looking at now.

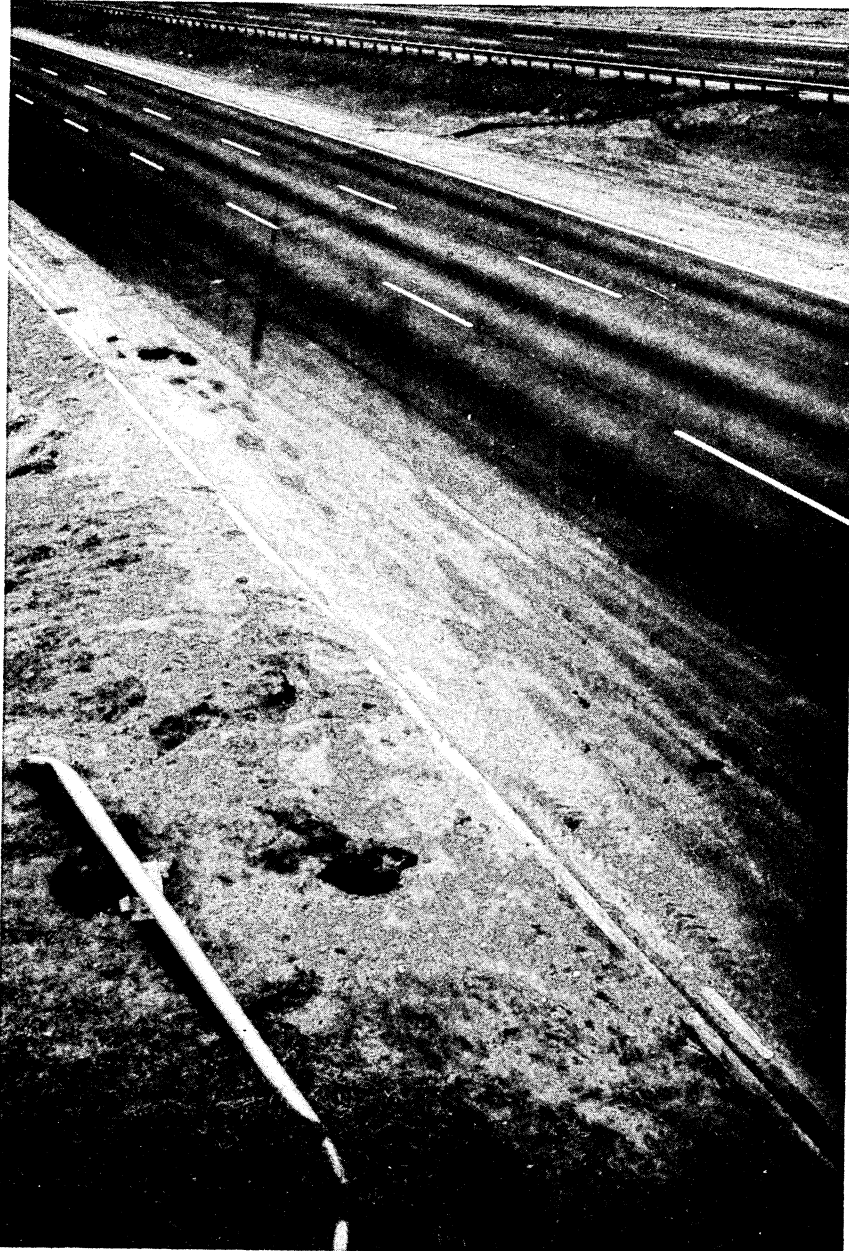
These poles are rather frequently knocked down because of their nearness to the pavement. And this is one knocked down that we saw. This is the base at this point, out here [indicating], just 2 feet off the roadway. This is the position of the pole as it came to rest.
