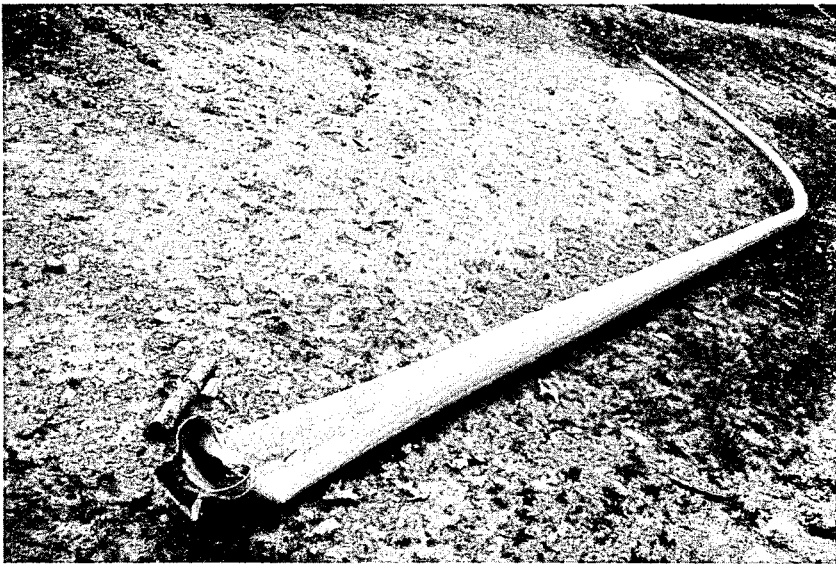
This is that pole knocked down showing the extent of damage there. Bending the lower part of this aluminum pole.

Of course, the luminaire itself, the glassware, is broken as it comes down.

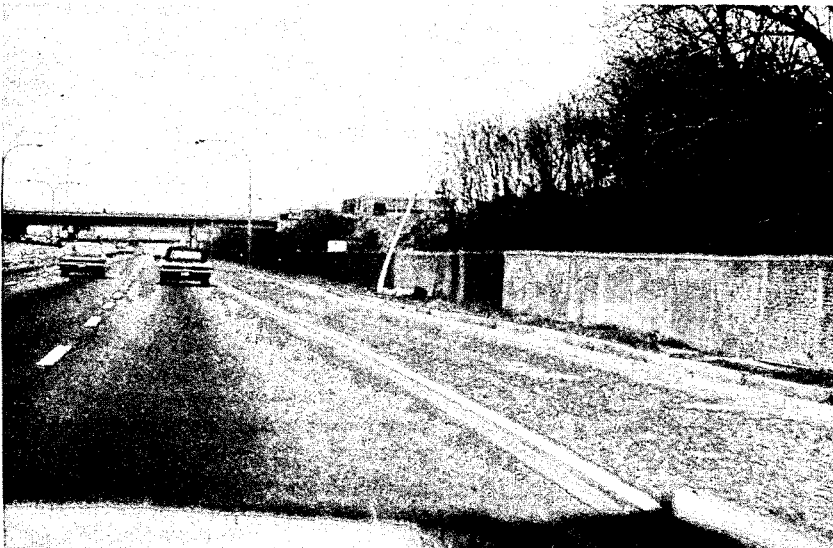
Here is another one—this is off the project but still on Interstate 95—indicating a pole knocked down. It is rather interesting to us that in the very short distance that we are looking at here, we saw four or five light poles actually laying along the roadside as this one appears.
