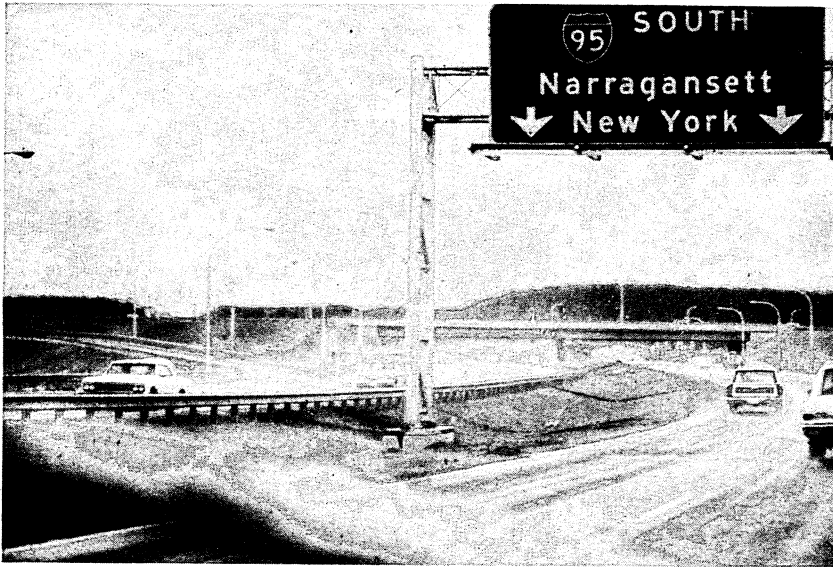
Moving now to the next one, south on 95, Narragansett-New York, we see an exposed sign structure support. This is in the median. I think I showed a picture rather similar to this yesterday, or day before yesterday, as we looked at the guardrail.
