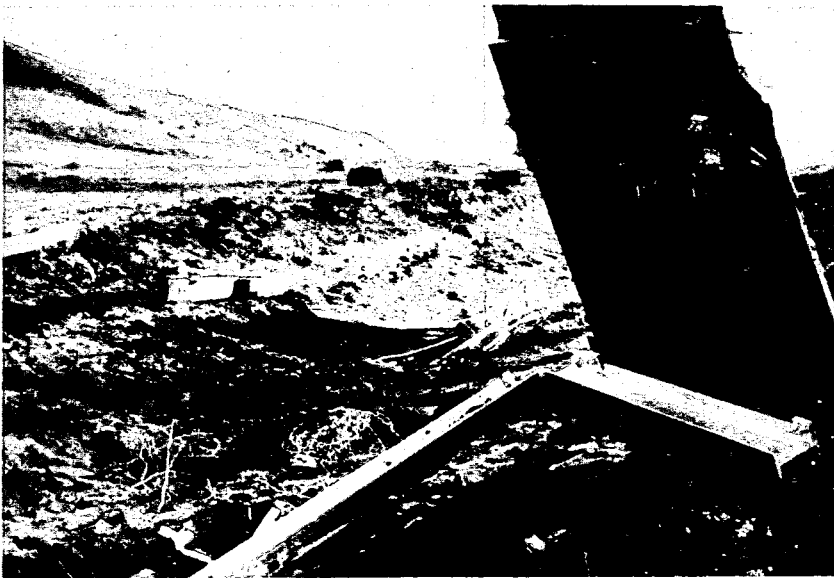
Here it shows how this hinge joint actually operate when it is struck by a car. It lets loose, and the web of the I-beam is cut through, all except this flange here on the back, on the underneath side. You end up with that kind of situation.
