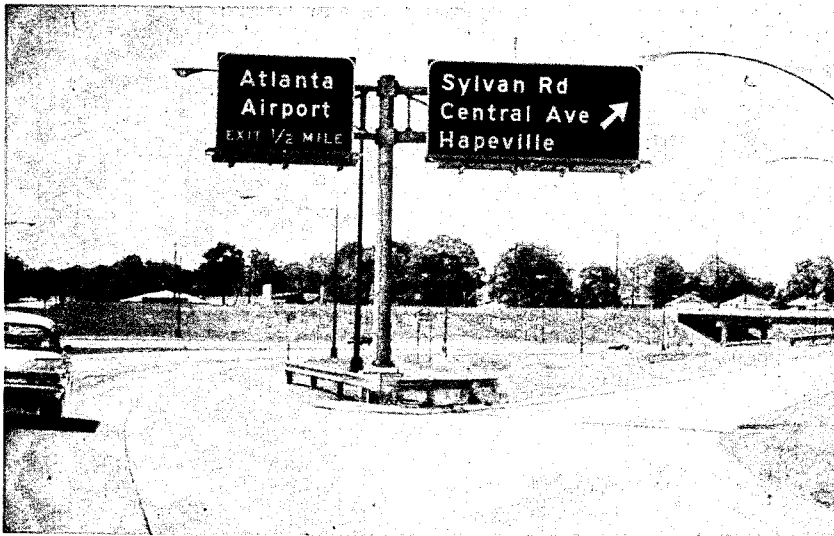
This is the condition headed for the Atlanta Airport, where you have a heavy concrete base here, very short section of guardrail, with two ends to hit. Otherwise, as you can see, it is fairly free and level terrain between the two roadways.

With the removal of that sign, the upright posts, the guardrail, the erection of the bridge a couple hundred feet in advance, this gore problem would be entirely solved.

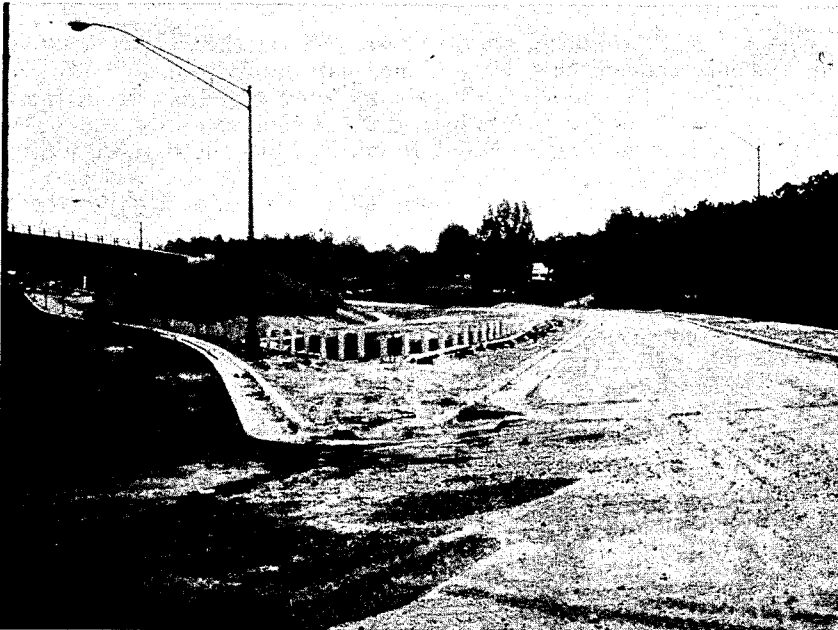
This is new work. I showed a similar picture to you before. I wondered, as I looked at this location, why this guardrail was put in here at all. I do not think I understand yet. It was being put in.
