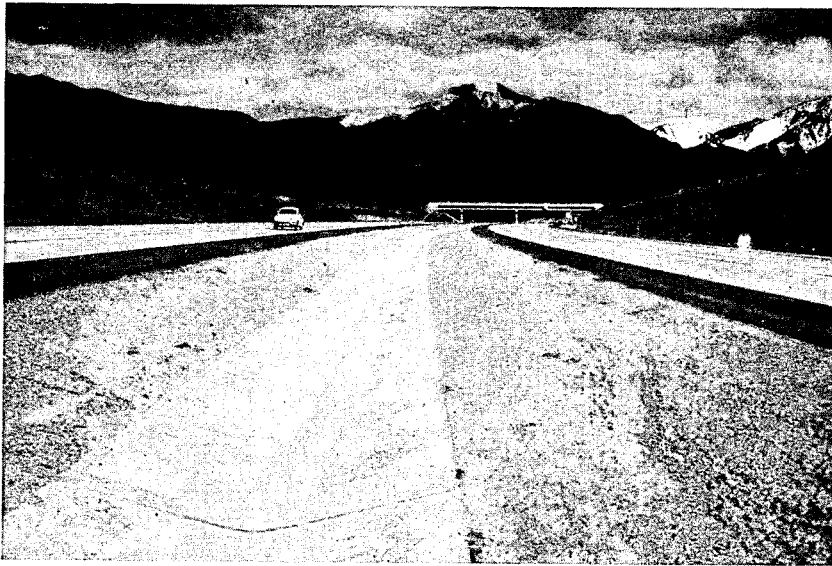
The median drainage is handled in a concrete paved ditch of this sort. Aside from the fact this has a rather sharp V at the bottom, I think it might be regarded as satisfactory.

A rounded bottom would probably be more safe, functionally.
