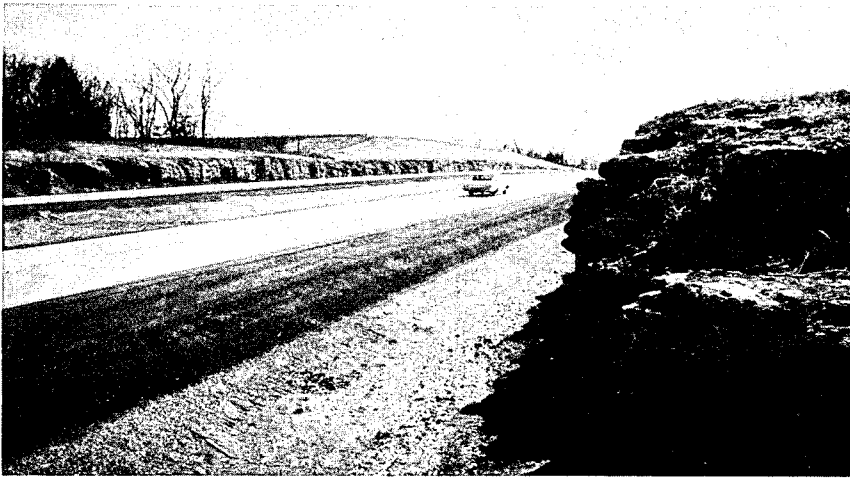
A special situation, of course, introduces itself if you find rock alongside, and in the severe cases here this has been cut back to 20 or 25 feet from the pavement edge, still stands there, somewhat of a hazard.

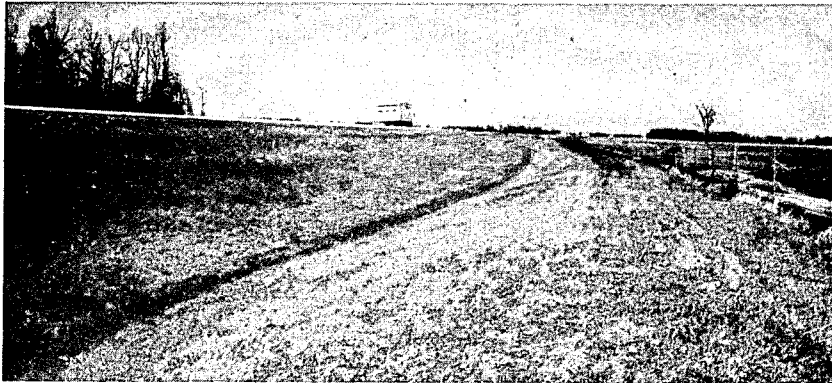
This on the Indiana projects shows relatively good slopes to the roadside, carrying on out all the way to the right-of-way line.
