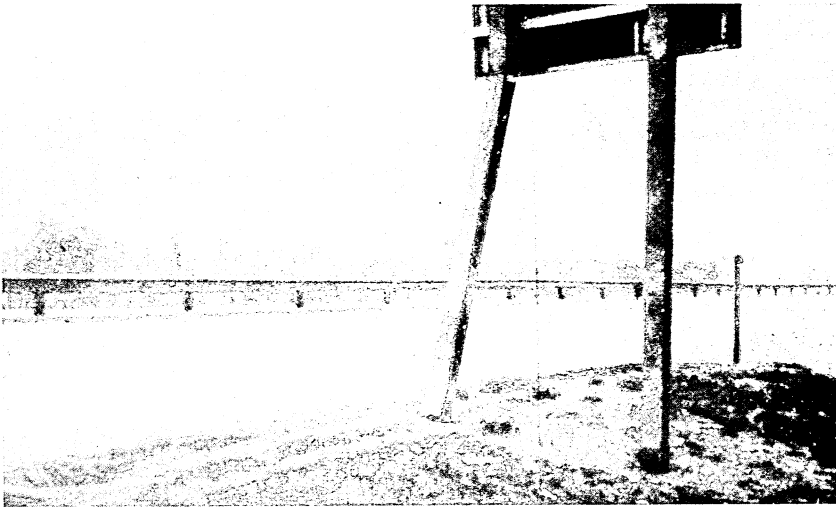
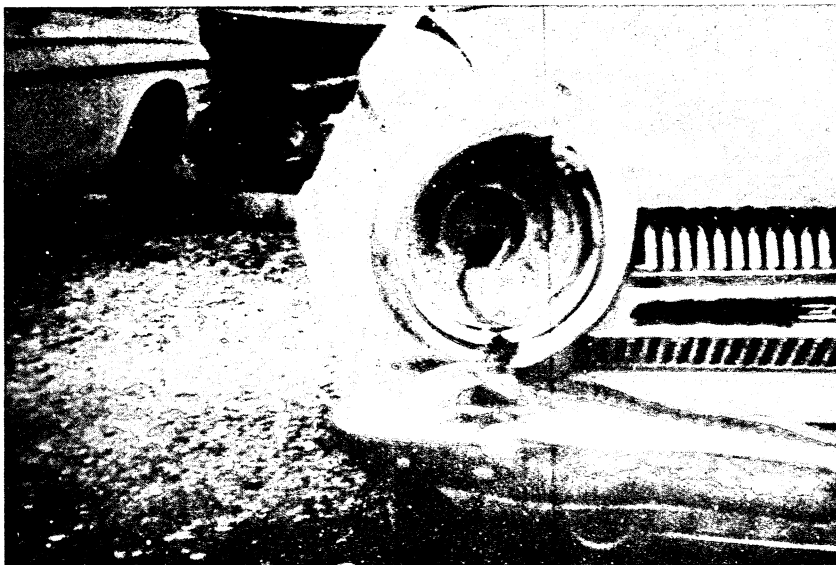
This happens to be a picture of the first sign that was hit after they started installation of these along the highway, and it just happens that this particular sign was put in or the installation was completed at 5 o'clock one afternoon. The driver struck this sign at 6:30 the next morning, and this is a picture or view of the front of the vehicle after impact.

Dr. KEESE. The Texas Highway Department contacted this individual and asked him what the effect of hitting the sign was, and he replied it was about like hitting a chuckhole in the road. He also said:
