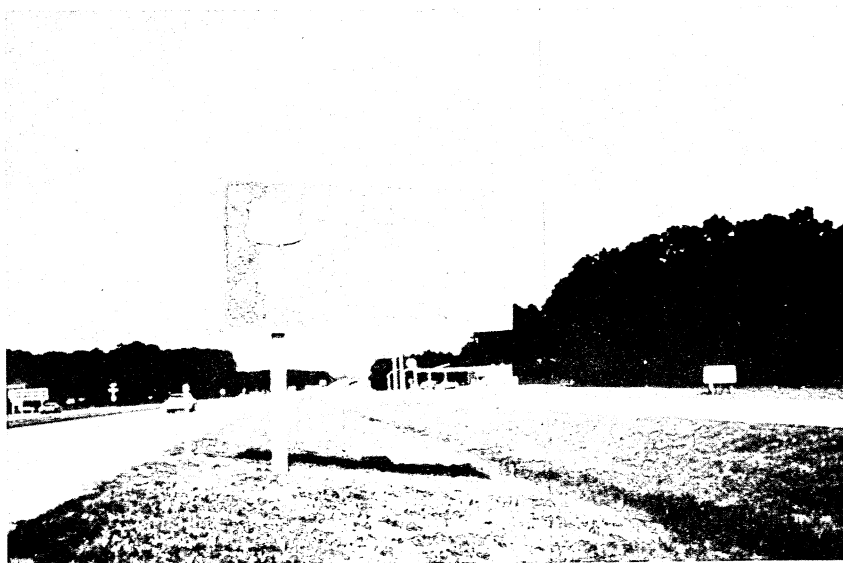
This is another picture of an outside post being hit. The driver went to sleep, and I might point out that that post is approximately 25 feet from the edge of the travelway. At that point I might read, if I may, from some of the accident reports. We now have 69 of them documented.
