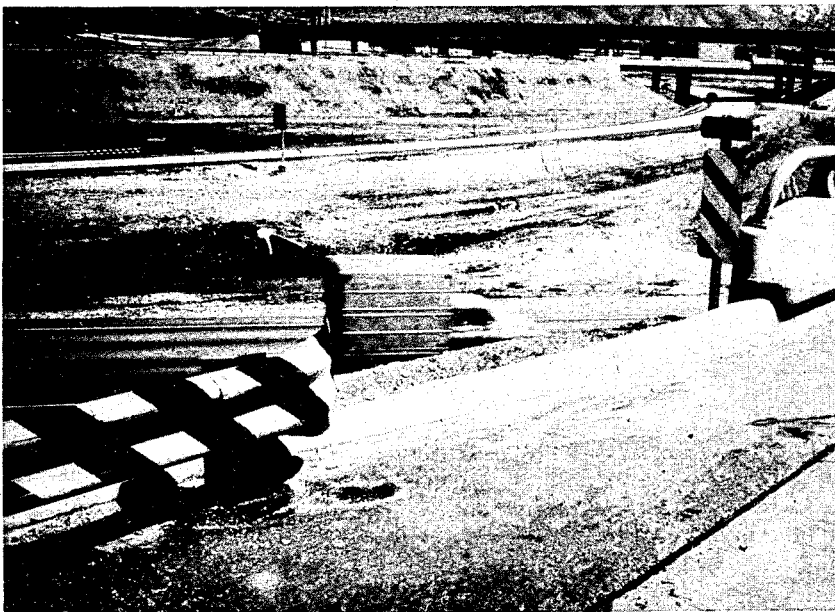
Here is another installation in Salt Lake where the guardrail misses coming to the end of the bridge by some 8 or 10 feet. It is enough to drive between without touching either the bridge or the guardrail.

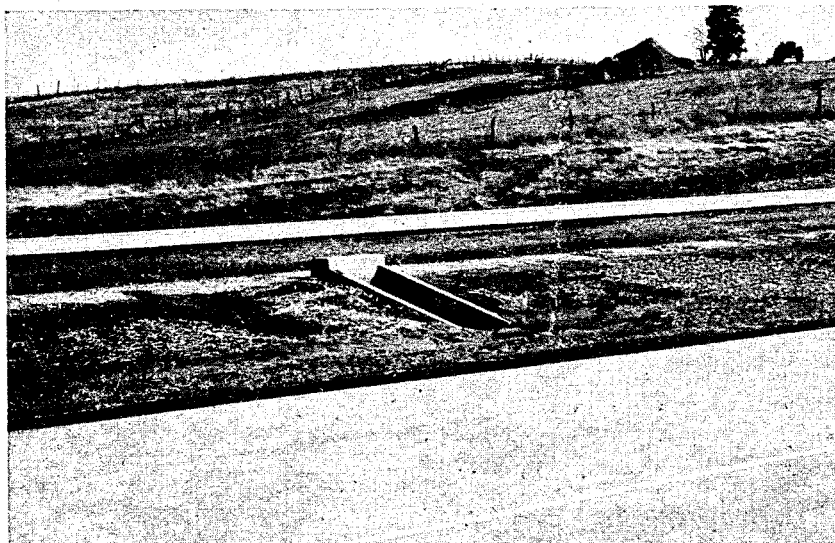
This is a concrete headwall and drainage structure placed directly off the inside shoulder.
