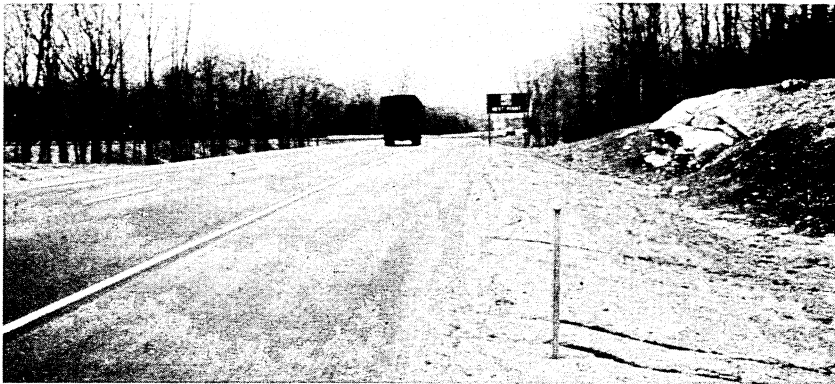
This is another photograph taken in Rhode Island which shows the existence of a formidable piece of rock which was left off the right shoulder at a distance of some 15 feet in an attempt to provide esthetics. This was a common situation on that project.

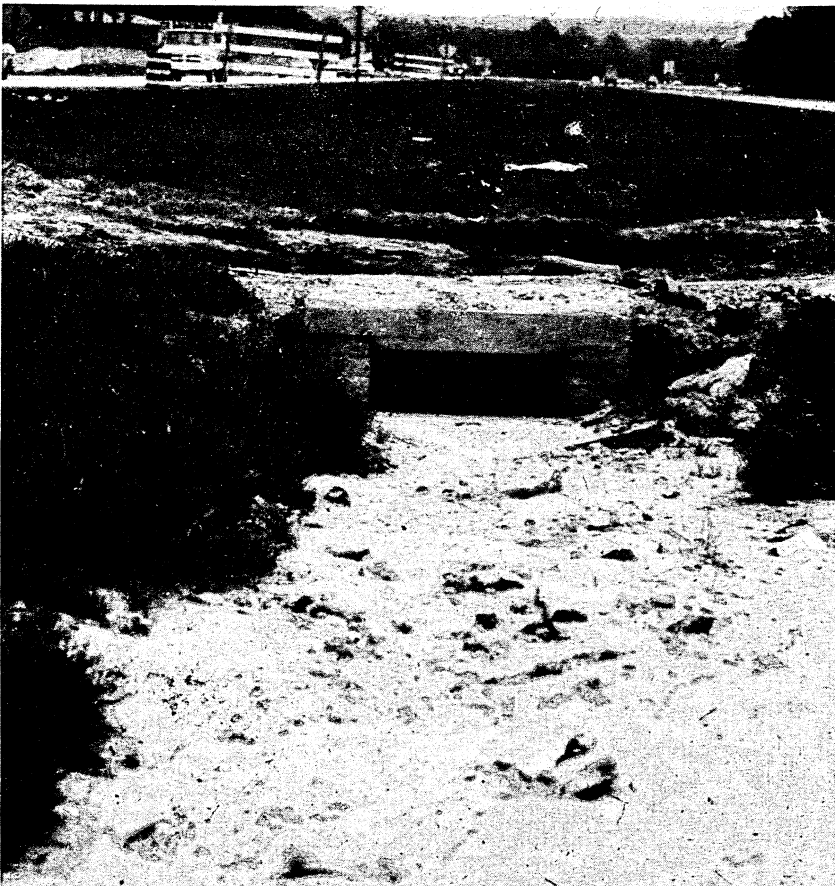
This is again in Georgia. It is a median structure.
