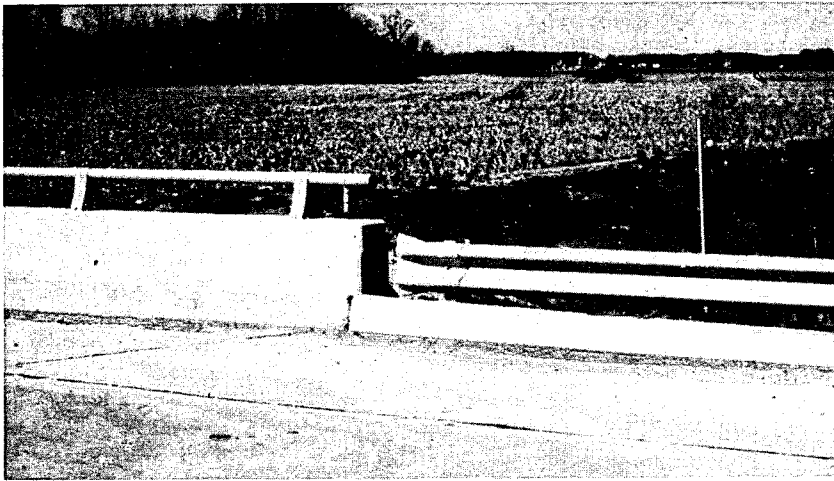
This is another bridge which carries the shoulders through the structure. No transition from the guardrail, in this case to a concrete parapet bridge railing.

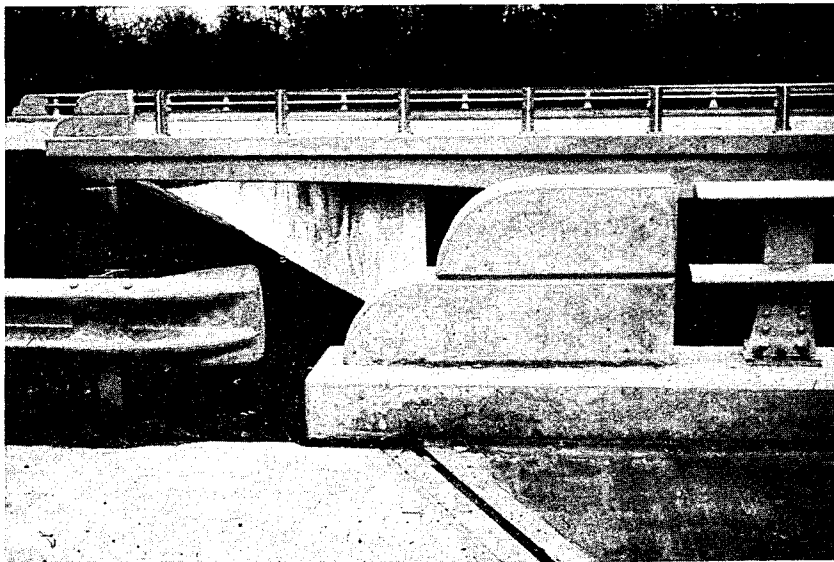
On the newest project here they used a new standard to upgrade their work. You find that they used here a rather nice aluminum bridge railing which appears to be effective from the tests. But again we have no transition from the guardrail to the bridge rail, and at the point of transition we still have remaining that ever-present concrete parapet at the end of the bridge.

Does that have to be there, Mr. Turner, that concrete parapet?
