HIGHWAY SAFETY, DESIGN, AND OPERATIONS Roadside Hazards

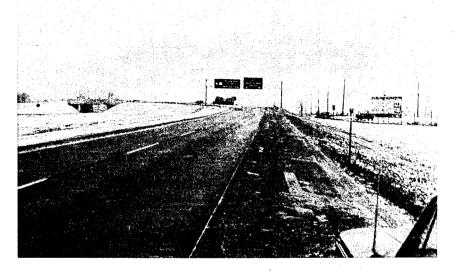
This is an expressway turnoff well marked, heavily signed. There is inadequate guardrailing around the base of the signpost. But 1 day the individual did make this turn, a 17-year-old young man driving his parents in a brand new car, and he swung a little wide. You cannot

really see it, but the road edge is right here [indicating], along here. He swung wide and got into this area

It had snowed during the night. He skidded along the guardrail, which performed like it should; it held, it kept him on track—but the thing is that a few of the legs in here [indicating], near this end, were loose. The car snagged on the guardrail. It then spun around and the left rear door hit the cement monolith, here at the end of the guardrail, crushing the door in, killing the father in the rear seat, and the mother in the rear seat was ejected out the opposite door and down this embankment. She suffered serious injuries.

Had we had these legs implanted more strongly so that it would not rock and snag the car, and possibly the overlap of guardrail over the end here [indicating], this possibly would not have been a fatal acci-

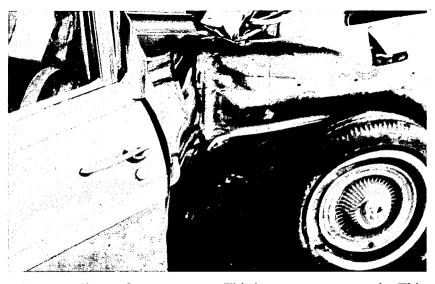
This is the side impact against the door next to which the father was seated.

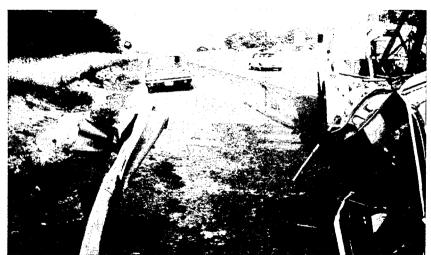
I am standing under an overpass. This is an expressway again. This car (at right in photo) went out of control one early morning. He was

towing another vehicle. You can see the tracks as he came sliding side-ways into the exposed end of this very short section of guardrail, which crushed in the door, killing the driver.

Had this end been buried, this individual would not have sustained

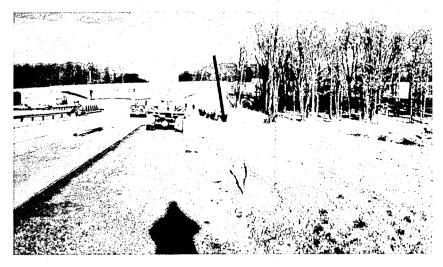
Here is an expressway, again a fairly nice clear area here [indicating], so that if you go off the roadway in this area, you have no trouble whatsoever. Beyond the truck there is a drainage ditch.

A vehicle knocked down a reflector sign, went straight on toward the ditch, and then hit this part (arrow) of the retainer wall—which flipped it up into the air. He completely catapulted across the ditch, landing on the top of the roof; then the car (circle) rolled over. He was killed.

One of the concepts that has been advocated for an area like this is: Is it really necessary for drainage ditches that pass beneath expressway system to remain open? Why not enclose them for 30, 40, or possibly 50 feet away from the road edge? So that if this, for example, had been covered over and this individual had gone into the area, he would not have had the strong deceleration forces applied to the vehicle to cause it to flip over and for him to be killed.

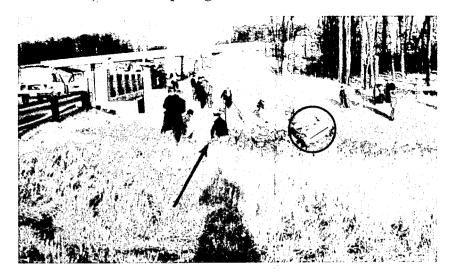
There are data available to indicate the angle at which vehicles leave the roadway, especially expressway-type systems. Using that type of information, a more adequate guardrail could have been constructed

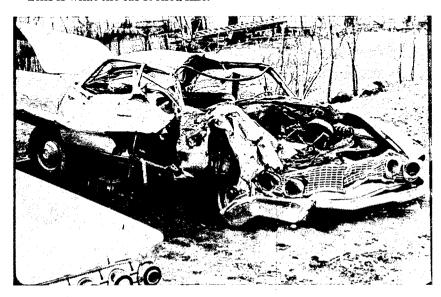
This is what the car looked like.

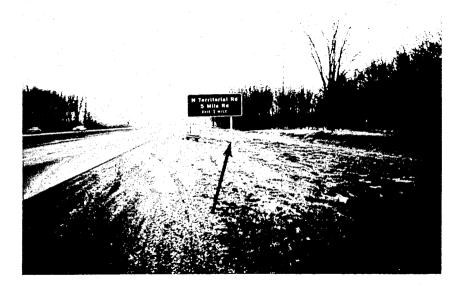
Now, here we see a typical sign on the expressway system, at least in Michigan. These are 8-inch I-beams, support posts, imbedded firmly in concrete; and look at the guardrail we have adjacent to it.

First of all, this guardrail is so short in length that if you did crash into it by leaving the roadway, you could run over it and you could hit that left leg of the pole, anyway. But notice that even the right leg is not protected. And they say, "Well, we do not have to protect it because no one hits these things."

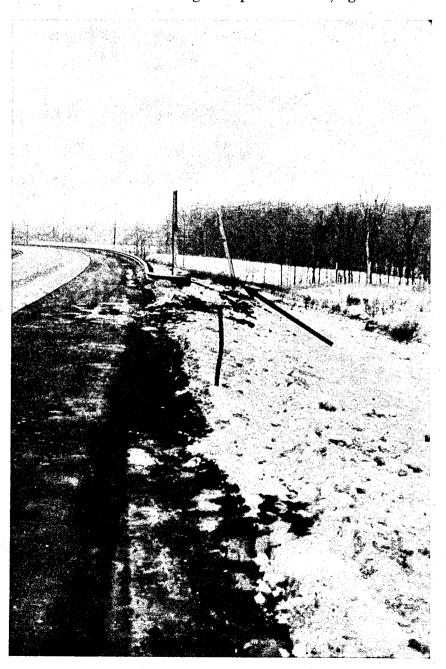
Well, here is a very extensive guardrail; this goes all the way along that curve. Look where the sign was placed for this, right at the be-

ginning of the guardrail, so the left leg is protected, but the right leg

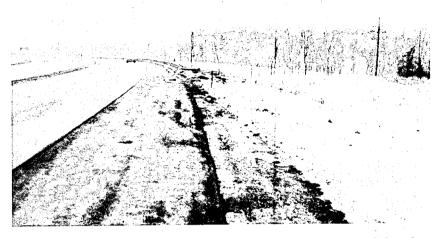
A long shot shows you how shallow this angle was of his approach to the leg.

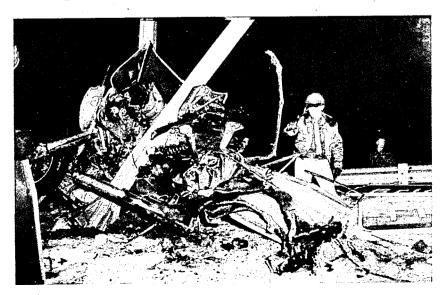
Here is the on-scene photograph. It is very difficult to explain what we have got here, but I will try. Behind the officer is the guardrail and

the road is beyond it. This is the engine area. This is a Pontiac convertible. The front bucket seat is fused to the rear seat. The post was knocked over at maybe—not even a 45-degree angle. The engine is 65 feet in front of the car. And the instrument panel is parallel with the left side of the car. The driver was found killed.

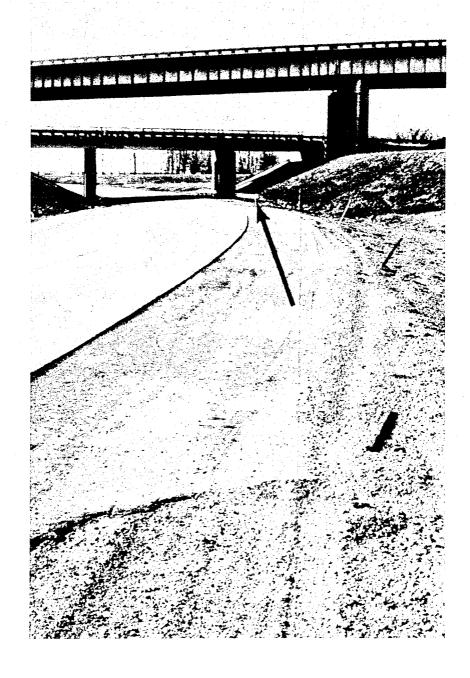
Here is a brand new expressway with a fairly tight curve in it. One night three boys went off the road here, nipped the end of the guardrail (arrow), getting behind the guardrail, hit the very end of the bridge pillar, and the car then continued up in this V area and through it, and then rolled over. One boy was killed. But look at the direct line

that would take you into this heavy mud embankment, and note that the short segment of guardrail is not adequate for protection against that type of bridge pier.
Mr. W. May. Mr. Prisk, is that a proper installation of the guard-

Mr. Prisk. Mr. May, I think that would be pretty hard to defend on the basis of the experience that has been had with short sections of guardrail and the fact that the end is exposed—that very definitely could easily be folded back into the bank and anchored so as to give a smooth transition.

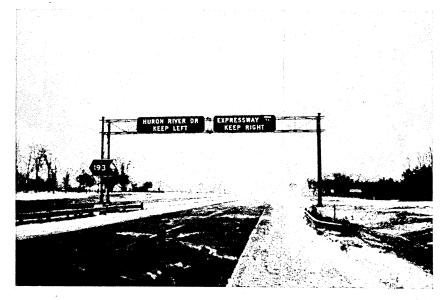
But a little bit farther down, this is what they have done. Almost all the way in the area they have put the shield of the expressway system on the sign. Why did they not do that back half a mile?

But as we approach this area—see, "Expressway" here—you keep right to go on the expressway; but a quarter of a mile back, you had to keep left to keep on the freeway. This gets confusing.

More adequate signing, I think, and proper signing there to alleviate the confusion would have been helpful.

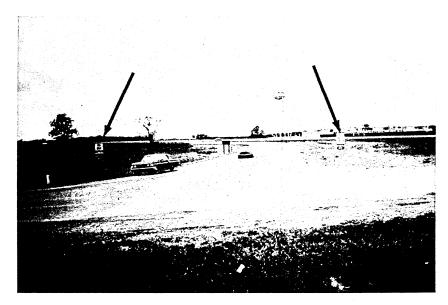
One night a man came along here wanting to go toward Ann Arbor and he thought this was the road. He got onto the exit ramp and from this point on after he had missed these signs, there is no further indication that this is an exit, not an entrance; he accelerated, and by the time he had gotten up to the expressway, he was probably doing 60 to 70 miles an hour when he hit a car with teenagers in it here [indicating]. This was a quadruple fatality accident, wrong way on the expressway, and this is how he got on.

Notice there is a signpost here for the drivers who come off in this direction; another sign could have easily been placed here saying, "Stop, Wrong Way," or something like that. And maybe even another one on this side, giving him multiple chances to correct the mistake that

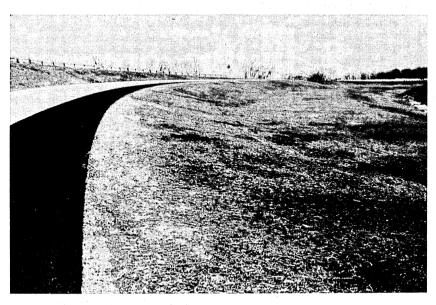
Notice this broad, flat, smooth area extending for probably 200 feet off of the road area. This is a nice clean area if a vehicle would tend to leave the road surface and go off into here.

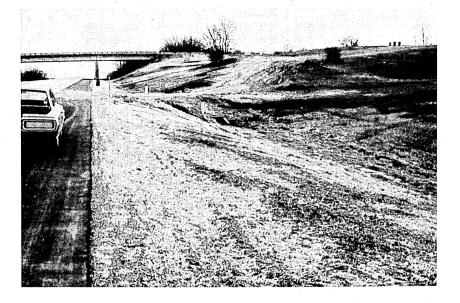
Farther on, on the same expressway, however, we get this. This is a gravel pit that was used when this road was being built. It is no longer being used to any extent, but yet it is there. There is a barricade over here so you cannot get through. But notice what would happen if a vehicle would go off into this clear area; notice the earthen embankment that the car could strike and the deceleration on the

vehicle would be the same as if the car would strike the bridge pier. These earthen embankments are serious.

Mr. Prisk. Yes; it could be a violation of access. It appears from Dr. Huelke's photograph that there is a drainage culvert under that roadway also. I would expect that that entire slope could be graded to a safe section, safe cross section, with a little effort.

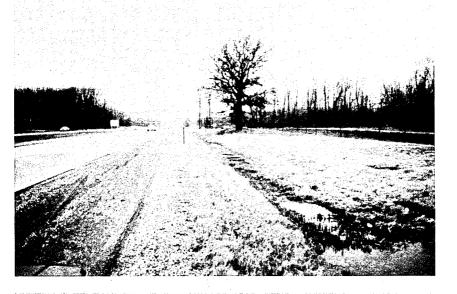
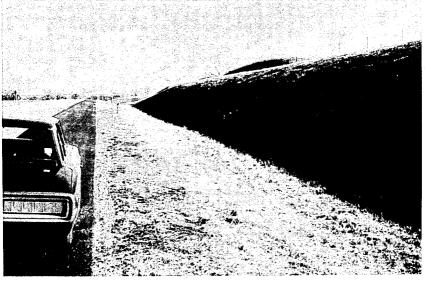
Dr. Huelke. Now here the road clearance—there are no trees, but notice the high earthen embankment that is less than 20 feet from

this edge of the offroad area [indicating]. And, again, whether it is trees or retainer walls, or what have you, this can be just as serious for impact, and obviously the proper grade is not there to allow a vehicle to go up that grade without striking directly onto it.

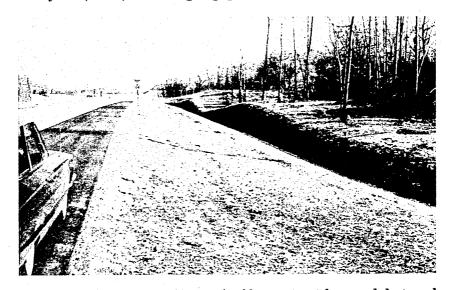
Dr. Huelke. A little bit farther on. Same roadway. We see we have a very nice, clear, flat area going quite a considerable distance away

from the road edge; but then again, if we get out here and do travel that far, the heavy earthen embankment beyond.

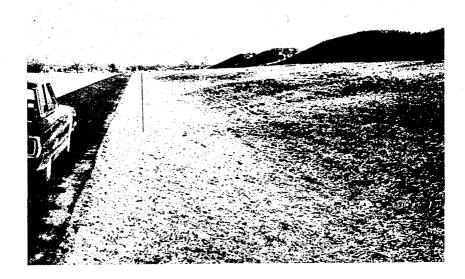
Here, however, less than a quarter of a mile down the roadway, is a perfect example of a clean offroad area. So this one stretch of roadway

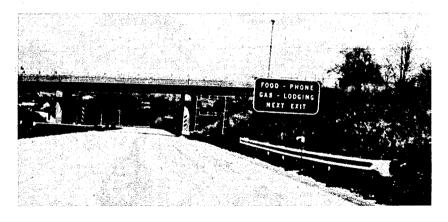
This happens to be on the border of New York. I strayed onto this Route 84 and I noticed that they were making mistakes like New York

had been making. Here you can see that instead of putting this sign at the bridge abutment where there is a guardrail, they put it in advance and created a second hazard. It would have been less costly to put it at the bridge abutment and there would have been no damage there.

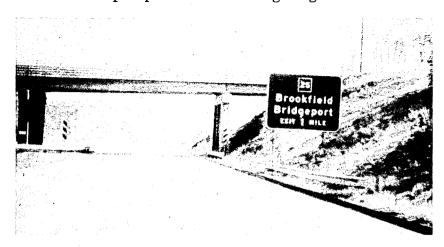
Mr. Linko. Here also, you can see an unnecessary sign hazard that could have been put up ahead at the existing bridge abutment.

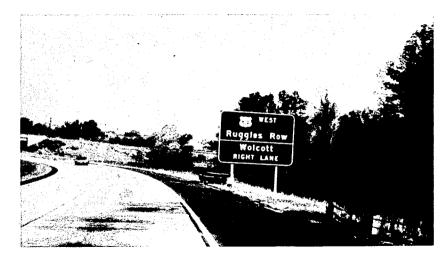
Here you have a double rail and the right leg of the sign is not being protected. It would be safer to bring this sign forward behind the guardrail. This happens to be on an outside turn, and that is where a car would be most likely to go.

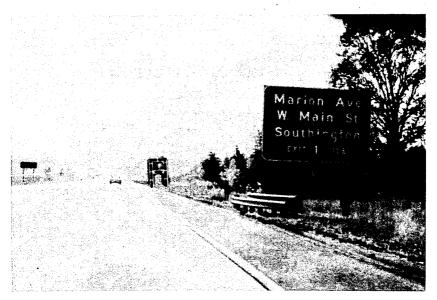
And here also you can see a 1-mile sign. It will not make any difference if you back these up behind that guardrail. You can put it at three-quarters of a mile rather than 1 mile, when that creates an unnecessary hazard.

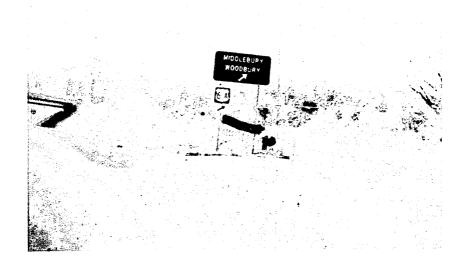
Here is a place where you have a clear gore area and a clear road with a nice shoulder, and they have about 200 or 300 feet of guardrail somebody might run into and which could be removed. I have a line there to mark the guardrail.

Mr. Prisk. I think this is the kind of location, Mr. May, where that could be seriously considered. From what I see of the terrain there, I also fail to see the reason for the guardrail. It would seem to me that they probably had more guardrail than they need.

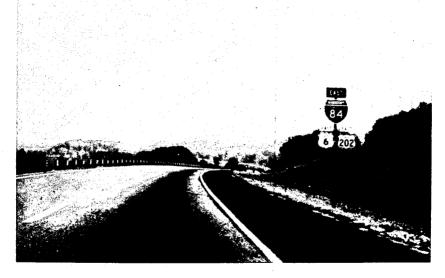
I am even against this small sign. You might think I am picking on it, but even a sign like this is a hazard. You could be traveling along at 50 miles an hour and one of your tires might get in that ditch there. The average person approaching a small sign, or any kind of sign does not know if it is an easily knocked down sign. He will swing away and lose control of his car at 50 miles an hour, so that sign is considered a hazard.

Mr. Prisk. It might be considered a hazard, but certainly not in the class with the I-beam structures. This appears to be a U-frame support. But there is a degree of hazard associated with it; yes, sir.

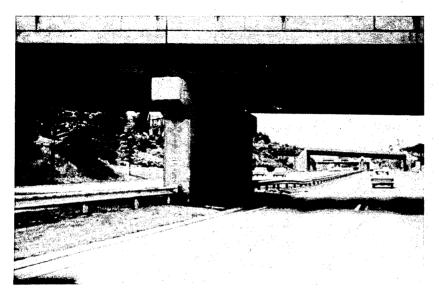
I noticed practically every curb on Interstate 84 constituted a hazard. Here is a picture where a marine died. He slid along the guardrail and went right into that abutment there. That was about 11 months ago.

I went by this location the other day and I noticed they were putting guardrails around, but it took them 11 months to do it.

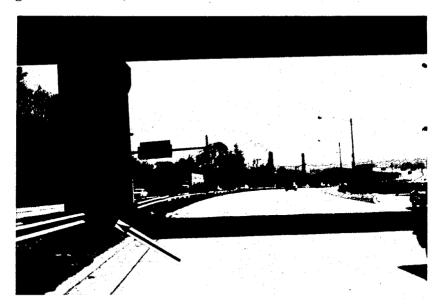
They did not get around to doing it on this one—or that one. Look at the many targets you have, and with a tapered curb you can ride up

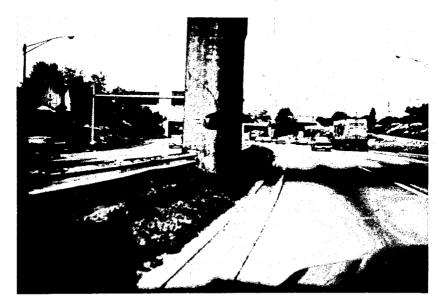
nice and easy. I feel you need a crash program to get all these hazards off our roadways. It is an interstate highway and the speed is high here.

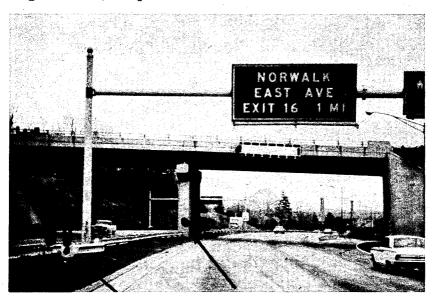
Here you can see the sign could be mounted on top of the overpass and the pole could be put inside the center divider. Every one of these places is an extra snag. Even at the bridge support, the guardrail does not go around it; it stops in the center.

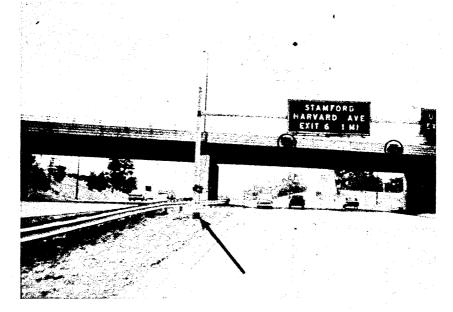
This is similar.

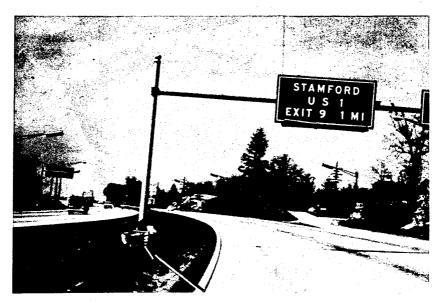
This one has been smashed into.

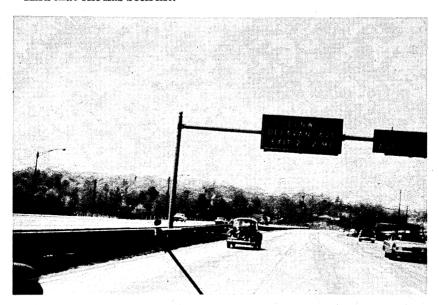
And that one has been hit.

And that one has been smashed into. Where the dots are is where they have been smashed, because they are about 2 or 3 feet away from the rail.

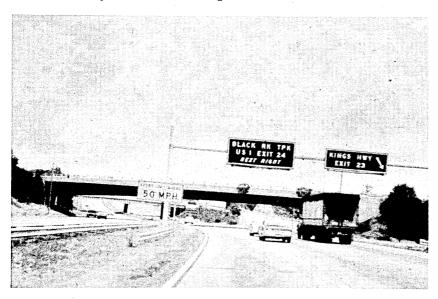
Here they felt, well, somebody might run into it, so they put 75 feet of guardrail here. But you see, somebody running into that still has a problem; they did not solve the problem here.

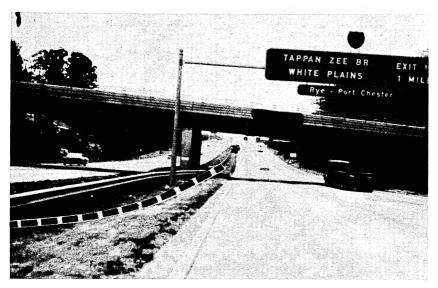
This is a brand new rail. If I was doing the job, I would go around that hazard. But nobody had any intention of removing that hazard. They just put the guardrail up because somebody had it on paper.

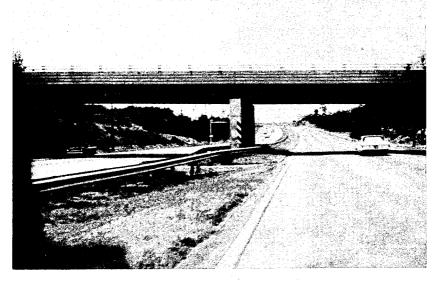
Mr. Linko. Here you see a 20-inch block. Anyone riding along this rail will be guided into this 20-inch block and come to an abrupt stop. All passengers may go through the windshield.

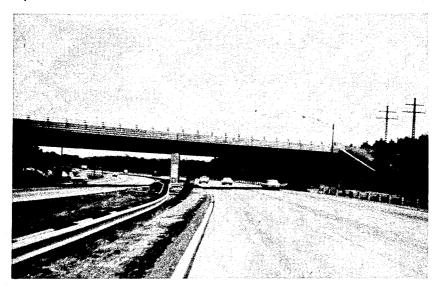
Here again, by curving the guardrail in the center in the proper manner—like I show with the line—you still would have a good shoulder and nobody would be in danger. This way here, the block is exposed.

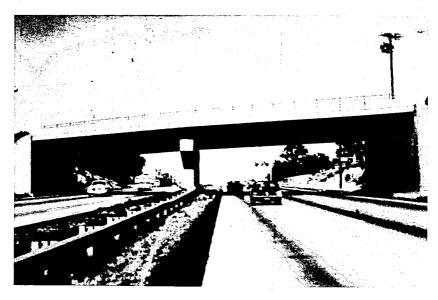
Mr. May. It looks like it might be tapered.
Mr. Prisk. I think so. If that is concrete, it would take a little jackhammer work.

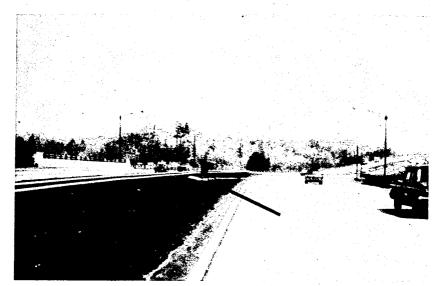
Here you have a tire track, which is hard to see, on the side. Somebody ran right along that guardrail and hit that block.

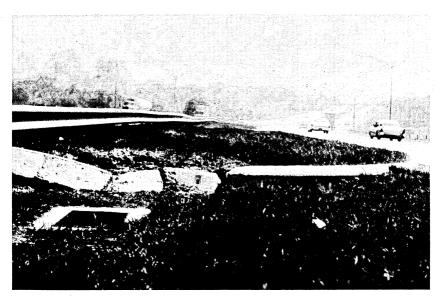
Here you can see it is all busted up, so he must have hit it pretty

This is not really necessary. It is not even the curb at all; the curb is here at the right so why can't we guide that car past, give him the 10-foot shoulder.

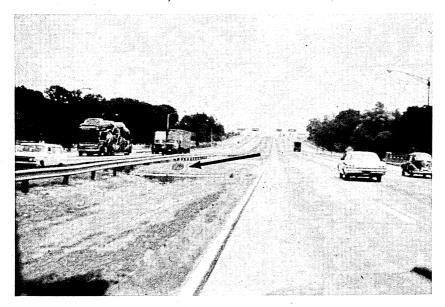
And here is another one; this is new work.

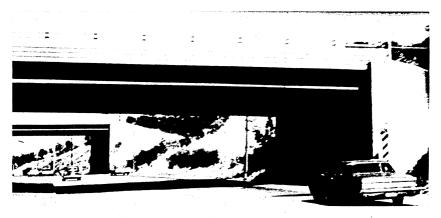
This is the last one on Connecticut and it points out we still have not got any guardrail at these bridge abutments, and I would like to know really what we are waiting for. We are still opening up brandnew Interstate highways and we are not putting any guardrail at these bridge abutments.

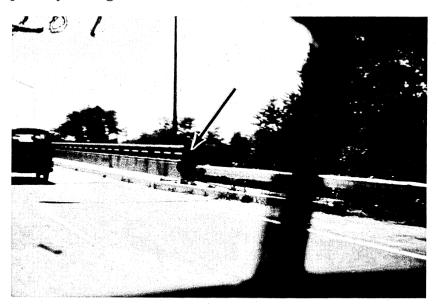
Here you see a guardrail back of this bridge abutment, where you probably would get hurt.

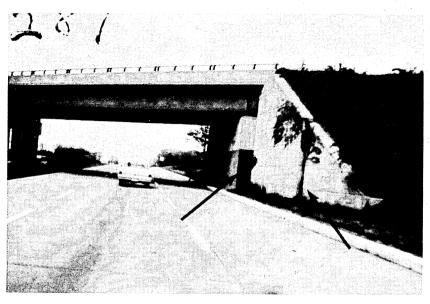
Here is Route 17, and that's an expensive installation. You could have the sign right in front of the bridge abutment. You have the proper length guardrail at this point, but the ends are not buried into the ground. The reason I am showing you this is because even if we had to put this bridge sign here, we could have killed two birds with

one stone; let's put it that way. Notice the bridge abutments are not protected. Everywhere I see the new work, it seems to be that they are only doing one thing at a time.

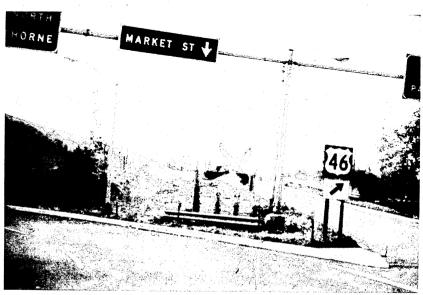
And here you see a gore area really saturated. Not only did we put the concrete stanchion there, but we put three high voltage transformers there. Some big truck is going to run in there and damage that at

terrific cost to the taxpayer to replace. That is, if it does not kill someone.

I would like to say again this should be off limits, especially a clear gore area like this, where a guy should get a second chance after he makes a little mistake. He is not going to get a second chance here.

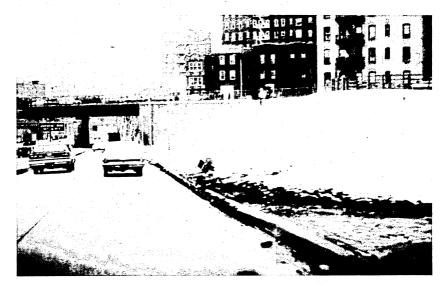
Here you see another car running by, barely missing a tree on the top. Now, in many places we have been planting these trees 2 and 3 feet off the shoulder, you see. He would not have gotten a second chance. I am trying to illustrate what happens to cars and trucks in their way back and forth to work.

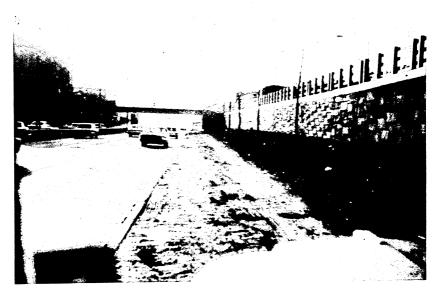
Here you see Interstate 95, and they are planting trees 2 feet off the shoulder. Other States are cutting them down 30 feet from the shoul-

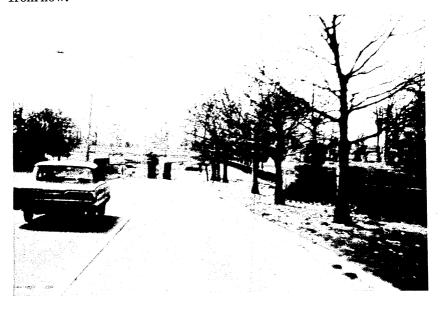
This is the way they are going to look in maybe 5, 10, or 15 years from now.

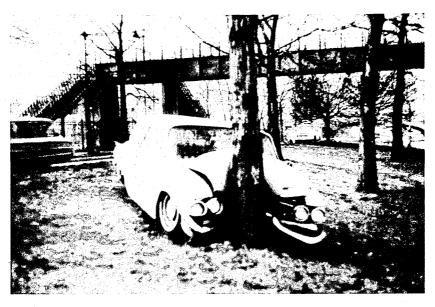
If we hit one of these, this is about what will happen—depending on the speed.

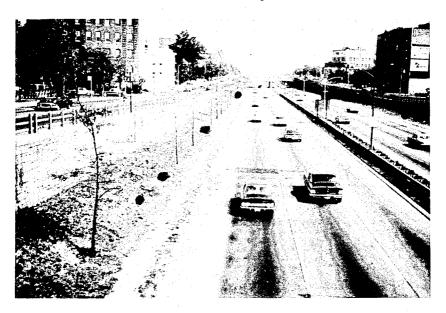
I am talking about brand new work. Here you see four of these trees on the left have been knocked down already and three on the right. If the others survive, they are going to be the killers of tomorrow. Also these trees cost a lot of money.

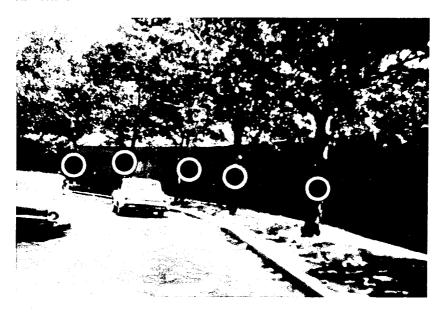
Here you see some of the old work where they have it on the outside turn. It is like an obstacle course.

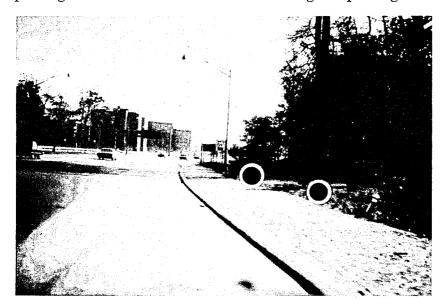
Here is a forest on the other side of the fence. You can see they are planting trees on this side of the fence. I am not against planting trees.

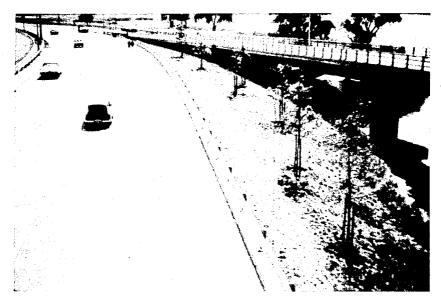
Somebody might think I am a tree hater by now, but I am not. I would like to see them survive. They cost about \$100 each, and if you put them behind guardrails, like this, I am for them.

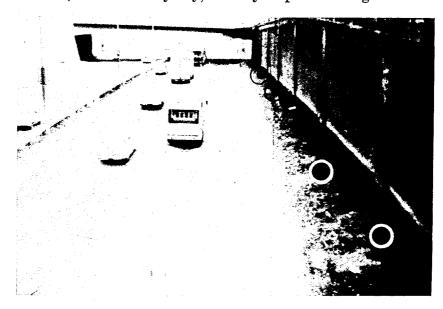
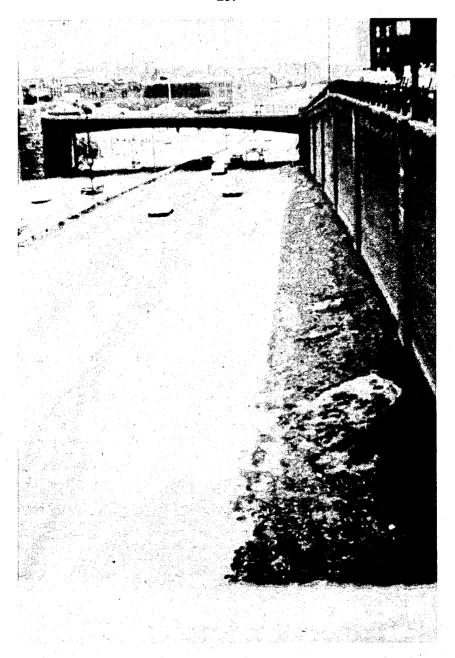
There were some spots where they were going to plant trees. I notified key officials and I tried to stop this job about a year ago. There you see the trees are there. They are small now.

It was impossible to stop this work. I went through the regular channels, I notified everybody, but they keep on building these.

You can see they are not going to survive anyway.

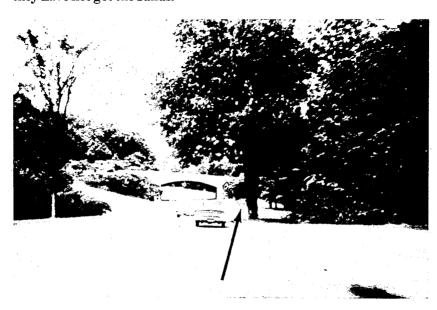
If somebody was to ask me what would I do with this tree—and I said I like trees—I would cut it down, because there are plenty of trees around here. The one on the right and the one on the left I would cut down. But if this was in Arizona and it was the only tree there, I would say install 300 or 400 feet of guardrail and protect that tree. But here there is no choice, no decision; the tree should be cut down.

I would like to see the Government help them do it, because locally they have not got the funds.

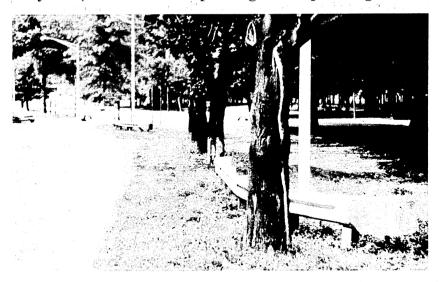
Here you see some guardrails protecting a brandnew light installation. This light pole is designed for easy shear-off. It has not even got a base. I do not think you can hit it, because it is behind the tree, and you see, there is a lot of expensive guardrail protecting that.

If you look at the end of that guardrail, you will see if anybody hits that guardrail, just hits it a little bit, he would slide right into that tree.

That tree has been scarred, hit many times, as you can see. Mr. W. May. Farther down in the picture we see a piece of guardrail protecting that light pole. You say that is a breakaway light pole?
Mr. Linko. Right. This one might show you a little better.

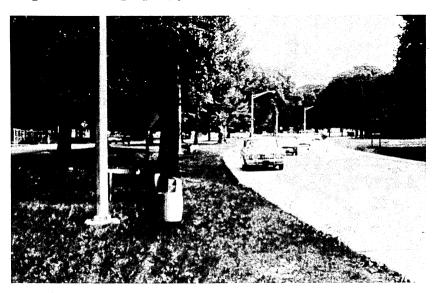
This is an aluminum pole and you just tap it; it will break off. It is designed for that purpose, you see. But as you saw in the previous

slide, there is plenty of guardrail to protect it. The guardrail is the

hazard, not the aluminum light pole.

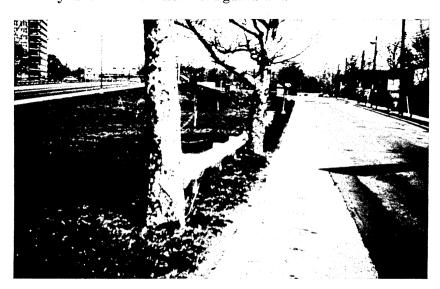
Here you see also trees in front of guardrails.

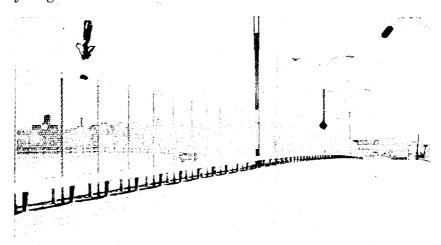
Here you see an easy-knocked-down aluminum light pole, which I recommend. Now, with this type of light pole, you can hit it at 50 or 60 miles an hour and usually nothing happens to you, and most of the time you can use the pole over again, you see.

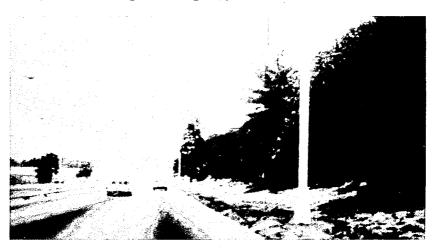
Here is a place where somebody snapped it off, and the aluminum shattered and there is a minimum of damage to your car. I feel we should consider this as standard equipment. In fact, we should make a standard on minimum shearoff on all poles along the highways. This way no unnecessary damage should be caused to an automobile. It is not more costly.

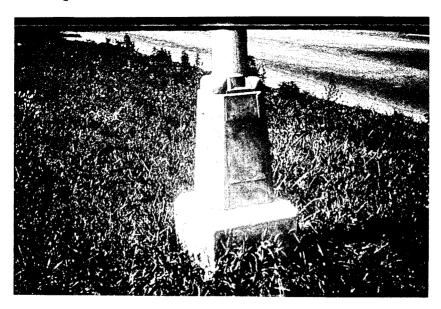
Mr. Linko. I do not know if this particular one is, but this one is an aluminum breakaway type with a concrete pedestal. If you run into this, you are not going to go any farther; you are going to stop.

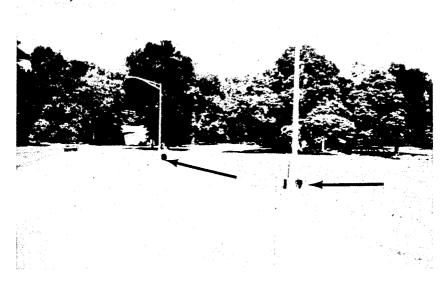
This is another one on an Interstate highway.

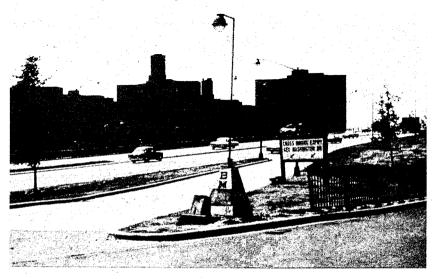
Here you see another light base which is a hazard. It is right in the shoulder area. It has been chopping up the cars for years and nobody wants to do anything about it. It is hard to see, but that edge is chipped off and as the cars ride this particular guardrail, they just knock down this pole anyway, even though the base is there, and they chop up their cars unnecessarily.

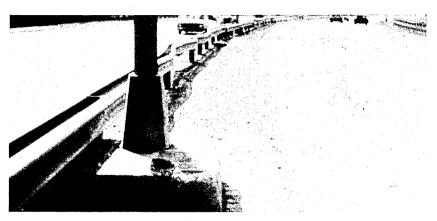
Here, also, you see an easy knocked down pole with 24 feet of guardrail, and if you look farther down to where the spot is on the bridge abutment, there is where we need the guardrail; here it is creating a hazard.

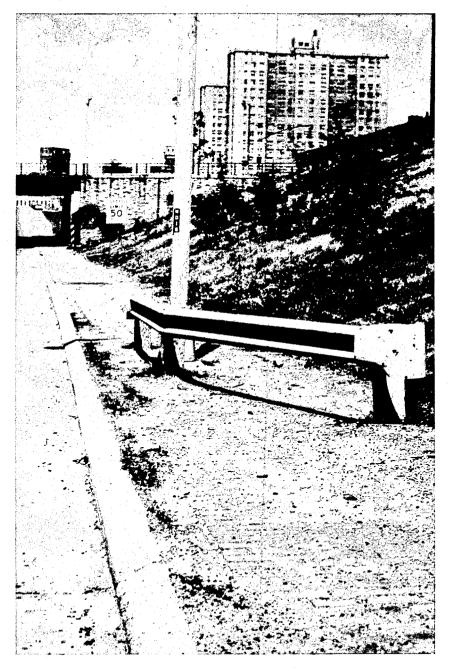
Here you see they are in the process of relighting our highways which probably happens every 20 or 30 years. I feel they are doing it wrong, because from all the books I have managed to grab hold of and read, they say these lights should be put beyond the shoulder—that means about 10 feet—and 2 feet beyond. Here you see they are not putting them back 10 feet in the center.

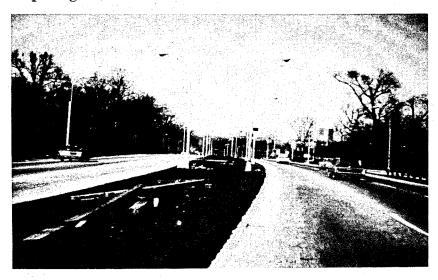
It should be done in a manner like this, giving you plenty of room to go by.

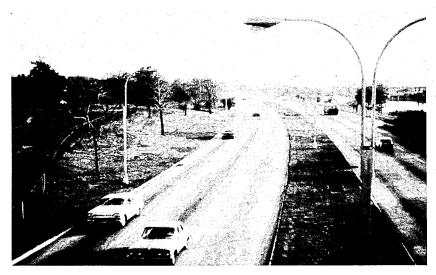
Here you see where they could use one pole and put an arm on either side, but they have two poles and they put one exactly where it is going to be hit, in front of the guardrail and right near the edge of the shoulder.

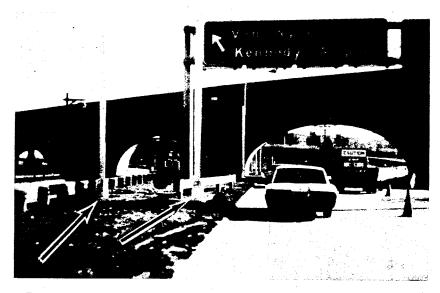
It made me mad as I watched them build this stuff. I read a book that tells them to put it 10 feet beyond the shoulder. Here they are putting it right back in the same old place. They are pouring a brand new foundation, not using the old base here. There is no excuse for it. They could have set these back. This is only a two-lane section, so they cannot say the luminaire arms are not long enough.

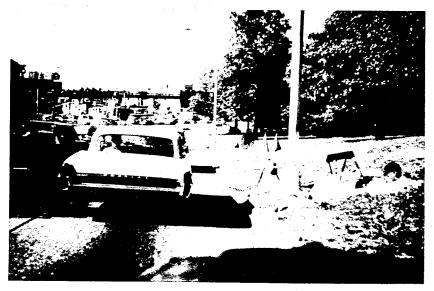
This is an Interstate section where you see them throwing it right in the shoulder. They are in the process of building this. This is one reason why I am here, because I told everybody else and nobody wants to listen.

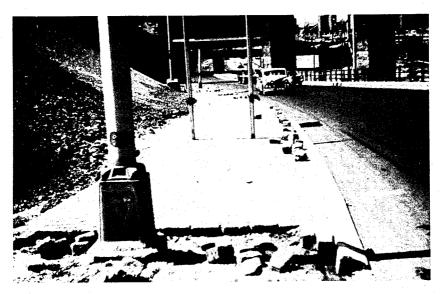
Here you see a sign right in the shoulder area, and also a light

I have seen some memorandums that the Office of Highway Safety sent out. It says not to do this, but you see them doing it and we are paying for it.

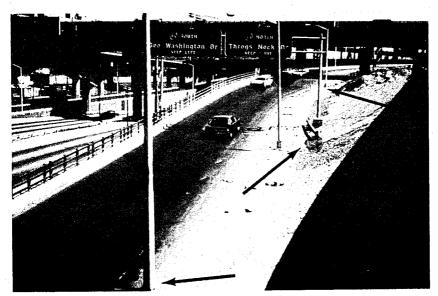
Mr. Linko. That is right. This is not a four-lane highway where you need a long arm. You are right at the edge. There is no excuse for this. This is brand new work and it is part of the Interstate System. System.

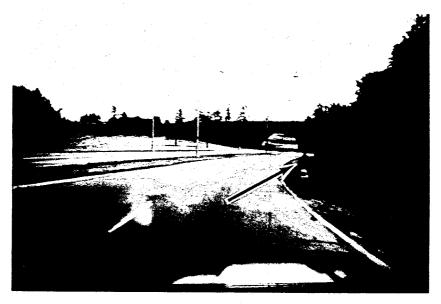
Here you see two that were hit at the same time.

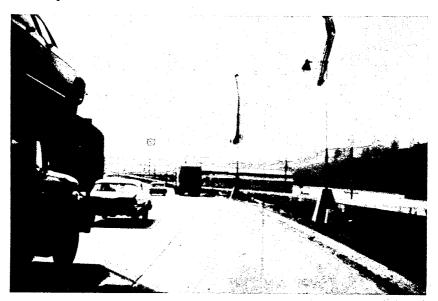
Here you see three that were down. Notice the brand new bases on them.

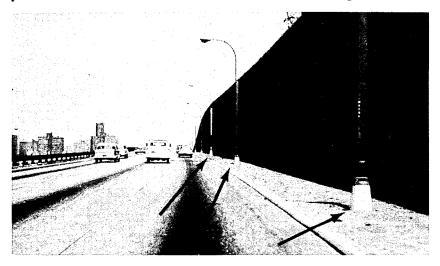
Here is where four poles were knocked down by one truck, all at once. And you see a couple of dots on the left showing they could have been put on top of the wall.

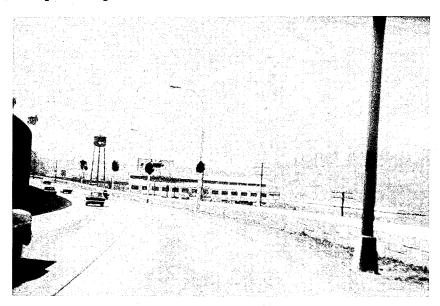
In this manner, you see. Nobody would ever hit them up there. You can save a lot of money.

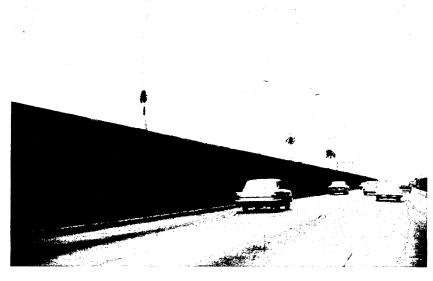
Here you see the 10" by 10" wood pole. New York City is tearing them down by the thousands and replacing them with aluminum poles. This is Long Island Parkway where they are installing them in front of guardrails.

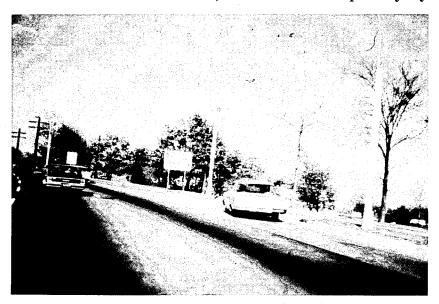
They have been hit.

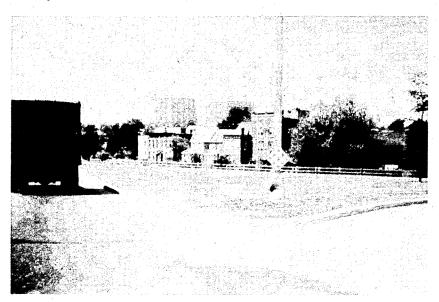
That one has been down.

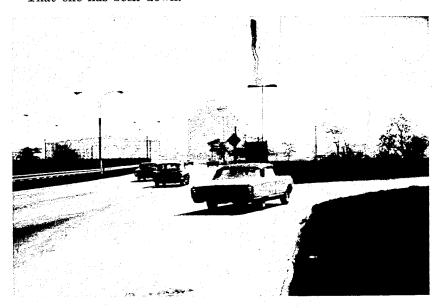
This is all new work. If that is not bad enough, you see the 12 by 12 concrete poles protecting the light pole?

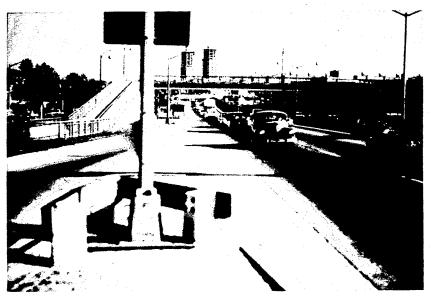
If someone goes through there, they chop up the poles anyway; the light goes down anyway.

car from knocking the pole down anyway. They get through, damage the car, the passengers go through the windshield, and the light pole goes down anyway, as you can see here.

And I feel the least we can do is go back and rip all of this out. This is on an Interstate highway and I do not think you need it here.

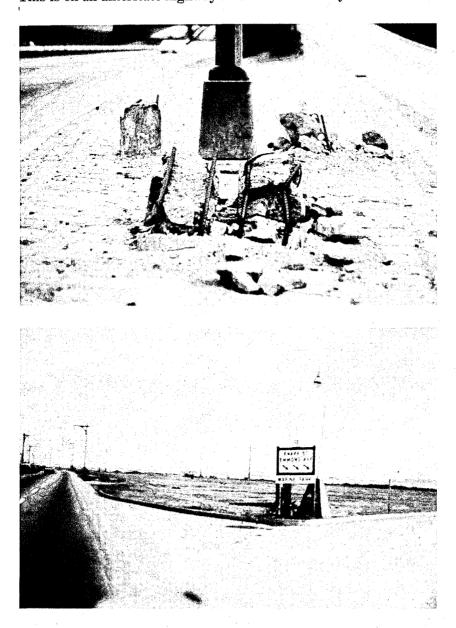
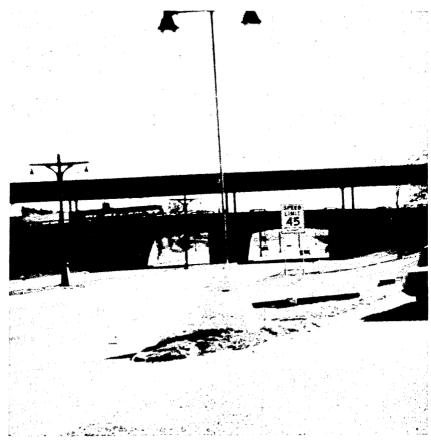
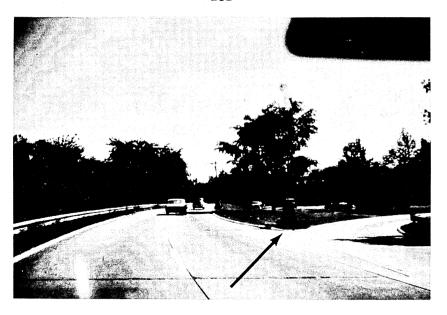
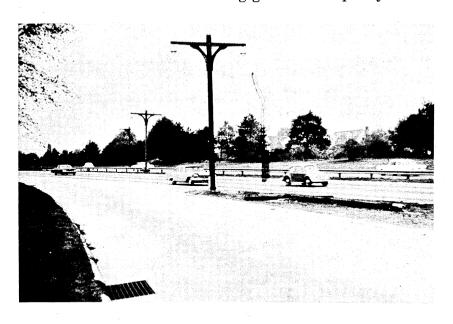
I have five different shots showing gore areas frequently hit.

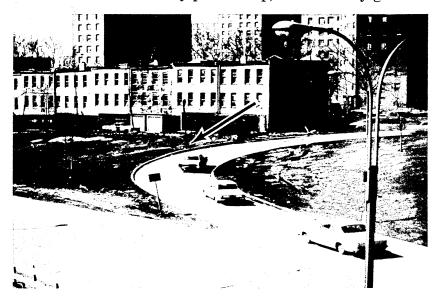
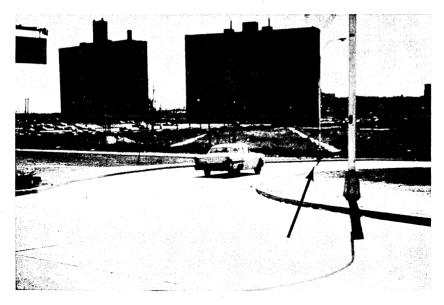
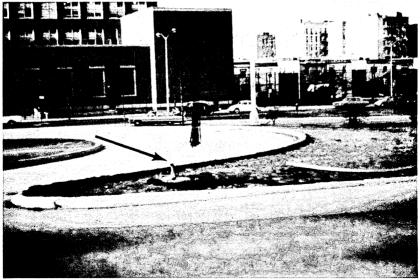
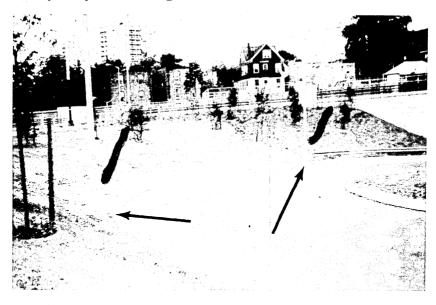
Here is a light placement on a curve. Now, this particular light has been down about 10 or 15 times. I have about six or seven photographs, and you can see the various types of poles that have been used here. It has been hit many times, but they would not move it. All they have to do is put it on the inside part of the curve and nobody will run over it there.

They are relighting highways and still installing lights on the outside turn. The faster they put them up, the faster they go down.

They really do not belong on the outside turn.

Now, a car cannot help pointing in that direction. It is downhill. You have an outside turn. Even if there is no ice on the ground, they

manage to get into these lights.

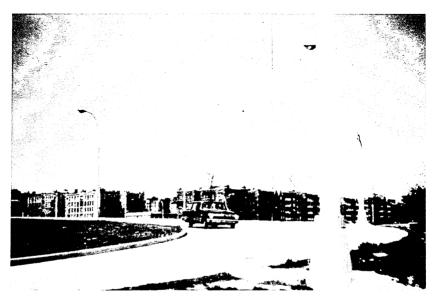
Next I will show you a series of pictures where it was decided to relight this median strip here. I took most of these pictures during the winter months primarily to show how often these lights get knocked down. It happens every year. No one groups them together so it does not look bad, so I did it.

Look at the median strip and the curb in these slides. They have angles or tapers to the curbs, and yet there cannot be any parking along there. If they were to put in a 10-inch curb, half of these poles might be saved.

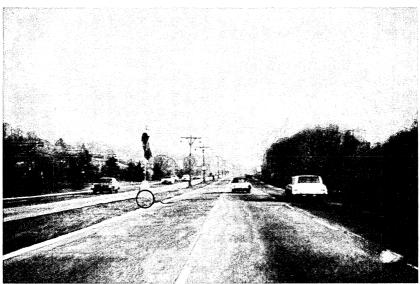
As fast as they put these brand new lights up, they get knocked down. These are all new lights just being installed.
(At this point, Mr. McCarthy assumed the chair.)

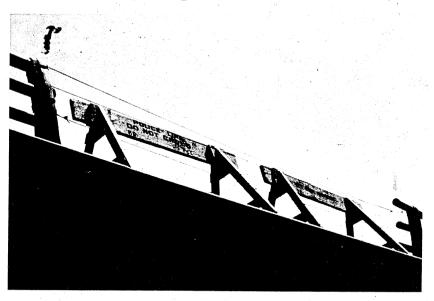
A car ran through this bridge railing and dropped about 30 feet. These particular bridge railings are made of aluminum alloy. I feel they have no business using this kind of material on a high-speed road.

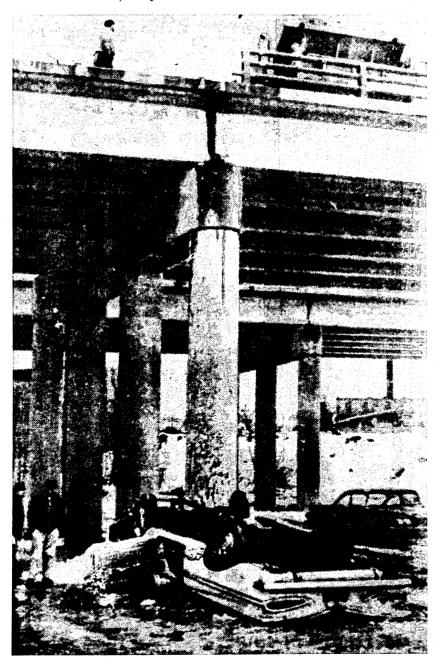
Here, this particular location there, you see they have a rope there temporarily.

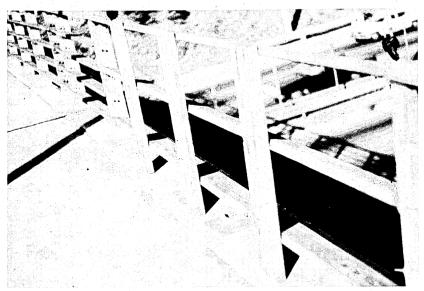
This is a different type of a guardrail. This is made out of aluminum also.

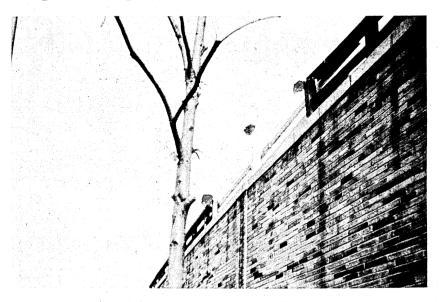
This is another aluminum installation. You can see it just snaps right off.

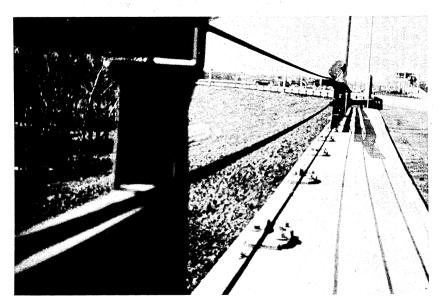
And this is another one.

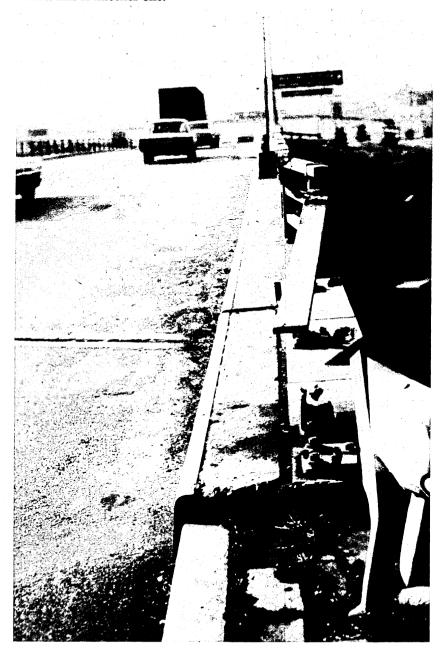
And here is a patched-up job where they put a section in there. Take a closeup look and you can see how they put it together. They are not even fastened. Kick it and it goes off.

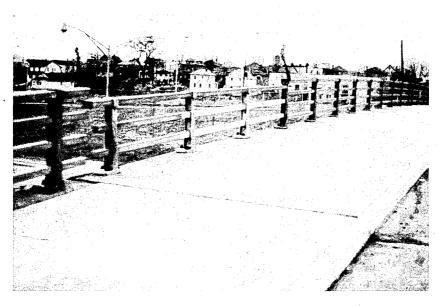
And here is another place that was struck and the rail gave way. There is a street below.

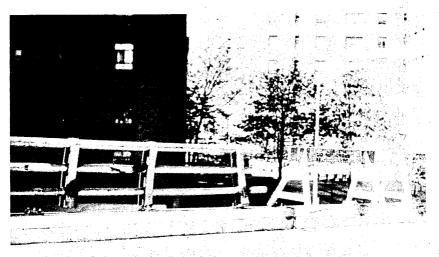
This is another aluminum installation. Nobody hit this particular installation. From expansion and contraction, this particular railing worked its way right out of the ground.

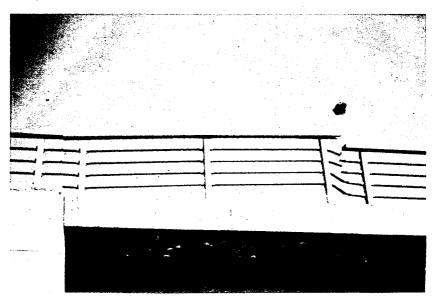
This is the type of aluminum railing.

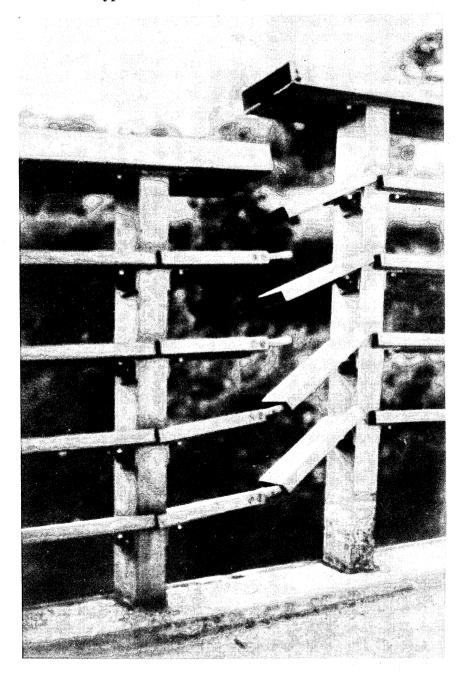
Here I would like to point out that this is a section of the aluminum railing I have been showing you. You can see one of these uprights has snapped completely off. There is not a mark on that railing. That means it could not have been hit hard. Aluminum alloy is not a strong alloy, so what they do is they temper it. In tempering it to make it hard, they also make it like glass. So if you just tap it, it just snaps right off. That is what happened here.

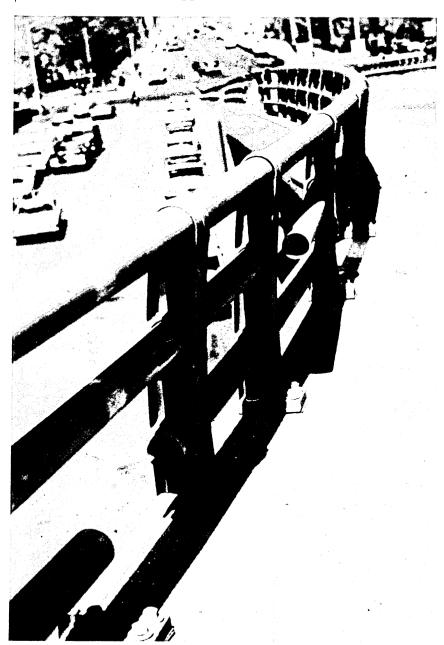
Just so you do not say this might be an isolated condition, here is another section in a different location showing there is no damage to that guardrail at all, but yet the part that is supposed to hold you from

going through snapped right off.

I feel we have a serious condition here, because most of our Interstate highways in this area have this type of guardrail. If cars can go through so easily, what is going to happen when a truck goes through there? Or maybe a busload of children? Or a gasoline truck?

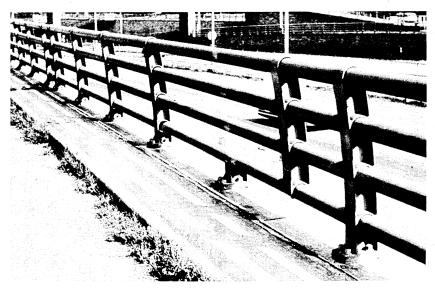
Now, here you see the aluminum guardrail protected with a barrier. This is in New Jersey. I guess they know it is not safe there, so they put a barrier there as a guardrail to keep the cars out.

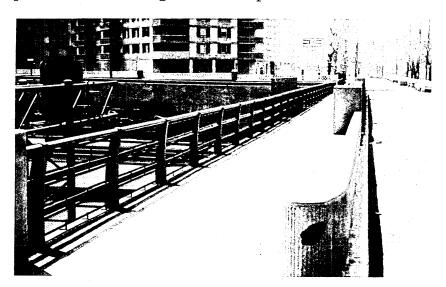
As you can see here we have trouble constantly. I am showing you all different locations so you cannot say it is only there.

I feel a simple solution, when you are pouring the concrete walls, is just to go up a couple of feet higher. I do not think it will cost much

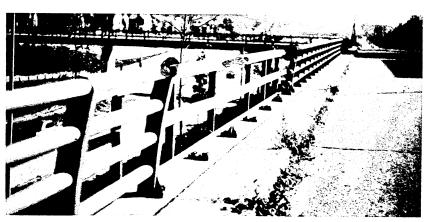
more money. Then you can put the handrail on top. The other type of railing, as you can see, even if it is steel sometimes, they do go through them.

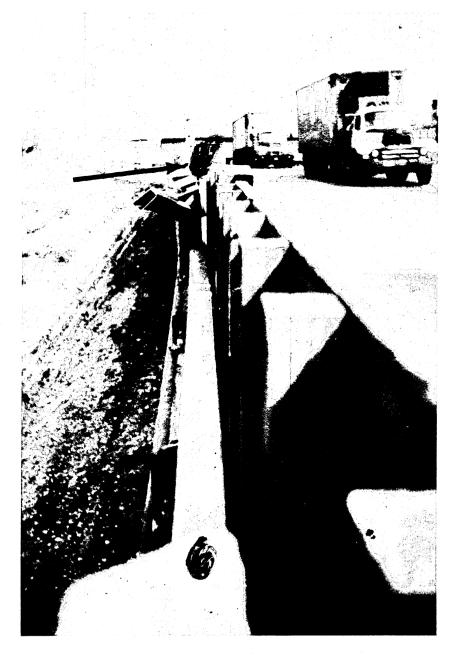
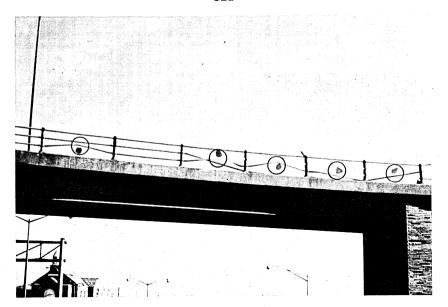
the upright is only 2 inches wide here. When somebody hits that, it will snap off right where the weak part is. In other words, you have 2-inch uprights holding this up. I am sure it cannot hold back cars. And this shot proves it, because as soon as somebody tapped it, it broke off where the 2-inch section is.

This is what happens when you just tap it lightly. If you hit it hard, you go right through.
