HIGHWAY SAFETY, DESIGN, AND OPERATIONS Roadside Hazards

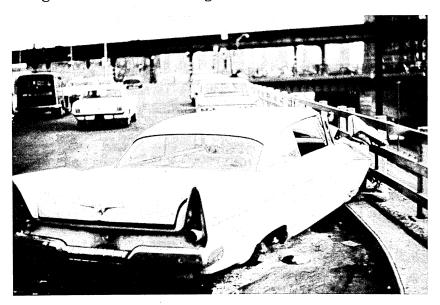
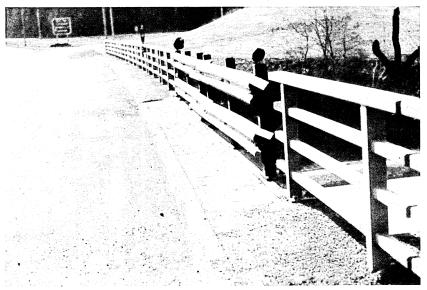
This is also a steel rail and I feel it is a pretty good rail if it was tied together. Here you see it was put up in sections. Now somebody hitting the thing just knocks out two sections and defeats the purpose of the good design in the rail, which is to be solid in the particular case. And I feel that you should go back to these points and maybe run a W-beam right through to provide a sliding action and to protect the rail from damage and keep the cars from smashing into the ends.

I feel we should do this pretty soon, because what are we waiting for?

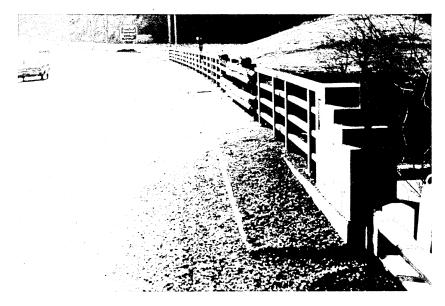
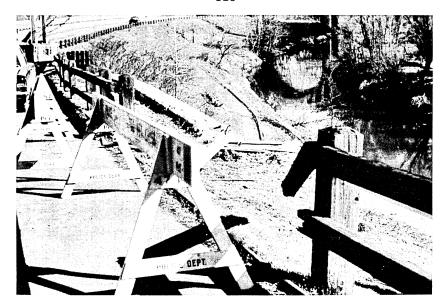
Here is a wood railing protecting on a bridge. A car ran right through, as these two pictures show, and went into the water there and the driver drowned.

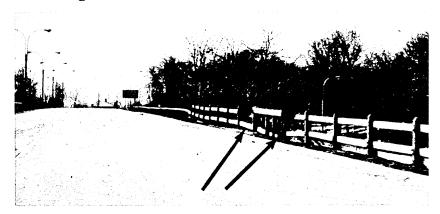
Here you see the railing on the left-hand side is rotting away. I do not know whose responsibility it is to maintain that, but it is not

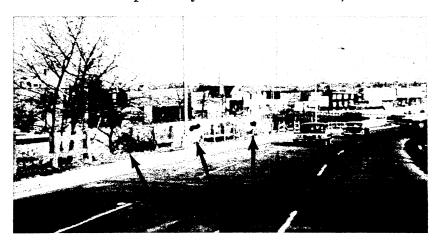
Here you see a chicken fence to keep cars from going through. This happens to be a railroad track and some car went right through that fence.

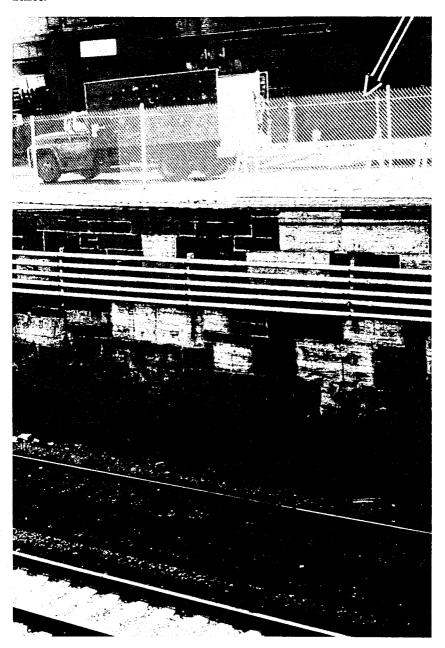
Here is the place where it went through. If you notice, you have a bridge railing there in advance, a solid railing on your left, on the bridge. But alongside, on the side road, they have just the chicken fence. They have high speed trains going by there every day.

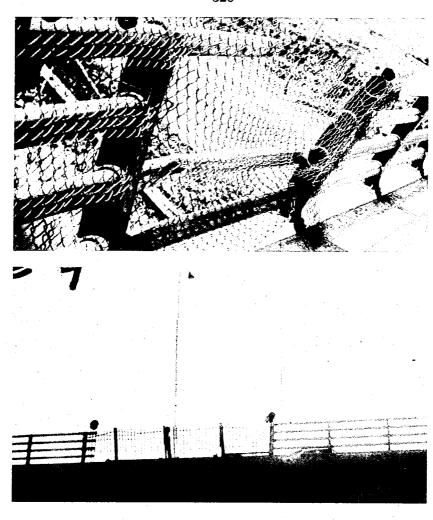
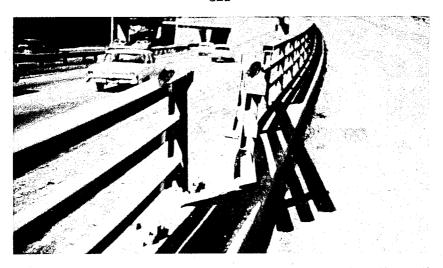
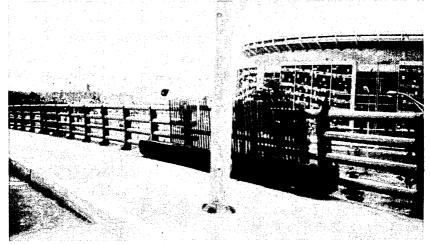
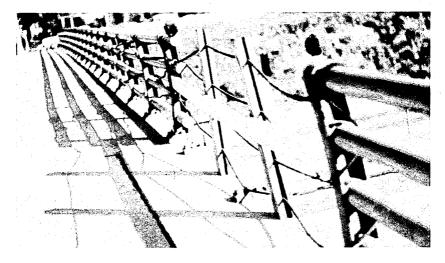
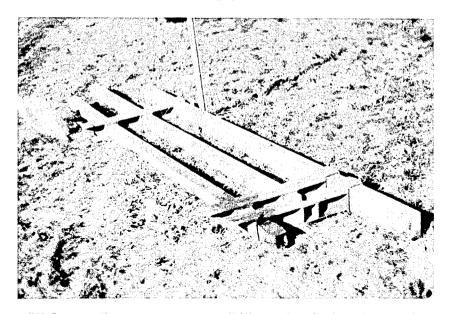
go through because they show there are many places being broken through.

The way they are now, they are just handrails, not designed to keep the cars on the road. You can see in several cases there is nothing bent there at all; everything snapped off. That is because the stuff is hard and brittle, like glass.

We have to live up to our responsibility and go back and strengthen these rails.

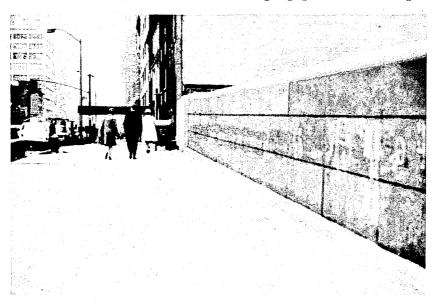
I feel we can use no-see-through fences like this. This is not an intersection, and there is no sight distance problem involved as far as safety in that respect is concerned. I think we should use no-see-through fences. The kids would not throw anything because they would not see themselves hitting the target. They have no satisfaction, you see. I feel we should use corrugated aluminum of some sort. Paint it a nice color; it does not have to look ugly. It would discourage people from throwing things on top of cars.

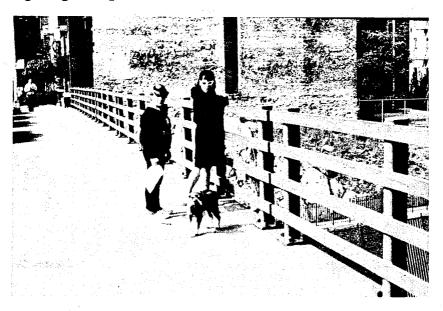
Let's take this particular location. It is not an intersection and if you had a no-see-through fence here, I think it would be an advantage. Also, take a look at the large space between the bottom rung and the edge of the walk; you do not have to do anything wrong here. Someone might have been shopping and the shopping bag could break and a Pepsi Cola bottle could fall on a moving car 40 feet below, smashing the windshield.

We should realize some of these problems and fence some of these things.

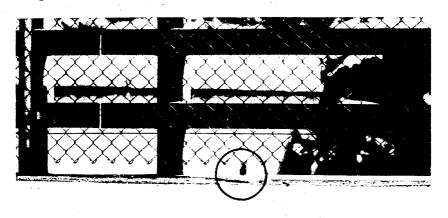
Even when we fence, we have done a halfway job. Here you see a whisky bottle laying where the spot is. I put it there myself because

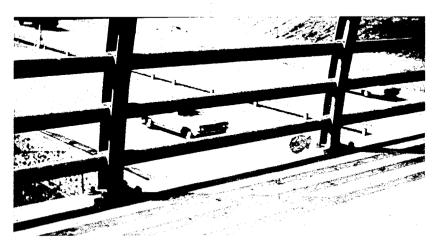
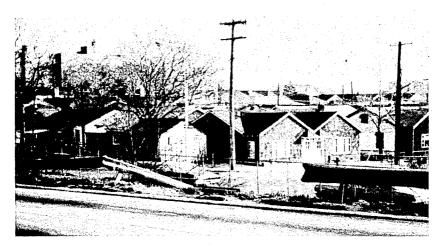
This covers some aluminum W-beams. I feel we made a serious mistake using this type of material. I favored aluminum before when I talked about use of it on our light poles and bases. I told you it had no strength and it snaps off and does no damage. That is exactly what it is doing here; it is snapping off.

Now you can see somebody tapped that. Instead of providing a sliding action, it snapped off and they ran right through.

This is the same location as the previous one from a different angle.

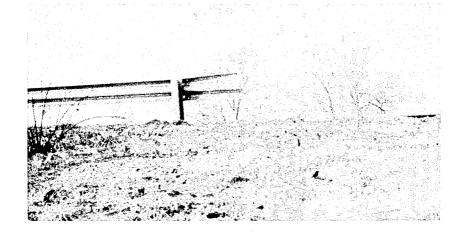
Here you can see that the guardrail is not even damaged, but yet the thing is snapped off. Some of the material has been used on our Interstate highways, too. If they cannot hold back cars, how do you expect them to hold back trucks?

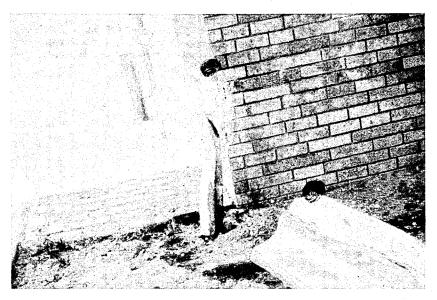
Here, it snapped off.

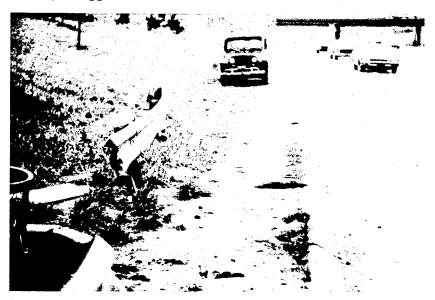
Here you can see where somebody went through a double rail. This is a downhill curve, right where you would expect.

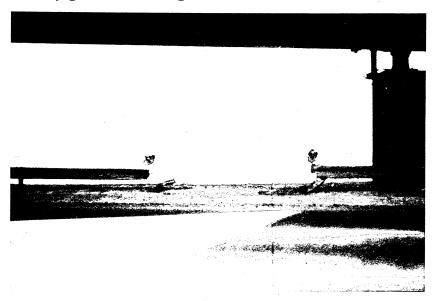
Here you can see where somebody came through also. The broken guardrail is pointing toward you, and that is a double rail. These are only cars coming through here, not trucks. This on an interstate highway.

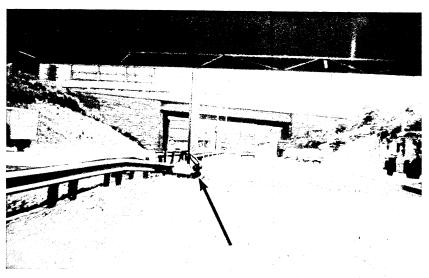
Somebody died at this location here. The double rail is broken. These two show broken rails.

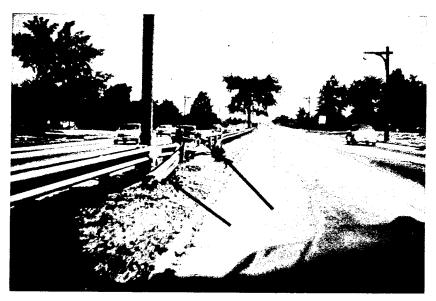
Mr. Linko. I do not know what happened here. I read about this in the paper. After seeing all this inferior type of guardrail in an outdoor area, I said to myself, "I wonder what kind of guardrail was protecting this particular one?" They ran through a guardrail here. I just pointed this out, you can expect something like this to

This is an urgent matter. I think we have to live up to our responsibility; go back to all these guardrails and bridge railings and fix them up so they can hold vehicles traveling these Interstate highways.

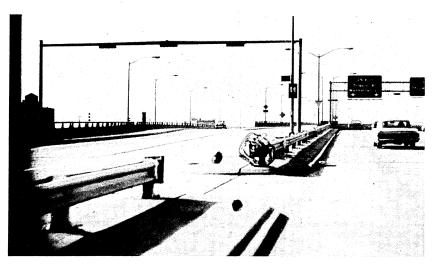
This points out improper installation of guardrails and anyone riding along this guardrail will smack headon into that other section. I feel that if you just reverse this guardrail where you see the dots, then it would be impossible to hit either end of the guardrail as is now possible. This is dangerous.

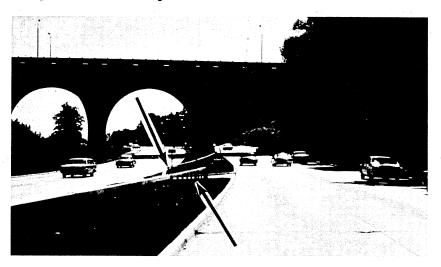
Here you can slide along there and it is impossible to hit the end of the opposite rail. They could have done the same thing at the other location, but no one was thinking.

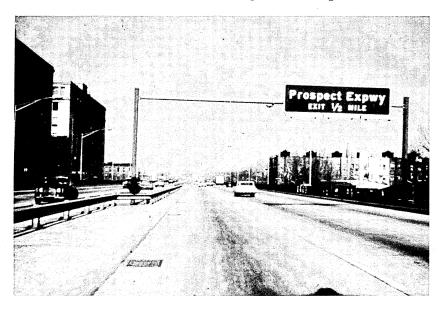
Here on this side you see it is impossible to hit this pole; you can slide past. But the opposite side is not sufficiently protected.

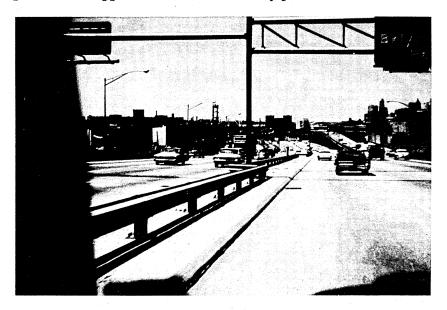
Or you had a choice of putting it inside the center, like this, where you have a sliding action on both sides. But most of our signs are not put in areas like this.

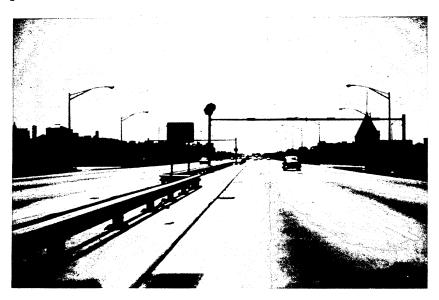
Even in a particular case like this, they should never angle it out at the severe angle that you see here, because if happens to slide along, that severe angle may throw you back into traffic. They should not angle that so you slide out into traffic.

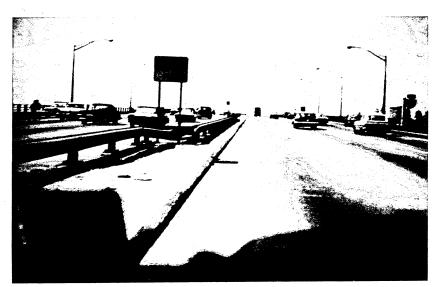
We have failed; this is the damage you see constantly; people running into this—unnecessary damage.

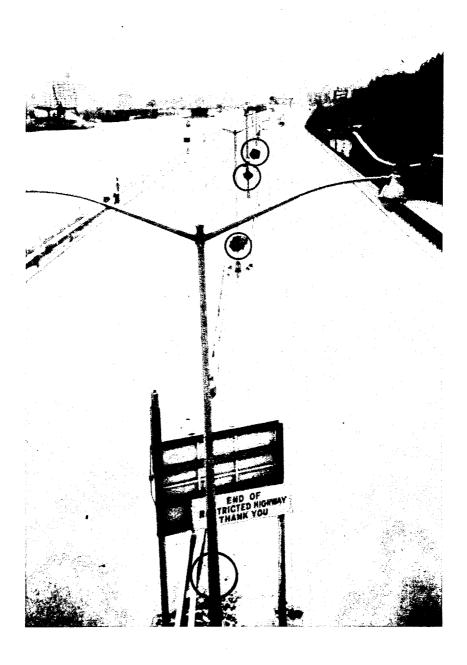
They should be put inside of the walls, or on the top like this. You cannot knock this down; this is much better.

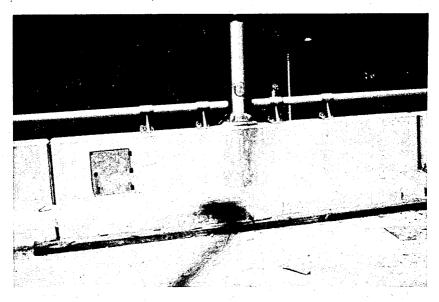
If you look on the right, you can see that is a good job. But on the left in the center this is what you will see. You have the lights lined outside

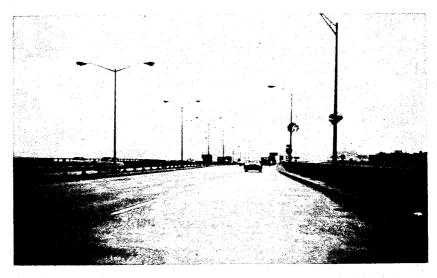
with the guardrail and these are the ones that I told you about. I counted hundreds of them hit every year; they are constantly being knocked down.

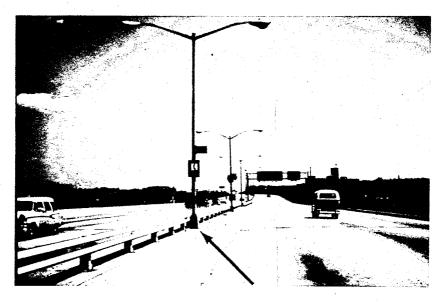
These have been knocked down; they have temporary bases.

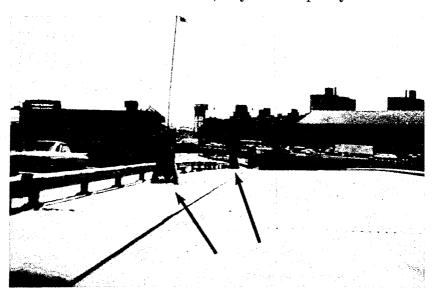
Here you can see half the job again.

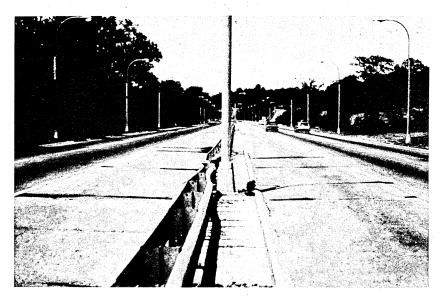
Not only the lights; you have fire alarm boxes there also.

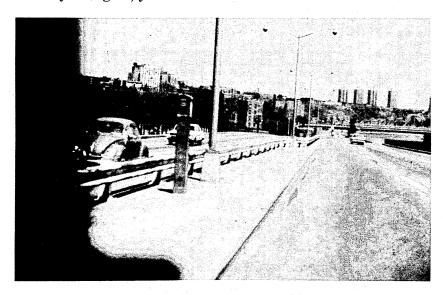
Here you can see, we do not tie the guardrails together but we leave open spaces between the lights. As a result we have constant damage to light poles and unnecessary damage to cars that hit these rail ends. You can see that rail end sticking out where the dot is, lined up for the next car. If one hits it, it is in serious trouble.

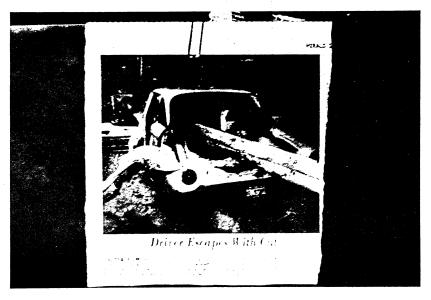
Somebody pushed that in. With the height of that guardrail end the way it is the next guy who goes through there will have the rail go through his windshield. And as I said before, it takes them a long time, as much as 2 years, before they get around to repairing some of these. This is an invitation to death.

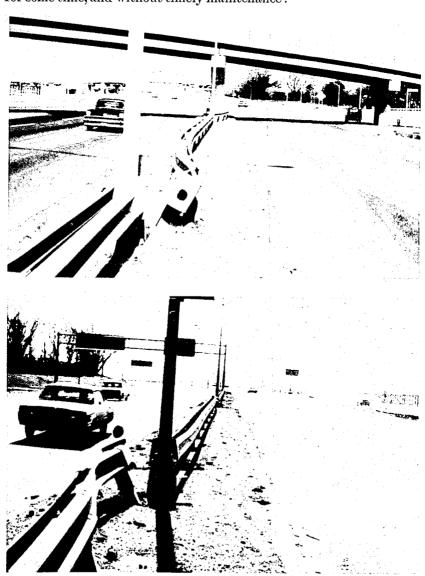
Mr. Linko. In this particular case, it was only a week, but I have pictures pointing out where these guardrails have not been repaired for 2 or 3 years. They are dated; I have proof.

I feel it is more important to fix the guardrails at once than put the light poles up.

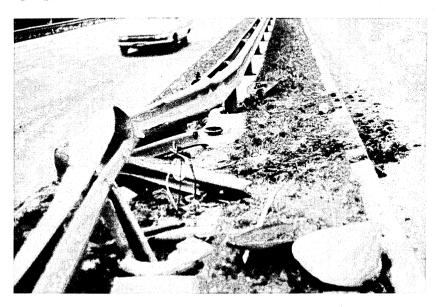
And this is what happens when these things are hit. The light pole will go down anyway and the guardrails are sticking out.

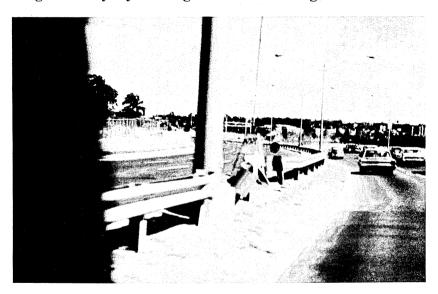
Here you have two targets. I feel we should go through all of these places and install another piece of rail on either side to provide sliding action. It might help save some light poles, and I am sure it will keep you from slamming into these ends and bases and give you serious damage.

Because these ends are not tied together, all of this unnecessary damage is caused. If it was done the right way you could have had a

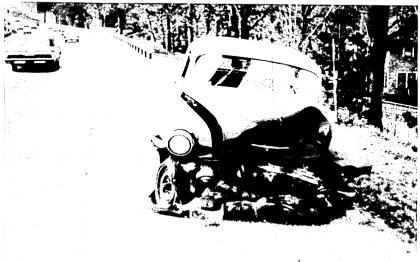
And here you can see the base sticking out. The rail ends where the dot is. Someone slammed into that and knocked down a light pole.

Because you do not have continuous rail to utilize the full strength of the steel railing, we get a lot of unnecessary damage and the light poles are going down anyway.

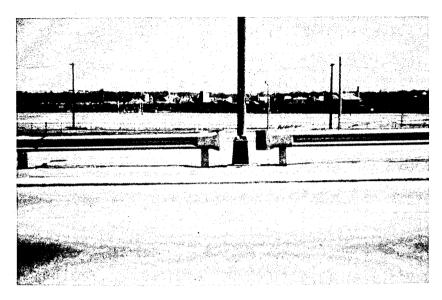
This is what I am talking about, you see. That seems to be the standard installation.

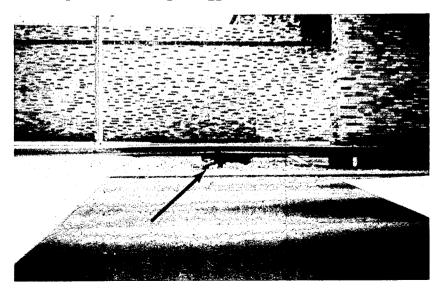
Now, this is the proper way to install these lights inside the center guardrail. This shows we know how to do it. We have to get to it. Wherever we messed up in the past, in some way the money has now got to be supplied fast. Actually it will pay for itself because of the current damage to these poles and the constant knockdowns.

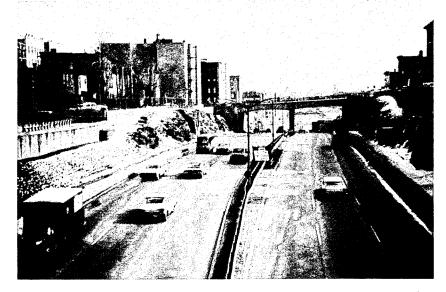
Here you see, on the left side you have a heavy sign support that can stop you dead and split your car in half. Beyond it is a light pole on this side. These could have been placed inside the center rail and the hazards eliminated.

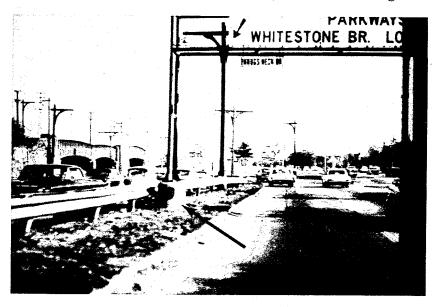
Here you can see on the right-hand side where we robbed 15 feet of the shoulder area that could be used by the motorist, if needed. As it is anybody can get behind this guardrail. The guardrail is there to protect the bridge abutment, but you can ride behind and slide right into the wall. The guardrail is installed wrong and is using up some of the space that belongs to the motorist.

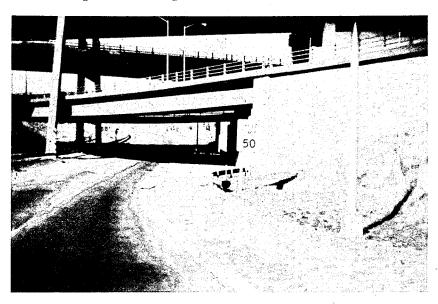
Here you see a guardrail that could have been phased right to the wall to provide sliding action, but this seems to be standard practice in New York to leave that section there to hook onto.

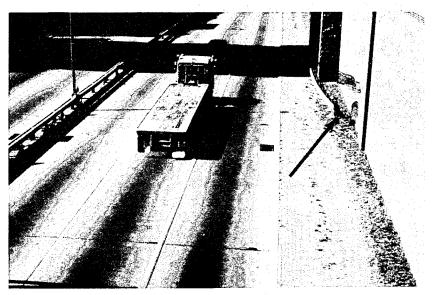
Mr. Linko. Everywhere we look we have failed to provide sliding

action. We are wrecking cars, rather than scratching fenders.

Up ahead at the underpass you can see where the rail was phased into the wall. However, see on the right where they didn't protect another hazard.

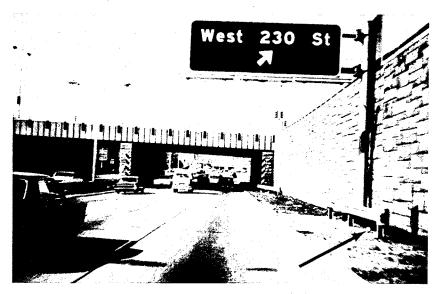
Here you see a place that has been hit. It could have been a scratch, but because of this it wasn't.

By the way, this particular installation has not been repaired for about 6 to 8 months. Once you hit it, it lays around until a big contract is given for an entire section.

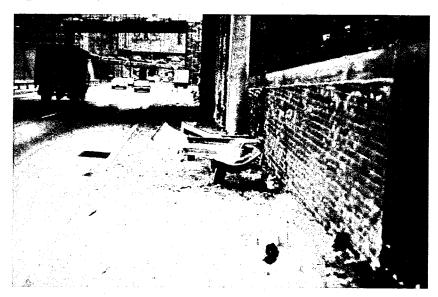
This points out if you bolted this end to the board, a car could slide by. But that 15 inches is enough to grab it.

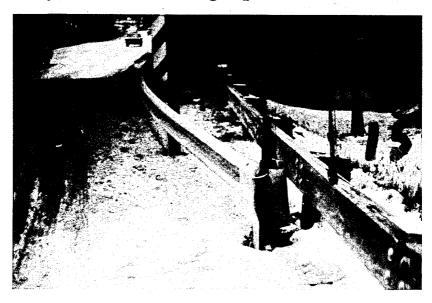
If you look at this, riding along you think it is a good job; but I went up and took a close view of this.

First, let me point out there is an offset, or bridge abutment, that is not needed. This is a depressed highway and you should not need or have such abutments on depressed highways.

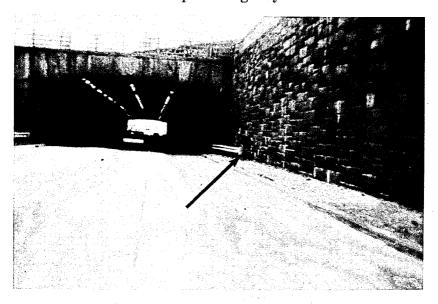
In trying to make up for and protect a 15-inch abutment, the guard-rail put there doubled the target; now it is 30 inches out. There is a lot of guardrail that cost a lot of money there, and actually there is more chance of grabbing onto it than you had to begin with.

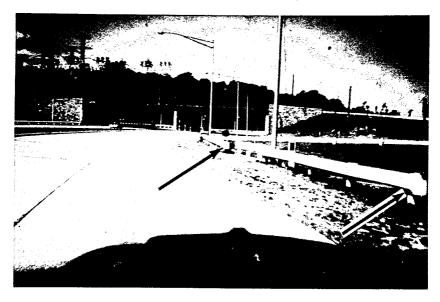
Everywhere you look, you will see where we have no sliding action. Look at the end of this guardrail staring at you. Also there was a

gap between the rails up by the light pole and they came along and put a short piece in behind the existing rail—what good is that?

On the right, somebody busted right through there, because there were two pieces of rail which were not tied together. There should

have been one continuous stretch.

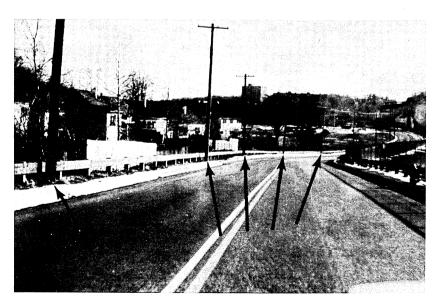
The property on the other side of these poles belongs to the State, so that is a poor excuse. They just are not thinking. Anybody sliding along these rails will come to a dead stop.

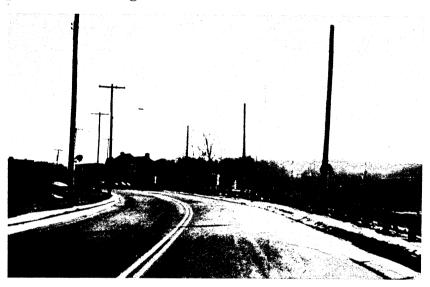
There is another location. This is silly.

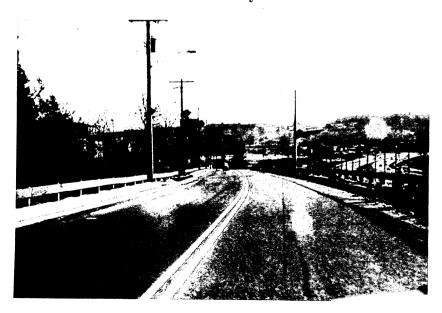
Now, this is a steel pole, 14 inches in diameter, that will split you in half. There is a guardrail on the left and there is a whole bunch of trees back further in the picture, but you barely see them. Every one of these is in front of the guardrail.

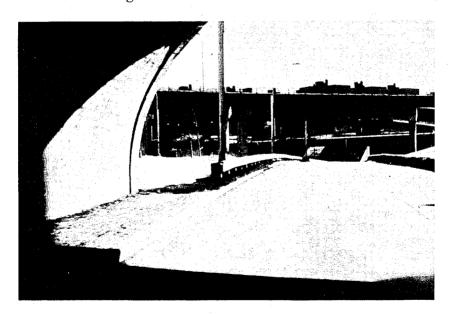
There must be something wrong when you see things like this on the highway, especially on new highways. All of these guardrails are installed wrong.

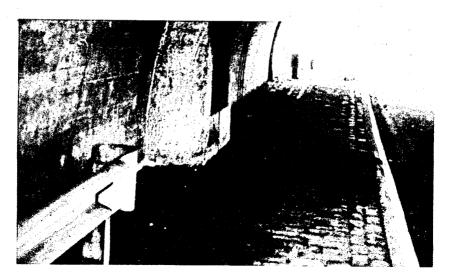
This should be behind the wall. These are designed to stop you. Not only do you damage your car, you damage the rail, and we have to pay, pay—for no good reason at all. Next I have a series of slides on rail ends.

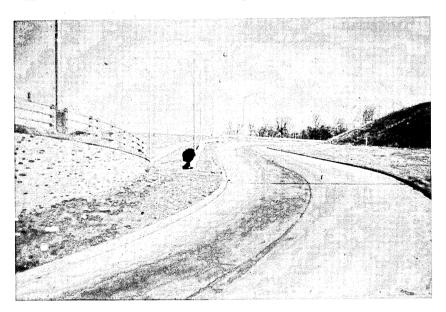
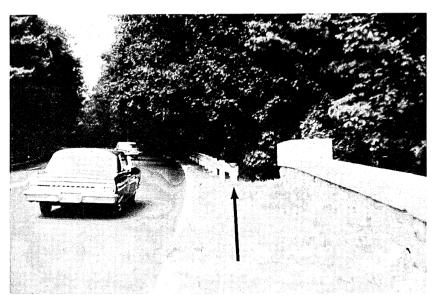
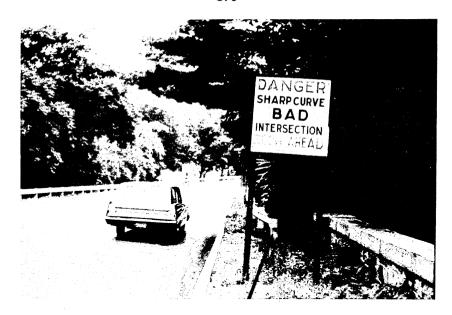
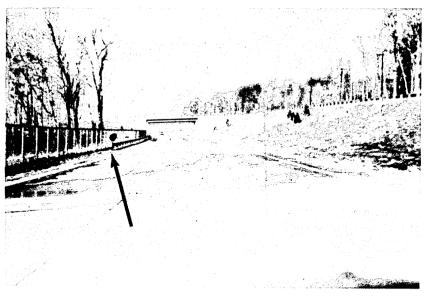
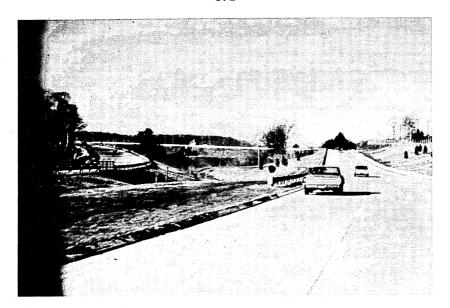
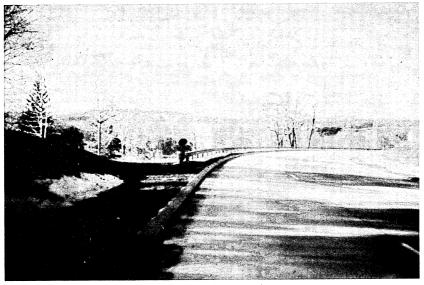
All these rail ends should be buried; these are dangerous.

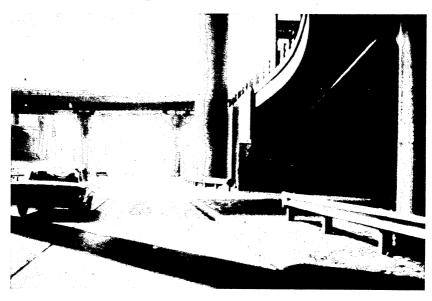
Here you see they stopped the guardrail where you needed it the most, right at the bridge abutment.

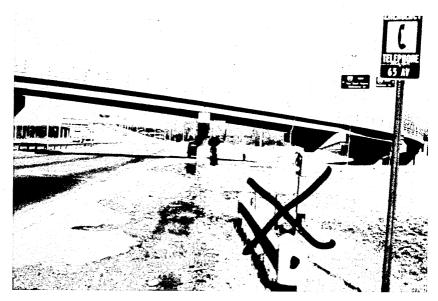
Here you can see the guardrail protecting a firebox that could have been put at the bridge abutment there. You can use that guardrail to protect the bridge abutment. There is none there.

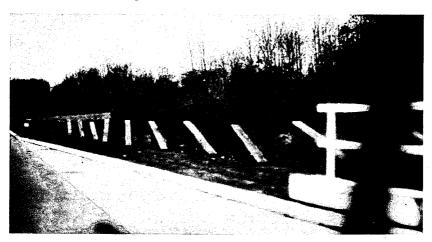
Here, wooden planks are being used on a brand new parkway in our area. This is 1966 or 1967. The speed limit here is 50 miles an hour. These wooden planks cannot hold back a car.

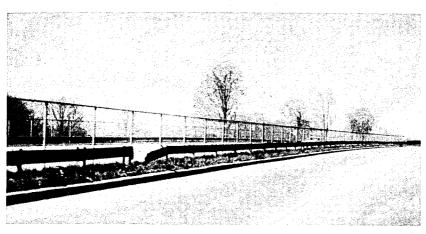
They will split off. If you do not believe me, here you see one.

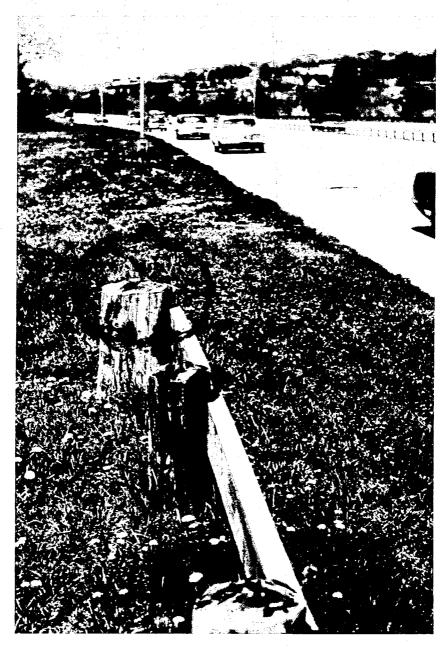
Here you see a post that is 15 inches in diameter. Disregard the rotten pole, the second one. You should put a weaker one in the front there to give a guy a chance to knock it down instead of stopping him dead.

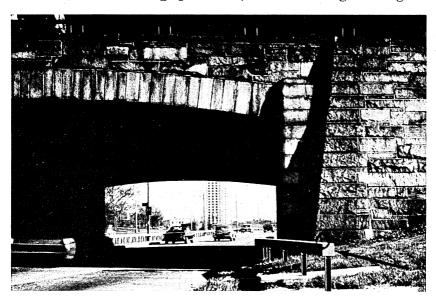
Here you see the brandnew square-type box beam, the best rail we have and I think it is good. They call for burying the end, but because the end is sticking up like that, a car can run right through it.

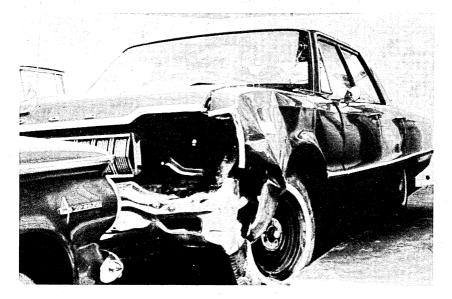
Here you can see where a square beam went right through this car and came out on the other side. This driver was lucky; it went right by him. Maybe it will go through the next guy. And this is very new work.

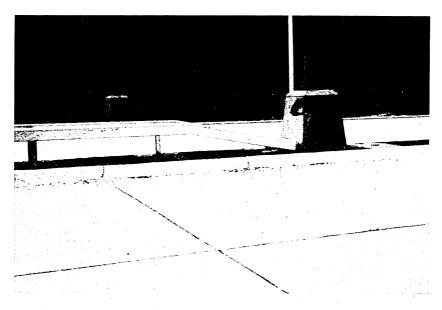
When are we going to learn? Here, they tapered the box beam rail down to the ground which is what they should do ordinarily, but not at this location. If you drive along this rail, you are going to hit this base.

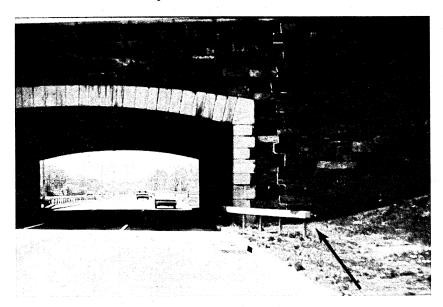
This is what I am talking about. If you get up on that shoulder, you will head toward that abutment, but you will never reach it. You will be killed first by that railend.

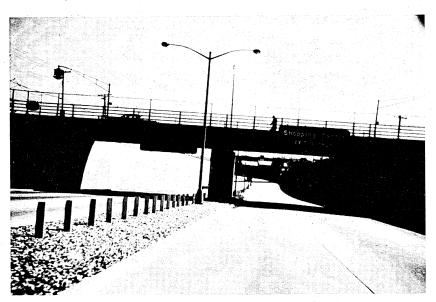
This is about maintenance. There never used to be a guardrail at all of these abutments so they later decided to put in a guardrail. But it takes many months and I feel it takes too long to finish the job. There should be more consideration for the motorist. Here you see where they started to install a new center rail.

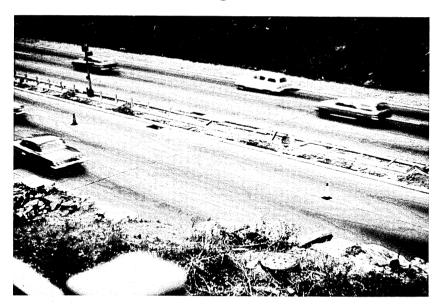
This shows the urgency where these guardrails are needed. The maintenance people are getting mad. They are knocking down the posts before they can install the guardrail.

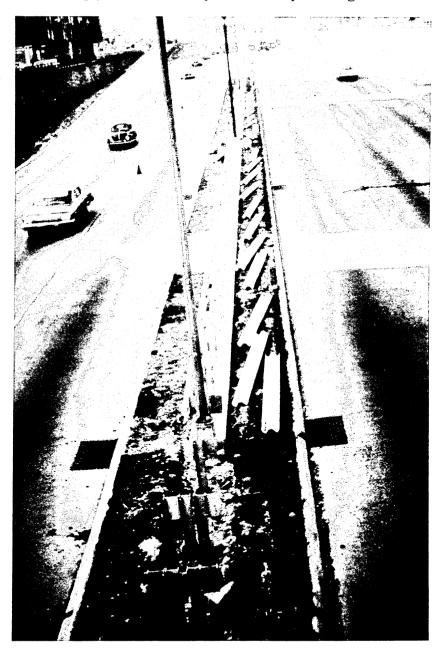
What they do, they place the beams along the side— to discourage the people. If you get tangled with these, you get in trouble, but they want to keep you off there. They are not really thinking.

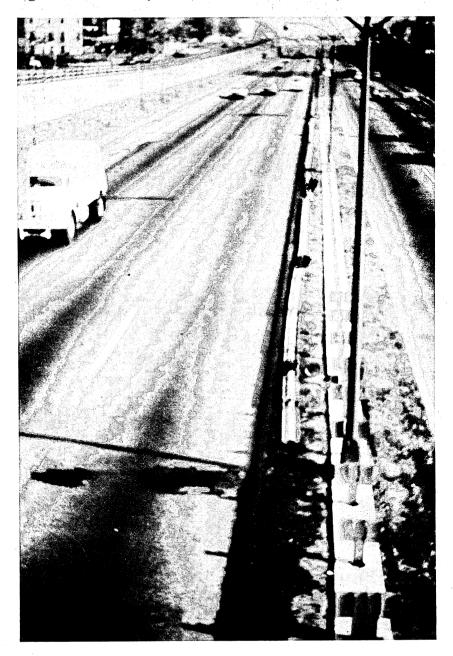
These are hazards when you tangle into them. I feel we should regulate construction jobs to cut out these unnecessary hazards.

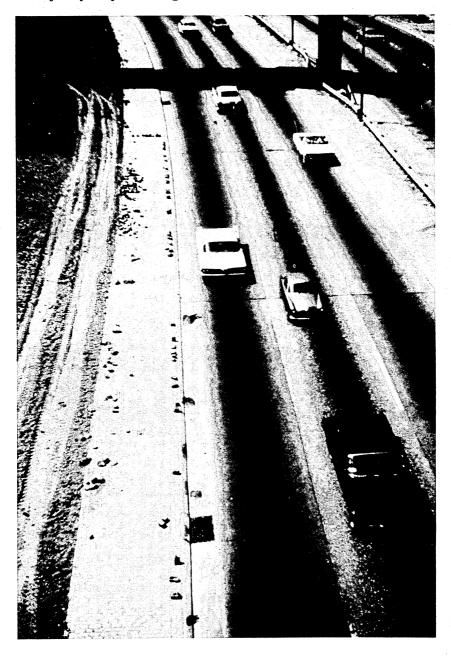
Here you see these small bricks or cobblestones. They measure 8 inches by 7 by 6 inches, and they are used to divert traffic. That is exactly why they are using them on this job here.

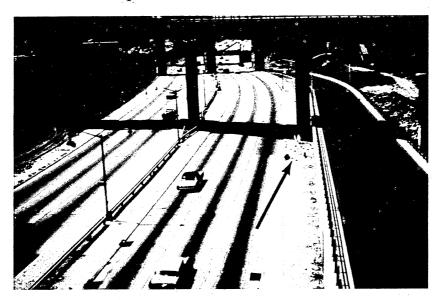
You can see that if some car hit that area just right it could blow out a tire. This is the way they attempt to keep traffic out of these areas. This is a standard practice.

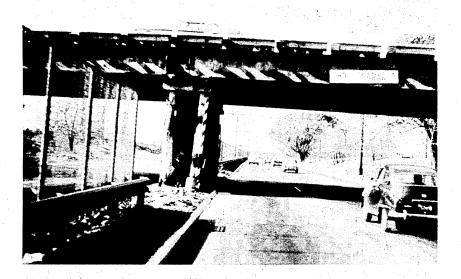
But others are not. Some of these stand like this for 2 or 3 months and provide no protection, they are hazards. There is more hazard now than before they started. They are not using this particular location, this area here; they leave it over the weekend. They should replace this guardrail here to give the motorist a break.

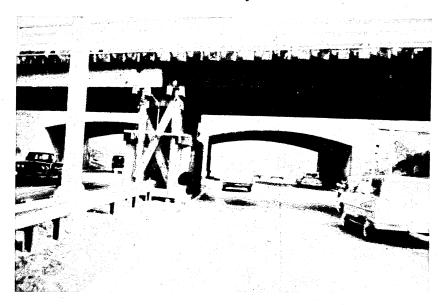
As you see, that is a target right at the edge of the road. All you have to do is deviate a few inches and you hit an abutment.

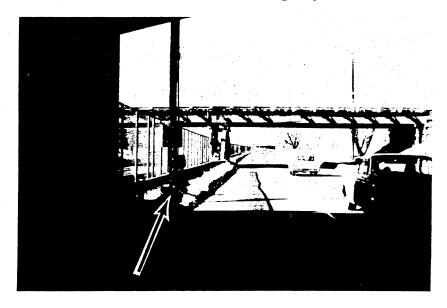
Here you see a telephone pole, but no marking, no reflector, no nothing.

Here you see a rock that has been there for almost 2 years. The only reason I think it stays there, I don't think one guy can lift it to put it on the truck. But it is a serious matter.

That is a big stone there. Any car running into that is going to have a serious problem. This is an Interstate highway. I understand the

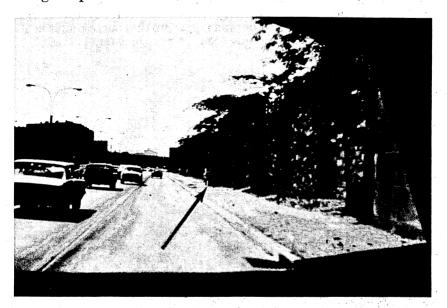
Here you see a steamroller left on the side of the road over the weekend with no markings or anything. Somebody could run into that and get wiped out.

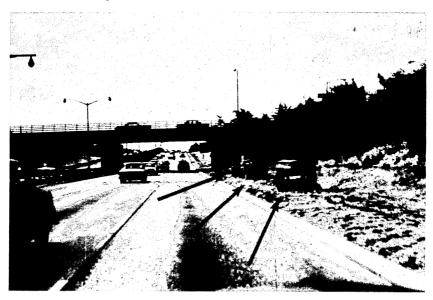
Here you have three separate pieces of equipment left on the road. The least they could do is put them all together. You would have one target. Here you have three separate targets. In fact, the right way is to take them up in front of the bridge abutment and put them behind there so you cannot hit them.

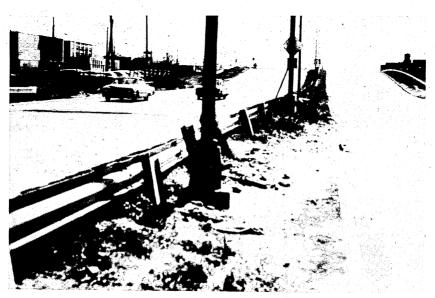
This guardrail is broken—has been for 2 years—and never replaced. Finally somebody came by and replaced it, but forgot to make a double rail and put the guardrail on this side for sliding action. The day they put it up somebody came by and wiped out the section there. They knocked down the light pole and ripped up the concrete abutment up farther. And it is the same way today, 4 months later.

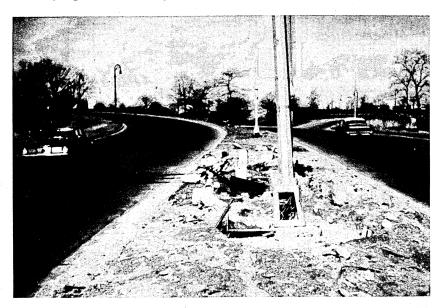
There used to be a guardrail here also until it got chopped up. It has been laying like this for 2 years.

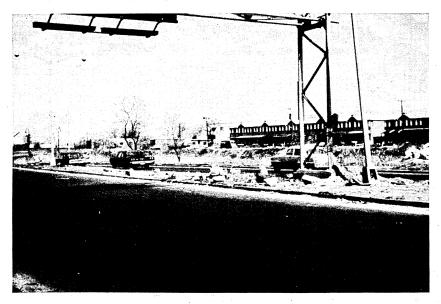
That concrete stump was there for 2 years. They just recently took

it away.

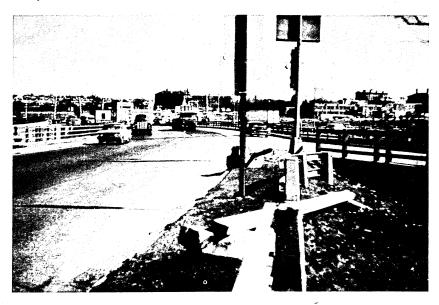
Here you see a pole protected only from one side. It was hit from the unprotected side.

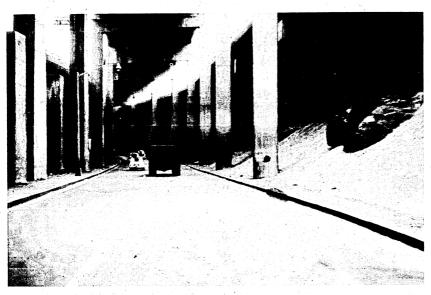
This used to be a safe highway until they put this new highway over it. Now you have the targets on the outside turn.

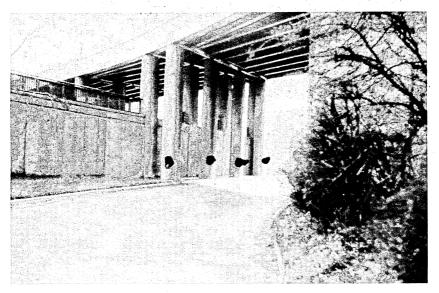
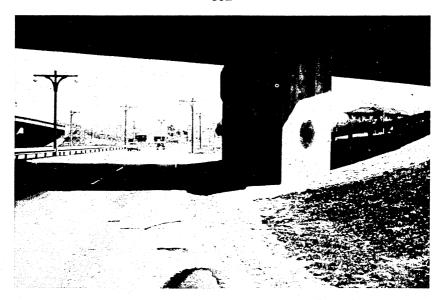
And these. This is new work, and when they do the new work the old road is overlooked.

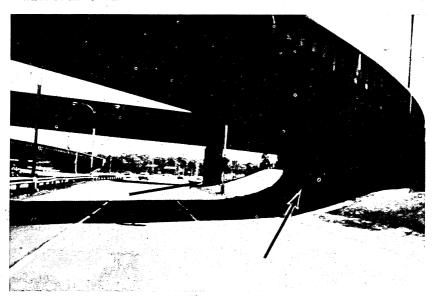
Here you see a line in the fence in the background. This is a new bridge that is being built on top here.

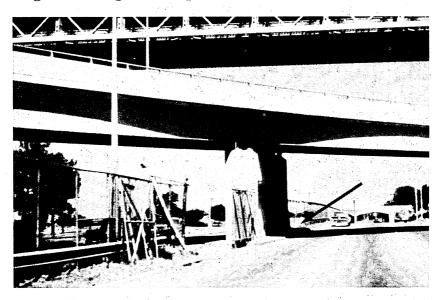
There is the finished job. There used to be a guardrail here, but now that they have finished the job you have an unprotected abutment. This is a serious matter. If we do any new work, we are going to have to protect it.

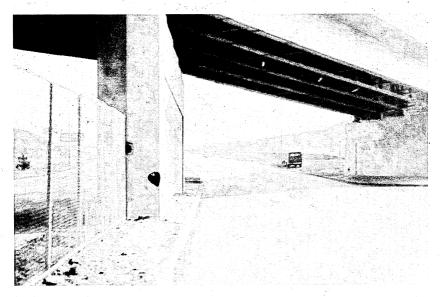
Here you see many targets with low curbs.

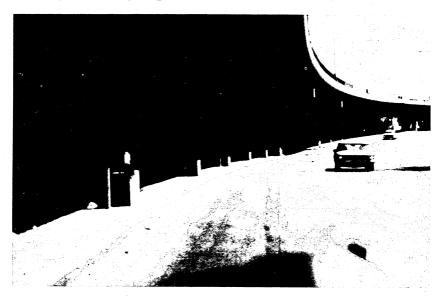
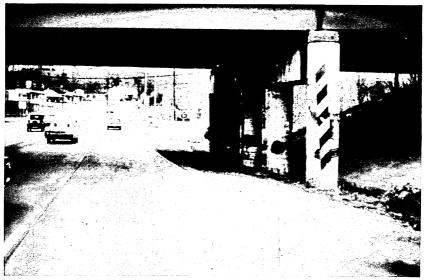
This has something to do with maintenance. See the sand barrel sticking right on the shoulder area?
