## HIGHWAY SAFETY, DESIGN AND OPERATIONS Roadside Hazards

Mr. W. May. Mr. Chairman, today we are going to receive an analysis of the Capital Beltway primarily from a statistical and road-side hazard viewpoint. At a later date in the hearings, we shall receive additional testimony on other aspects of the beltway.

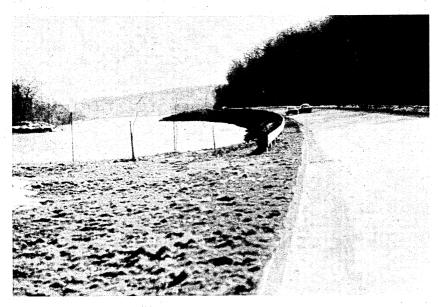
Here you see a guardrail supposed to keep cars from going into that river. It will not do the job. Somebody could go right through there and drown. Those trees won't do the job either; they're too small.

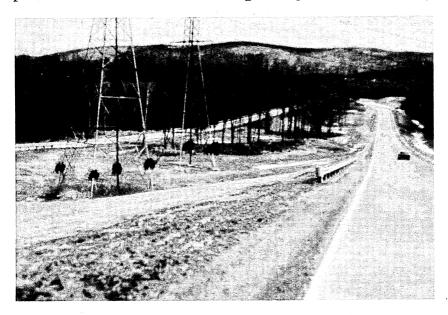
Here you see high-voltage wire towers. Anyone riding over this curb will have gravity to help them go down and they will just cave in that particular installation there and the high-voltage wire will fall on top

of the car. I feel you need a guardrail there. A large truck can roll over the cable.

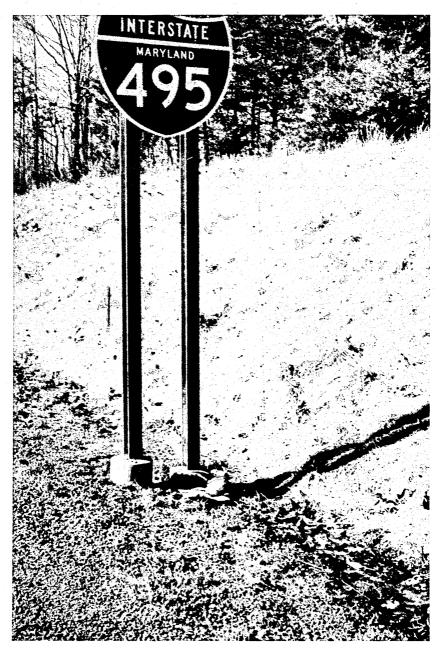
However, the shield is on top of those two steel I-beams. That shield is 36 by 42 inches. It is mounted on two steel, 4-inch I-beams, which are mounted in 3 feet, 6 inches of concrete. That is a concrete base at the bottom of those I-beams.

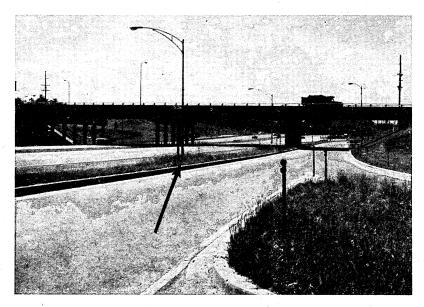
After the accident, the sign was put back up. This is a photograph I took subsequently of the exact location of the accident scene which we just looked at. Now the sign is mounted on one 4-inch I-beam.

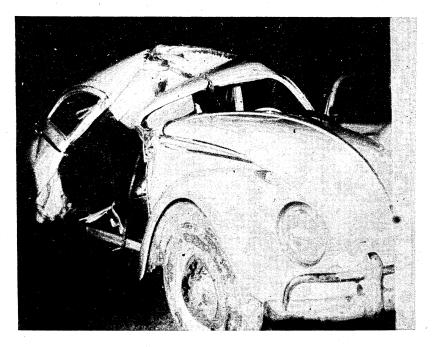
And this is what can happen to a vehicle which hits one 4-inch I-beam. This was a 1966 accident. The driver in this car was severely injured.

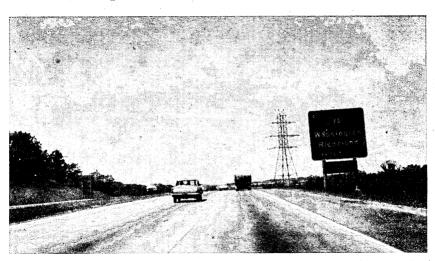
Mr. Chairman, this is a typical sign known as a destination sign, which you will see on the Capital Beltway. Again it is extremely large, mounted on steel poles.

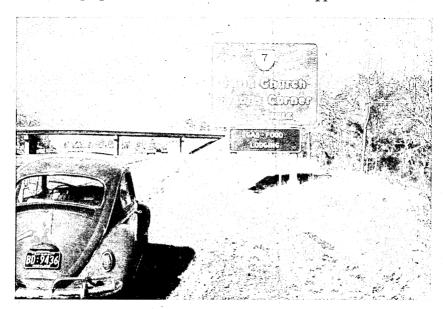
And here we have a concrete drain (indicating). Now the staff has seen photographs and the results of what has happened to a vehicle

which has gone down this drain. It could lead you right into this sign

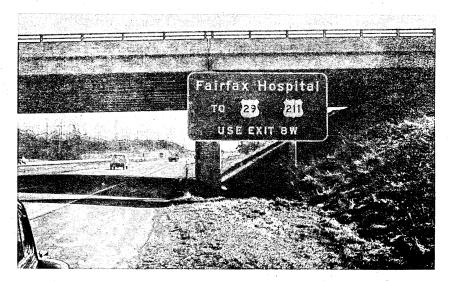
Here is another sign on the Virginia side of the Capital Beltway. Again, the sign is mounted on the steel post embedded in concrete; but this time it is up against the bridge. And neither the bridge piers nor the steel posts have a guardrail to shield a motorist who might run off the road and run into it.

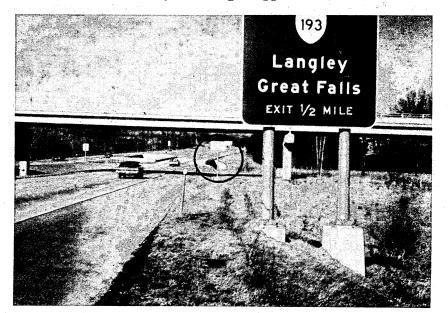
And here is another sign on the Virginia section of the Capital Beltway. I have shown this one to show you the amount of concrete which is above ground, especially on this right support.

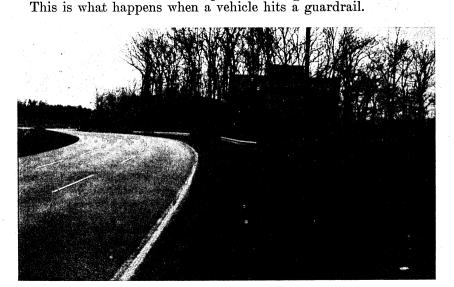
Now this installation of guardrails is typical of what you will find in Maryland. This particular scene is just west of interchange 19 on the Capital Beltway in Maryland. And look at this area, if you will

You have a road which is curving at this point slightly to the left. Here is a fixed object, a steel light pole embedded in concrete. Here is the end of a guardrail meant to shield this sign. Yet there is an open space in here. The guardrail could have been longer. It could have come down here [indicating in front of light pole]. Here they have discontinued the guardrail for a distance of 40 or 50 feet [indicating beyond sign].

There is a drainage area in there. They could have carried it in here [indicating between two guardrails]. Back beyond the end of the guardrail here is a speed sign, mounted on two 4-inch I-beams,

which could have been moved up behind the guardrail.

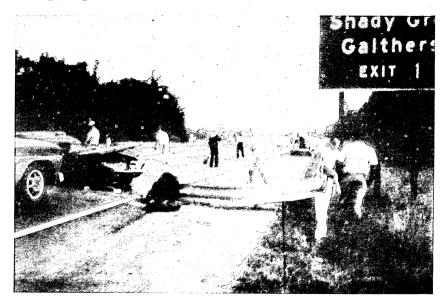
A couple of months later a similar accident occured on Interstate 70–S, and I show this photograph only to show that this guardrail installation is typical of what happens on the beltway and other roads. This guardrail which was facing us, as we are looking at this scene, is the end of the guardrail. This is the vehicle which ran into it. And in this case you notice that the sign is mounted on wooden posts. The runoff area is fairly smooth. It is not even, but it is not a deep drop either.

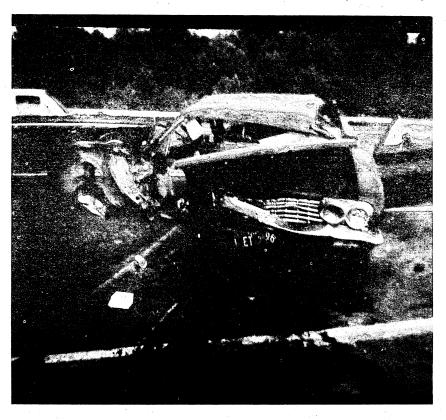
And here is a closeup of that same car. The driver of this vehicle was severely injured. He was alone. Maybe we should say fortunately.

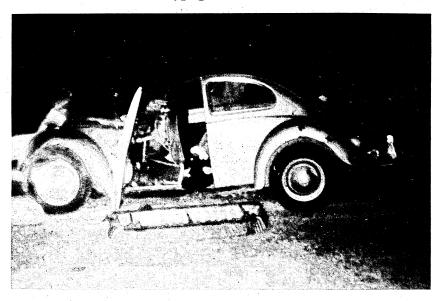
It extended beyond the car. One person was killed and one person severely injured. The same type guardrail installation.

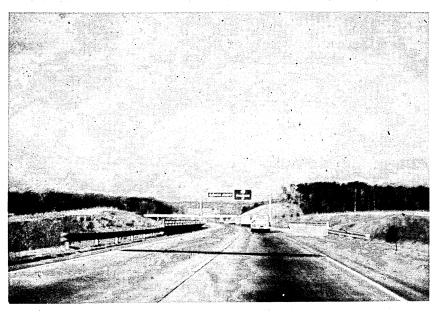
We can go to Virginia and we can find similar situations. Here you have a guardrail approaching a bridge. Here is a guardrail not flared back on the left. The guardrail runs up to the bridge parapet. It is not anchored. On this side the guardrail extends back somewhat like an arrow. It ends at the bridge parapet. In this case they have taken the shoulder through the bridge.

Mr. Prisk. I do not think so. The tests that have been made, and certainly the lessons that are displayed all too gruesomely with experience as recorded on these slides, I think teaches that the ends of guardrails need to be taken back away from the road, flared, anchored, otherwise smoothed into the approach alinement so that you have a smooth surface where you have to introduce guardrails.

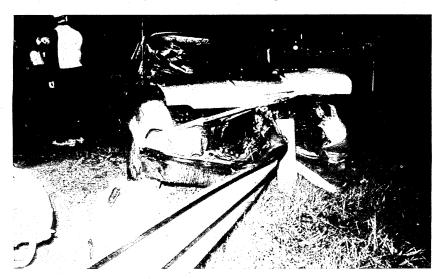
And here again is an accident in Virginia in 1966 where a driver hit the end of a guardrail, and the guardrail end went through the window, through the car, and killed the driver in this case.

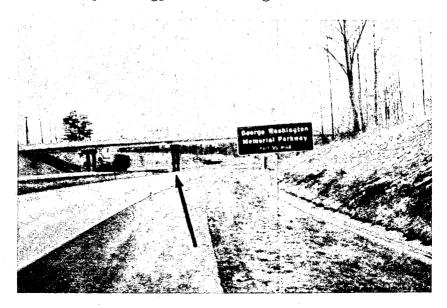
This is a photograph of the approach to the George Washington Parkway on the Virginia side of the beltway. In this area the road is curving slightly to the right and again you will see there is no guardrail to shield a motorist who might happen to wander down in this area [indicating]. Nor is there a guardrail on the southbound

shoulder [indicating] and there is no guardrail over on this side, the

northbound shoulder.

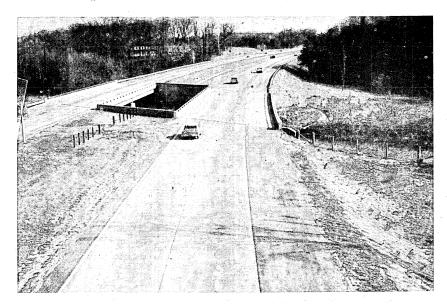
A few minutes ago I showed you a sign. And in the background was this particular bridge. There are a lot of things to look at here. We are approaching this from the south, heading toward Maryland. And for orientation purposes, this is just north of Dulles Airport. There is a creek which passes under both spans of this bridge.

You will notice the bridge is boxed in. This is a solid piece of concrete extending from the northbound lane to the southbound lane across the median. As you approach, you will notice a number of places where there is no guardrail. There is no guardrail here [indicating] in the median. There is no guardrail to protect a vehicle from the bridge parapet or from the end wall or from running off the road down into the creek. There is no guardrail on the far end of the bridge on the median side, northbound. There is no guardrail in the approaching southbound lane in the median.

There is no guardrail at the end of the bridge in the southbound lane. And here we have the ever-present sign mounted on a 4- to 6-inch steel pole embedded in concrete. There is some guardrail here on the southbound shoulder. You see guardrail in the southbound lane at the end of the bridge, and this approach to the bridge parapet from the north. You see guardrail starting at the northbound end of the bridge.

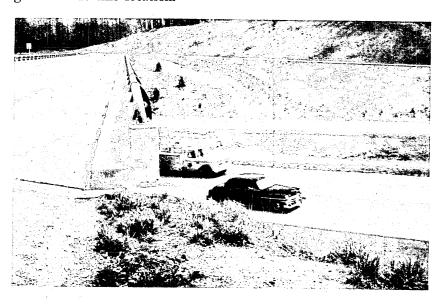
Mr. Prisk. This would appear to be a very hazardous omission of guardrail.

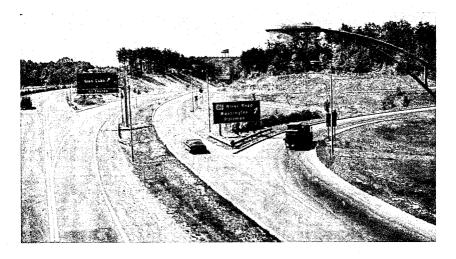
Mr. O'HARA. This is a typical Maryland gore area, which you will find on the Capital Beltway. This happens to be an interchange at River Road in Maryland. We are now looking southbound. This lane

here [indicating] leads to Glen Echo on the Cabin John Parkway. There are a number of things to notice on this particular picture.

It may be difficult for some of you to see some of the things I am going to point at. You will notice, first of all, this sign, which is for this lane, [indicating] is not in the gore area, where you usually find a number of signs. They put it over on the right, off the shoulder, and they put a piece of guardrail in front of the sign and flared it back. And yet in that gore area there is a sign which says, "No Hitchhiking," which is mounted on channel irons.

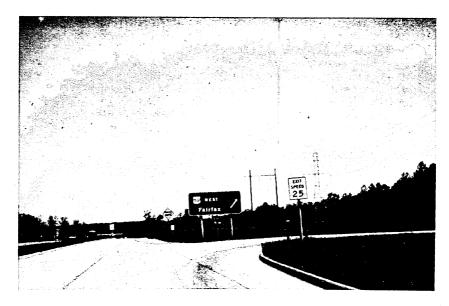
This is a gore area on the Virginia side of the beltway. They do the same thing on that side. Here is your deceleration lane leaving the Capital Beltway to get on Route 50. This is a collector-distributor

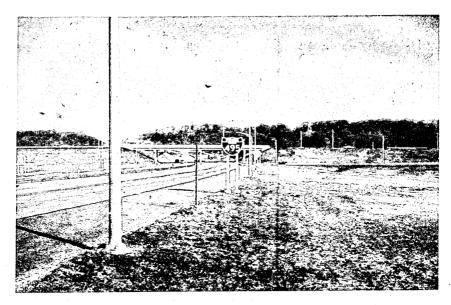
As you enter the Maryland beltway from Virginia, after crossing the Wilson Bridge, this is the interchange with Interstate 295. We are now looking eastbound. There are a number of things to be noted here.

First, the steel light pole. Secondly, a no parking sign mounted on a channel iron. Thirdly, a route marker, the I-beams and concrete.

Another light pole, a merging traffic sign, another light, and so on down the roadway.

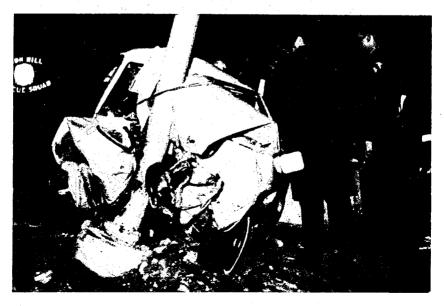
The following month, in March, this vehicle hit this light pole. There is the concrete base, partially out of the ground. One person was killed and two injured.

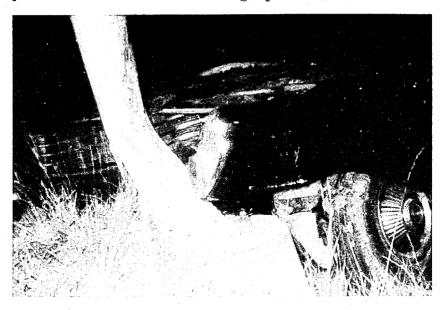
In June of last year this accident resulted in serious injury to one person when the vehicle struck this light pole.

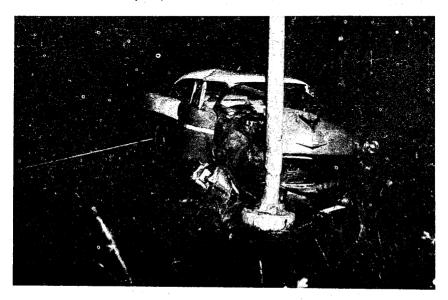
And in November of last year, two men were returning from a fishing trip. There is your travel lane of the beltway on the left. Next to it is your shoulder. They hit this light pole. It killed one man and injured the other.

Mr. W. May. We have learned that in those localities that have installed the breakaway light poles the experience has been wonderful in that people do not get killed.

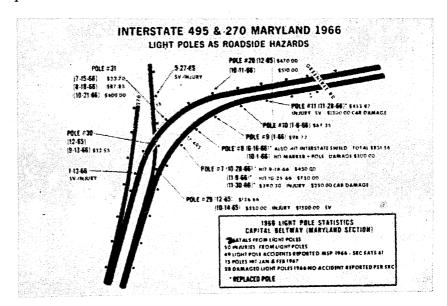
Another light pole which received more than its share of strikes, but is not reported as being on 495, is this light pole here [indicating] No. 31. This light pole was hit three times last year from July through October.

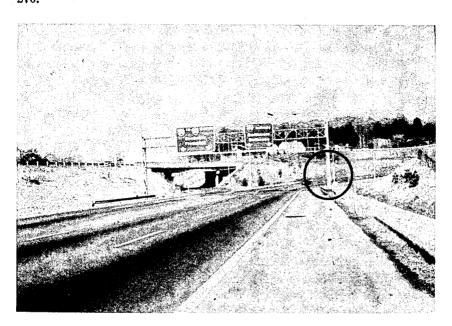
We are now approaching that gore area. I am standing on Bradley Boulevard. There are a number of things I would like to point out here. First of all it is a four-lane highway, northbound. This is 1,050 feet, roughly, from where we are to where the two roads divide at the gore.

I noticed, in talking to the police and standing out here making observations, that there were a number of vehicles which ran across this area in here which we call a gore area. This photograph was taken last Friday morning. I have a number of these, but this gentleman up in the gore just below the arrow was traveling in the fast lane of 495. He suddenly realized he wanted to be over here on the right. He had to make his move against this vehicle to his right and against these vehicles over in the other lanes. He narrowly missed the light pole, which is in that gore area which I showed in the last photograph.

He got by the light pole. In this area, in this northbound lane, there were 16 accidents and 13 people injured in 1966. Six were single-vehicle accidents, where the vehicle ran off the road and struck a fixed object.

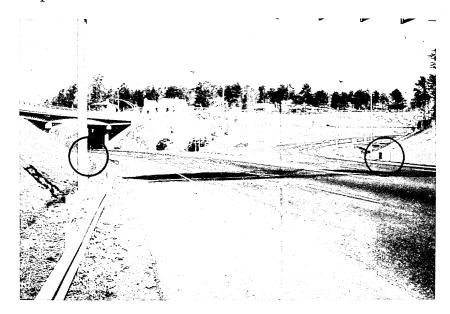
This is the piece of concrete upon which that sign support had been; on the left is the piece of concrete we referred to before, and you will notice they have lighted the interchanges on the beltway and here we have a steel light pole just in back of where the steel pole had

So we have taken one steel pole away and we have replaced it with another. In addition, you see here a number of 4-inch I-beams. The exact purpose of these, I do not know. It might be to prevent vehicles from crossing this area after they have passed and failed to negotiate the turn they wanted, and maybe this is the reason they put them in there. You have a "no hitchhiking" sign mounted on channel irons and there is a reflector, which at night is visible for a few hundred feet.

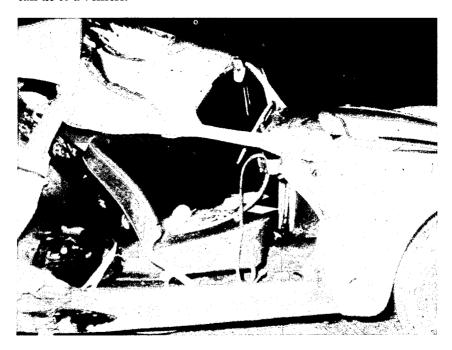
The driver was injured, and again this is what those 4-inch I-beams can do to a vehicle.

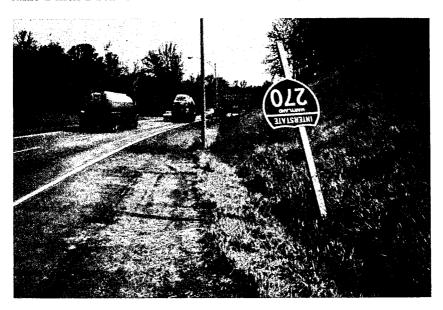
And 2 weeks ago it was hit again. Still in the same place, still on the same 4-inch I-beam.

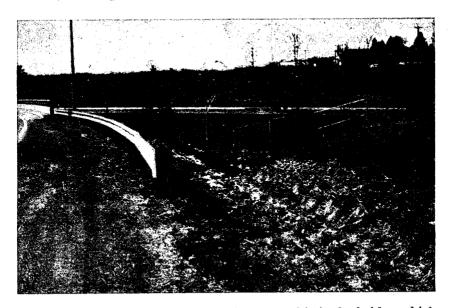
Here we are approaching it. To orient you, this is the bridge which passes over the northbound lane of I-270. This guardrail is short. It could have come back further. We are in a curve, curving gradually to the left, and it seemed to me a car could run off in here, in between the guardrail end and the light pole.

In checking the accident records, I found that in May of 1966 a man got behind this guardrail, hit the concrete headwall, turned his car

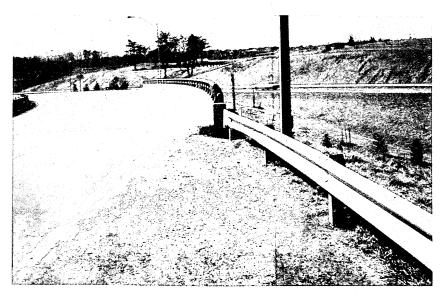
This is that same bridge parapet which in November of 1966 was struck by a vehicle. The vehicle first hit the guardrail, and you can see the guardrail gave way. The vehicle was carried into the bridge parapet. In this particular accident, the vehicle then went across the road—through three lanes of traffic, and slammed into the bridge parapet on the other side, as seen in this picture.

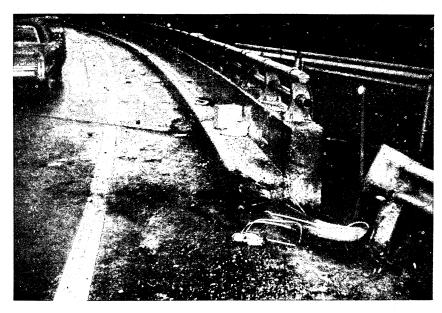
This bridge is skewed somewhat. He was able to hit the parapet end of the other side of the bridge.

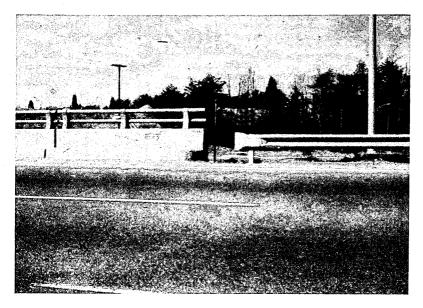
In checking the records I found in January, 1 month after I took the last photograph, 2 months after the first accident, a man traveling in the same location went off the road, hit the guardrail which guided him into the parapet and he was killed.

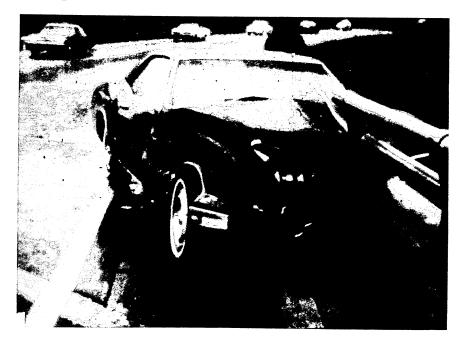
This shows you what happens to the front of a vehicle when it hits one of these bridge parapets. This is the same accident we were just talking about.

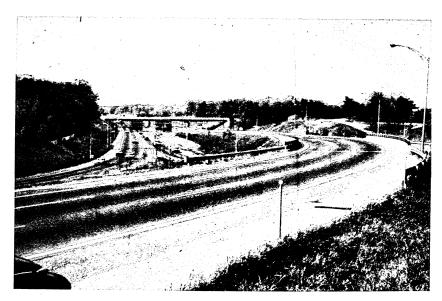
This photograph was taken last month.
Mr. W. May. That is the way it is today?
Mr. O'Hara. This is the way this interchange is today, after the accidents I have just shown you.

Mr. O'HARA. Same as before. No changes have been made.

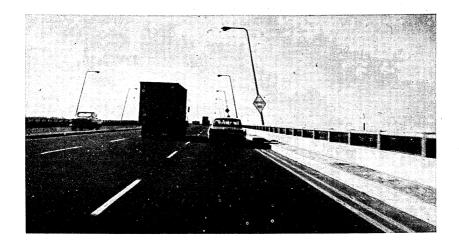
This is the approach to the draw portion of the bridge from the Maryland side. This is the first sign that you see. This sign says, "Drawbridge Ahead." It is 700 to 800 feet from the actual drawspan.

Mr. W. May. This is a very poor sign. A motorist can travel many miles on our Interstate System, over toll roads and expressways, and if this is the first drawbridge he comes to after traveling at a high speed, this is his first notice.

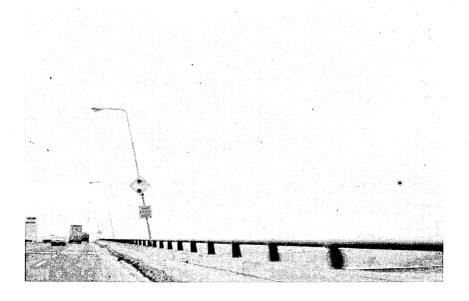
Here is the sign we were just talking about; beyond that at the drawbridge is the next sign. This says, "Drawbridge", and hanging over the roadway is the traffic light. If that truck had been over in the same lane as I and had been a little closer to me, I may have had difficulty seeing it.

There is no other light, other than this one, and the three other lights which are mounted on the barrier. If those three lights are flashing at the barrier and there is somebody in front of me, chances are I am not going to see them, because I am on an upgrade, and they are at the top.

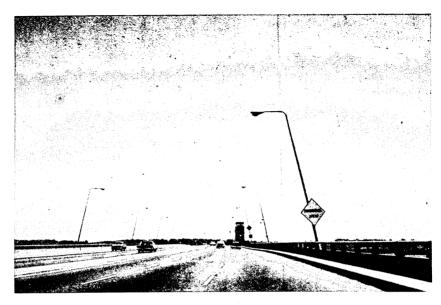
This is the approach from the Virginia side. This is the same situation, same warning sign. Beyond that you can see the diamond-shaped sign and the lights above it, which warn that the drawbridge is 500 feet.

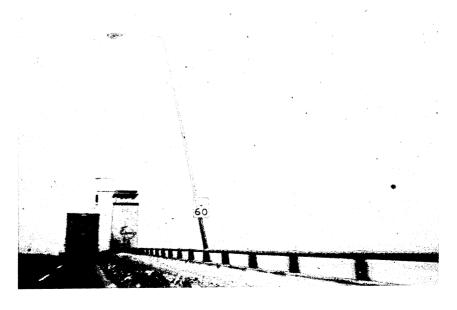
And here you get up closer to the tower, approaching it from Virginia. There is your speed limit sign, again your drawbridge sign, and the traffic light. That is an 8-inch lens hanging over the right lane. And I can tell you that you can have difficulty seeing that light when it is snowing and raining, because we have traveled the bridge a number of times in all kinds of weather to see what the effect has been.

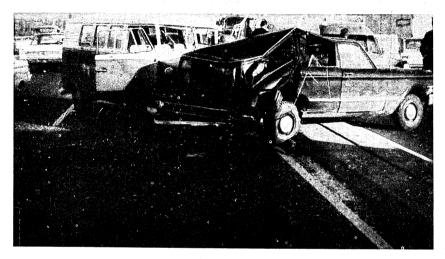
This picture illustrates what happens when a vehicle hits that median. The bridge span had been up. It was lowered. The driver of the vehicle, the station wagon straddling the concrete median, was unable to get the vehicle in gear. The other traffic started to move, and along came the Volkswagen bus and the driver did not realize the first vehicle was stopped. The bus struck the rear of that vehicle, threw it across the concrete median, where it blocked the westbound lane. This accident resulted in injury to four people.

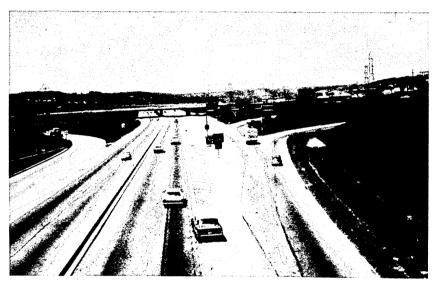
This next view is looking at the interchange with U.S. 1. If you are traveling away from where we are these right lanes are the westbound lanes as they come across the Woodrow Wilson Bridge, and at this point in the bridge there is a raised concrete barrier about 24 inches in height. This traffic on the left is heading toward Maryland. This left sign over the westbound lanes says "Through Traffic," with an arrow for this lane, and an arrow for that lane.

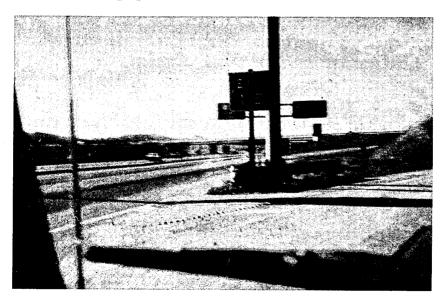
The curb just beyond the white lines is a ramp-type curb, that white patch is what they call a rumble-strip. I will show you a closeup of the rumble strip up where the truck is.

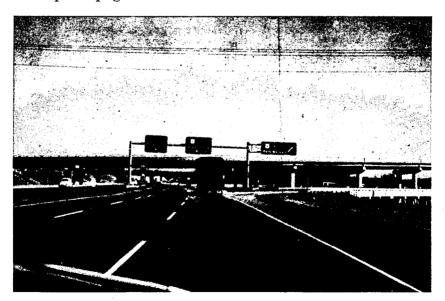
That is the rumble strip and there is a sign; and if you go up in the gore area on the right there is another rumble strip there. There is a steel signpost. There is a road going out to the right to Washington Street from the deceleration lane. There is a speed sign on a 6-inch steel pole. There is no shoulder.

Mr. W. May. Mr. Prisk, does that rumble strip make any sense?
Mr. Prisk. At that location, I fail to see that it has any value. It is

too close, too short, too close to the hazard.

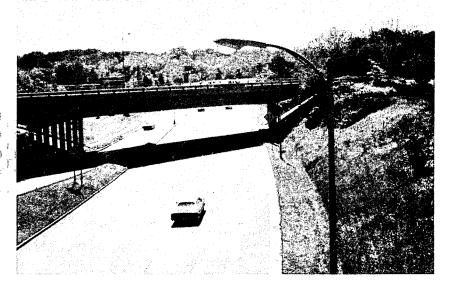
There is another gore area just beyond where this truck is. Here is another gore area. This is a deceleration lane. This is the guardrail in front of that steel pole, just a short section of guardrail. It ends and then it picks up again.

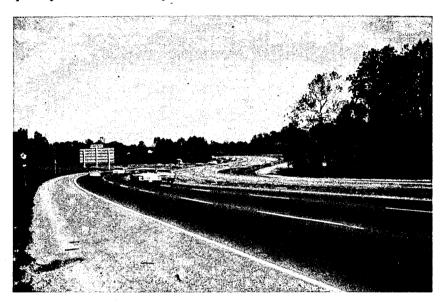
Another steel light pole, a reflector, and here a triangular-shaped sign, with two dark lines, and then the dotted lines in the middle. The

reason for this sign is that this right lane is about to end. We are traveling at 60 miles an hour. This is the first and only warning that

you have that this lane is going to end.

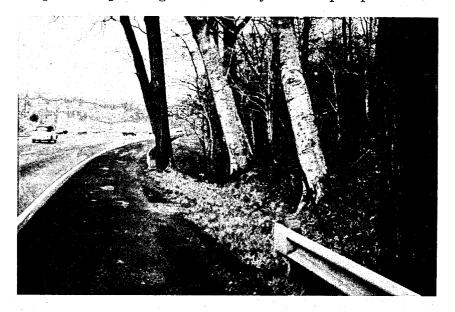
Now the last photograph I took was up in here, looking in this direction [indicating]. We are now heading east again, just east of Connecticut Avenue. Here the road is curving gradually to the left. This is where the road makes a sharp curve. The guardrail ends. A number of trees are back in there, the tree line being somewhat away from the traffic lanes. You can see a heavy front slope, drainage ditch down in there, and a tree line, with the tree line coming back toward the road and the road curving.

Up here is a piece of guardrail and beyond that open space.

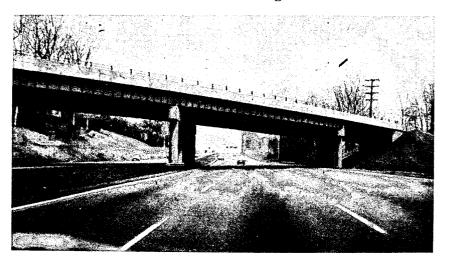
We are now approaching the B. & O. Railroad overpass. Here is the usual guardrail installation with sign supports off the shoulder. There is not too much of a runoff. The guardrail ends before the

bridge abutment. Over in the median, a short section of guardrail

and the concrete support for the B. & O. Railroad overpass.

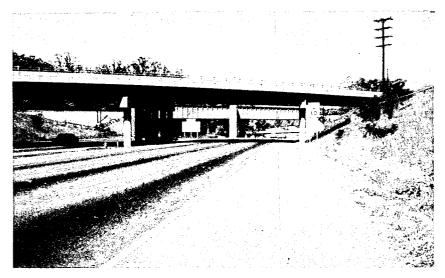
This is the next overpass just beyond the B. & O. Railroad overpass. There is a guardrail protecting the concrete piers in the median. On the shoulder there is no guardrail. However, there is a small piece of guardrail beyond the piers, but it ends just short of the

light pole.

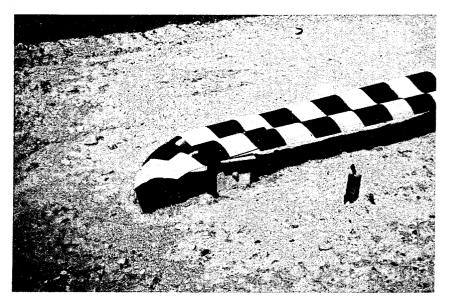
Here is the end treatment that is being used on projects in Salt Lake City now. This is a case where you have a rail section which comes on down, essentially, to the ground level. This is anchored and bolted to this steel post, and held to the ground level.

This is about the way this looks in the field. You can see there a slight flare away from the edge of the shoulder, 3 or 4 feet. The rail is, as you approach it, smooth, essentially with the ground level, then rises and twists through a length of about 25 feet. And then it carries on

along about 1 foot off the edge of the shoulder.

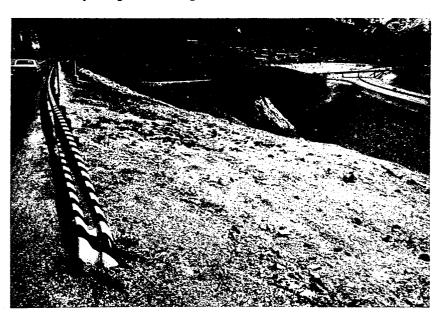
Here is another section, which is rather typical of what you find on this project on Interstate 80; this again I would remind you is the most recently completed and opened section in Utah.

The rail here is not blocked out but rather mounted directly on 8 by 8 wood posts. This is just a view of the general design, the way rail is used at that point.

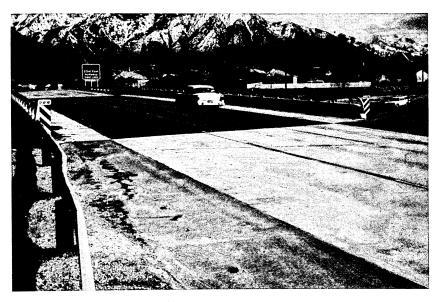
You will notice the treatment on the right-hand side of this roadway; there is no rail at all. The median is protected because of the hole between the bridges. The right-hand side has no rail. And here is a closeup of that same right-hand side [indicating].

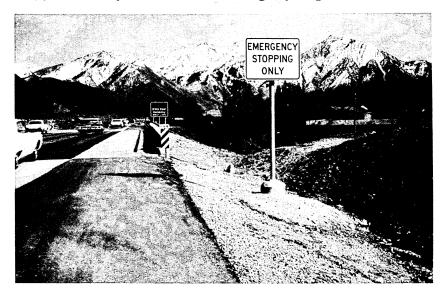
I think there is something a little bit ironic about that sign "Emergency Stopping Only," because if you reached the line of that bridge end, you certainly would make an emergency stop.

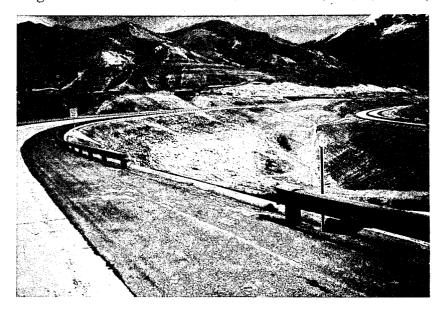
Mr. Wilson. On that last slide, I would like to point out a good thing about this installation is the fact that the curb, or dike, normally

used to control drainages, is behind the guardrail. At a lot of installations I have seen in the past years, this dike appears on the front, which would have a tendency to vault people over the rail. In this one I would say this is the place to put it.

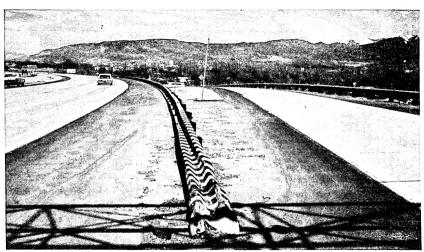
Here you have some discontinuous rail in the vicinity of a decision point, or a gore, as we call it. In this case it is a small section, very short section of guardrail installed here, behind the curb, a short break and on the other side the same thing, again giving multiple chances to failures of the rail.

This I would say is a section where the guardrail probably was not needed. An exit takes off into a portion of Salt Lake City down this roadway and this portion of rail [indicating] buried in here carries on around that curve rather nicely, but there is some question as to how much of this rail is necessary until you get up in this area [indicating].

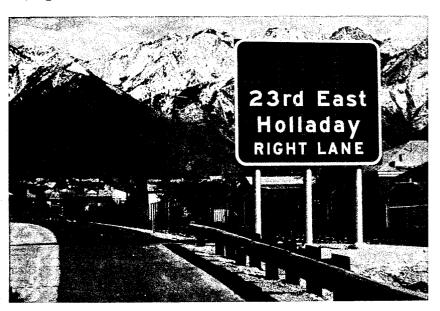
Mr. Prisk. Yes. Here is a case also in Salt Lake City where there is another gap, as you see, running from here down to here [indicating]. This rail was put in and in this case is blocked out for shielding this highway sign at the roadside.

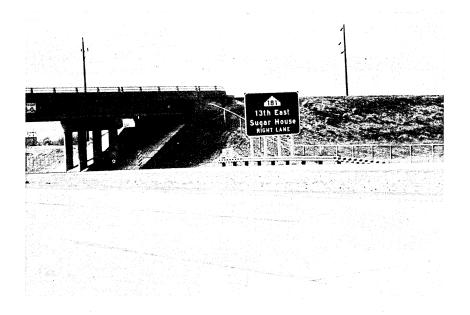
This again in the picture is a closeup showing about where the rail stands as far as these piers are concerned, and the sign post.

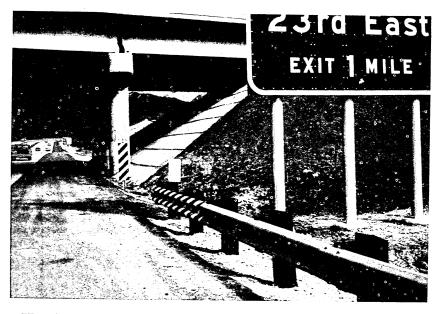
Here is a rail going partially through a structure on the median side and over on the far side for the opposite direction, the same kind of treatment and same kind of sign treatment as you see in the distance.

Mr. Constands. Of the four piers there, one of them is protected by the guardrail and the other three are exposed.

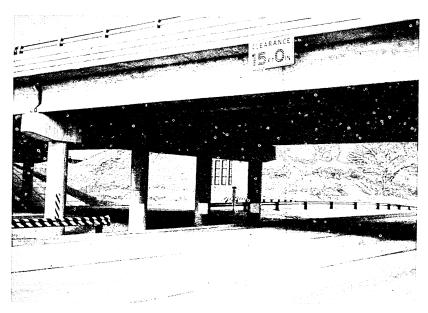
Now here again is a somewhat newer section we had the opportunity to see while we were in the State Lake City area. This is on I-15, and in this case there is a much longer guardrail, buried as you see desirably and carried right on through, past the median piers in this case; and also the same thing on the margin of the roadway. So there is evidence on this particular project of picking up what appears to be a more desirable practice.

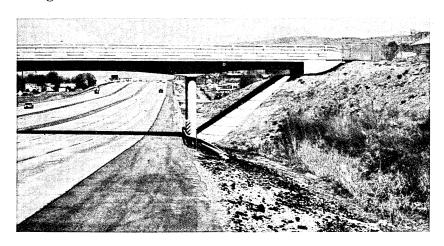
Mr. Prisk. This is another case where the rail is flared and carried through the structure.

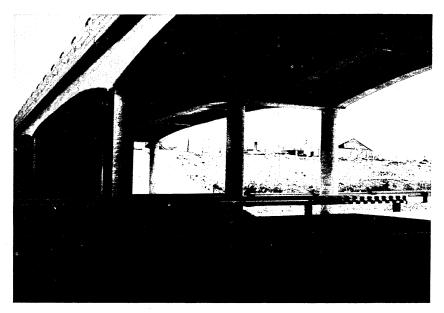
Here is a closeup running through the bridge on the median side. Now, here for some unexplainable reason you find that this guardrail is buried in line at the very edge of the pavement and runs through the structure, but there is essentially no real protection for that angle of departure from the roadway insofar as that center pier is concerned.

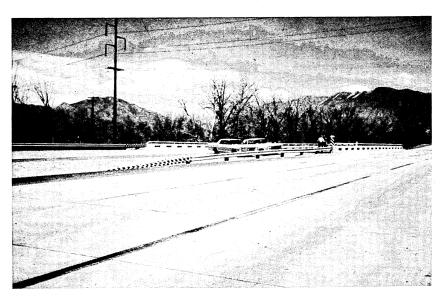
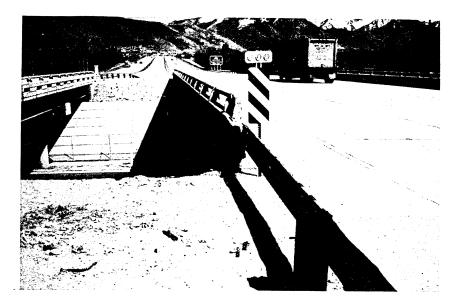
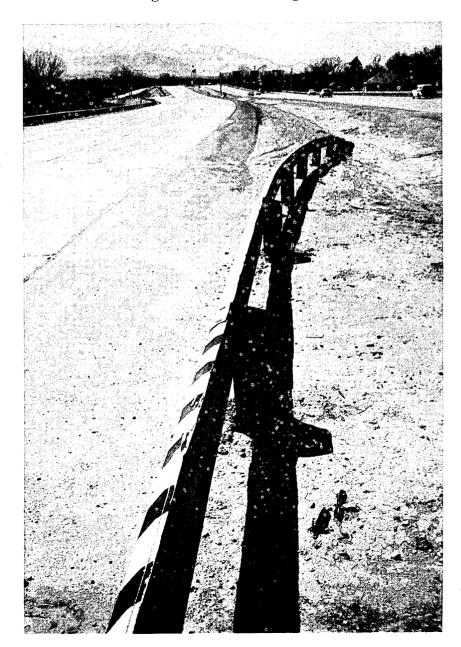
Mr. Prisk. Here are some pictures of a bridge which again is a twinbridge situation. You can see the edge of the traffic rail on the bridge itself has been damaged by collision, very substantial violence, of course, involved to cause that much damage. In the case of this accident a man rode the approach rail which you see here; he came off this curve pretty much straight ahead, came on up to the ramp section of the rail or at least got on top of the rail and rode on into the bridge and caused this damage. He then went through the air and landed on

all four wheels down here by this parking sign [indicating]. According to the measurements, he traveled 85 feet through the air and made a 26-foot drop and walked away from his car. Local police wanted to know which way he was moving on this roadway, and he said he was not, he was up here. [Laughter.]

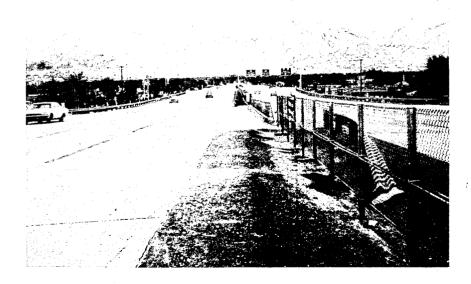
Here is the way the concrete wall looks when you are up close, and of course, I-bolts here to hold the cables for the California-type barrier system. That anchorage, of course, is a necessary part of this system's working, but it is rather unusual that you have three types of barrier here, and as you stop and look at that, you find that there really is not very much reason that you can see for continuing this.

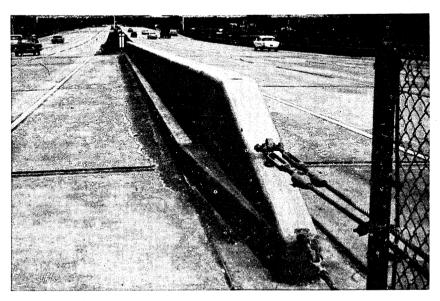
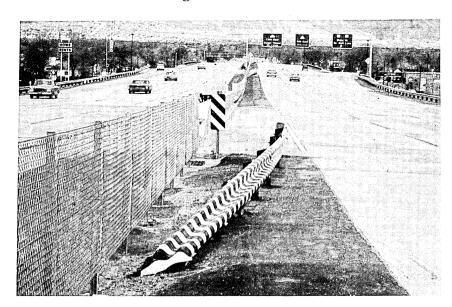
This is done not just at this location but up here [indicating] and at still another place, so that you have this rail which obstructs the clear shoulder for one thing. You have this cable rail which does its

job back here on the approach [indicating], and a wall up here [indicating]. Conceivably I think you might theorize at least that you could select one barrier, any one of these three barriers, and carry it straight through on a median line and possibly get a superior job. I have a little difficulty seeing why three types are used at that point.

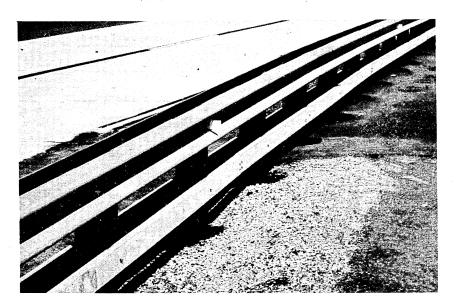
Mr. Prisk. This is the median barrier that Mr. Ricker spoke of. This is a relatively high one we found. This is toward the east end of this Interstate 80 project in Salt Lake. The top of this is 36 inches

and the rub rail down here at the bottom is to prevent, again, wheels from getting into these posts.

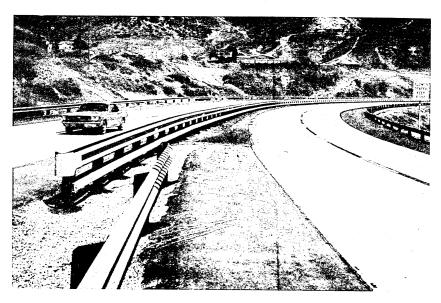
Mr. Prisk. This is an overlap, again a transition between two different types of treatment. The left edge rail is going nicely into the median barrier, apparently with no great difficulty going in that direction. Coming the other way you have a possibility of hitting the back end of this rail if you go straight to left of the roadway.

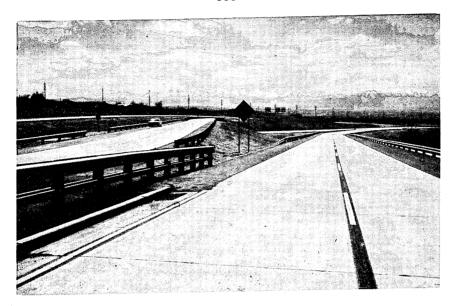
Mr. Prisk. Here is another shot about in the same—just a little farther to the east, where this high rail stops and the sign is in here, and then again you introduce the standard twist and buried section which again is another rather unaccountable kind of gap.

Mr. Skeels. I have just one comment on the last median barrier which I noticed was not blocked out. It did have the lower rub rail, but the upper one was not blocked out. This seems inconsistent with recommendations that I have heard. I agree with all your comments about the gaps. These are unexplainable. In this picture also you will note there is a curb back in front of the barrier at the left. I kind of assume perhaps this is a bridge, but this might be a good point to bring out the fact that, in general, all that curbs in front of guardrails do is help cars to get over them.

single rail after you get past this transition area.

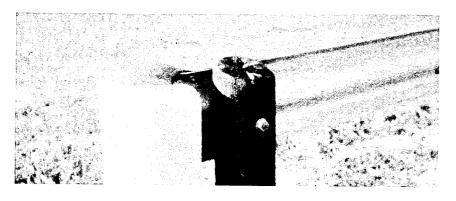
This is Ohio, again standard practice not to block out. Here you see a round post and this bulbous section on the end.

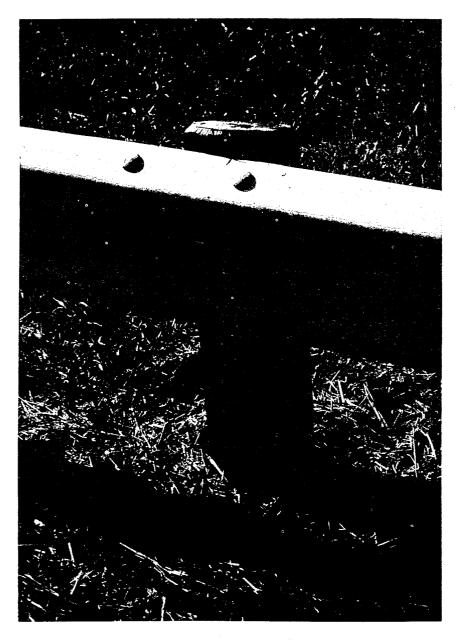
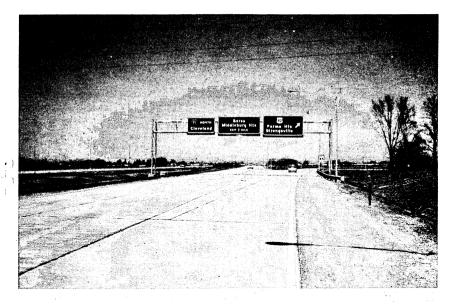
A post here also mounted rather low and in the case here, no washers are used on the head of the bolt. It does not show too well on the picture, but that is true.

Here is an installation we passed en route to the subject job. This is on I-71, near Cleveland, where there is a guardrail installation at an overhead sign bridge and it is rather short and moving up close to it you see what happened on the median side. This guardrail without the washers, as I said, was torn off the post.

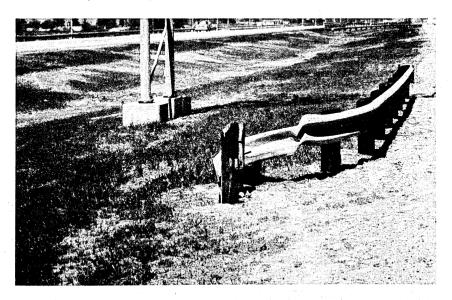
Here is a closeup shot. You can see the bolt still on the post and the rail actually pulled off the post coming right through without the washer. With the washer in there you would have had at least benefit of a little more guardrail than was working at the time of this collision.

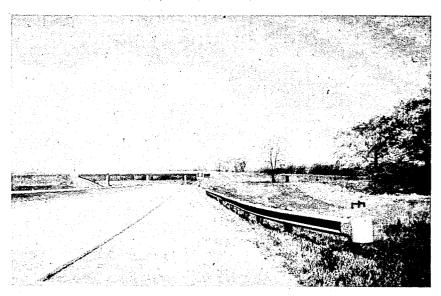
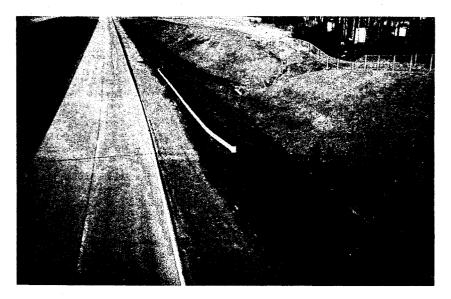
Here is a closeup of another installation, a slight flare at the beginning and a rather short run of rail across the top of the culvert. Mr. Blatnik. Mr. Prisk, in addition to the short run of rail, it

appears that the back is pretty steep, is it not? The slope is a little bit too steep to negotiate safely.

Mr. Prisk. That is correct. Probably it is 2 to 1 anyway.

Mr. RICKER. This illustrates a question of whether the guard rail does not present more hazards than the culvert did originally. We think it would be worth review. You can't judge this just from this picture. Omit the guard rail entirely and the hazard may be so small it could be ignored or else perhaps extend the culvert slightly and you don't need any rail.

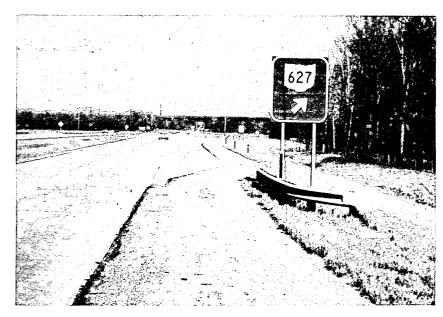
Here is an instance of a very short section in front of a sign, again

a very slight flare over a very short distance on this rail.

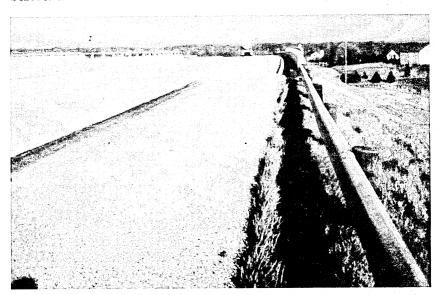
Here is rail lined up with the structure with the exception of the curb that sticks out in front. You see the characteristics we have noted before. The rail is not blocked out. The rail here is set back two or

two and a half feet from the edge of the paved shoulder. In some cases travel on that grass surface or on the off-the-paved surface, I

should say, presents a problem in itself.

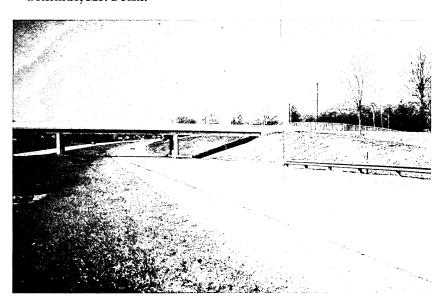
Mr. Prisk. Continuing, you find again there are sharp, uncomfortable gaps of rail. In this case, right-hand piers are shielded by a short section of rail, which begins shortly after another one stops. Very nice slope protections, you will notice, on the structure itself. The center piers are fairly well guarded from traffic simply by the slight slope that is there. We will talk about that on another series of slides.

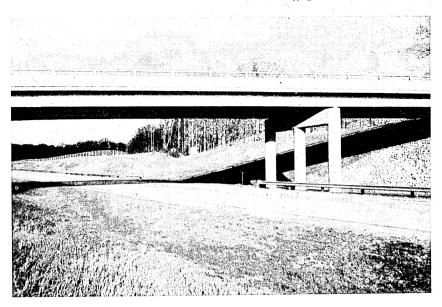
Here is a closeup of that same shot. You find the structure not only has that rail which starts a short distance before it, but after you get through the piers it stops and then there is another one that

starts for another reason. So here are some more gaps.

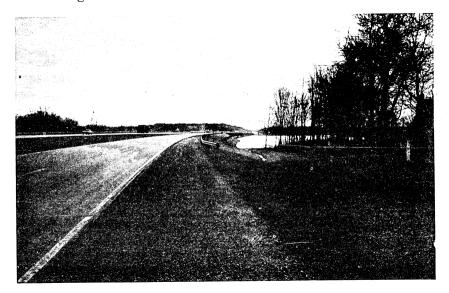
Here is one where, if you go far enough, you could be in the lake because the guardrail here does not too well protect that total slope.

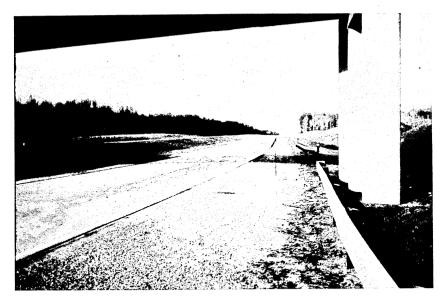
This is another consideration of a gap.

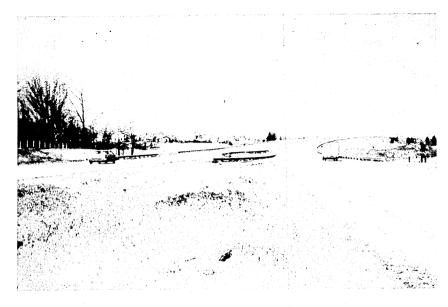
When you come to the dual bridges in Ohio on Interstate 80–S you will see from this picture they have done a pretty good job swinging the median rail back to protect and guard against that open space between the structures.

Mr. Ricker. There is another good feature of that. You will notice they have regraded the ditch between the two roadways and this is

necessary if that guardrail is to work properly; otherwise it dips down into the center depression and makes a different kind of hazard. This is a good design where the median has been flattened.

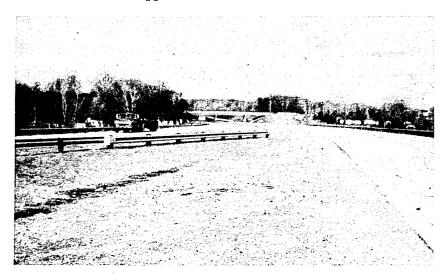
Here is a treatment on the end of that median flare that is doubled back so that actually for about seven or eight panels you have protection on which ever side you hit it, going in the direction of the camera shot or in the opposite direction.

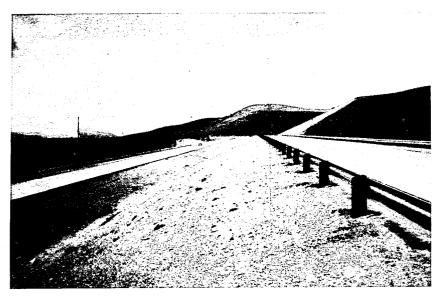
That position shows we are out in the country here. Here are the two roadways on separate grade, obviously, with very substantially different elevation. Standard guardrail installation is what you see, with no blocked-out posts.

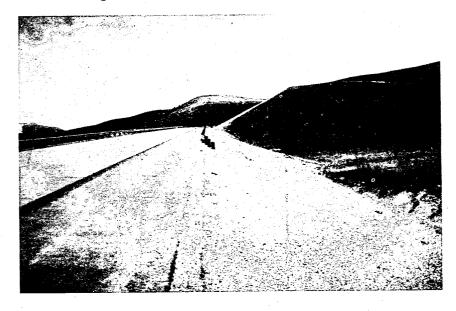
In this instance you will find that they are patching the ends—I should not say patching, but they are extending the ends of the guard-rail on the right-hand side, so as to get the benefit of a flare section.

This was field changed during the construction, and work, I expect,

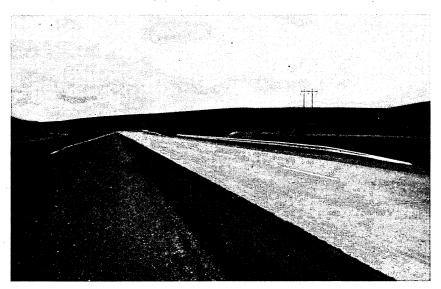
We move along on this section. This is about the way it looks as those portions are completed. The rail is taken down a slope, both in the median and on the right-hand side.

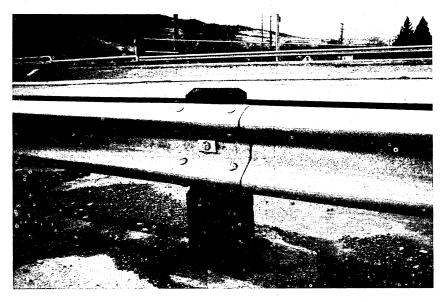
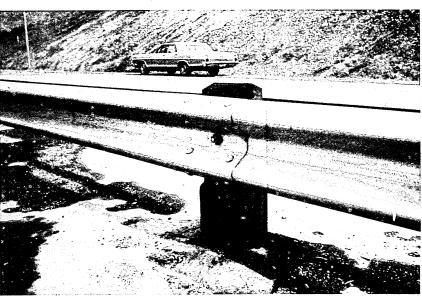
The sections in Montana have something to recommend them because here is the appearance of a washer clearly on a median barrier and this is back in the urban portion, near Missoula, and in this case the rail is not only not blocked out, but the rail is notched into a wooden post. There is an 8-by-8-inch wood post there and the post actually has been notched so it is down to about 5 inches thick at the top.

Mr. Skeels. I wouldn't dare say.
Mr. Prisk. Inquiring into this notching made me not say anything either. I found that this was done to obtain the 3.5-foot clearance to the edge of the pavement. That is the hard way.

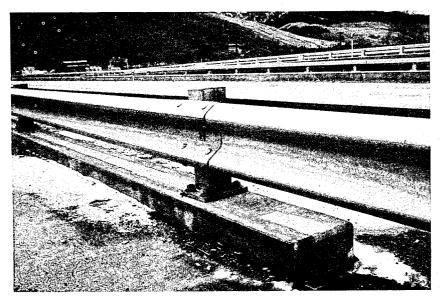
Here is a section on a structure where concrete curb is introduced as you cross the structure and steel posts are substituted for the notched-out wood post and I dare say this is a little better to hit than that other section, from a number of viewpoints.

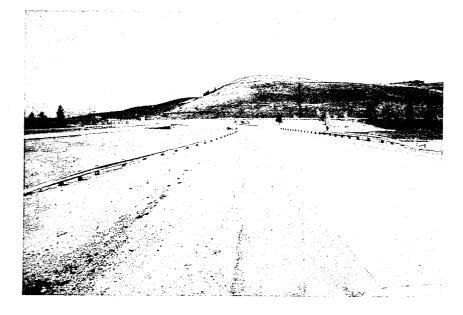
Mr. RICKER. I notice in the picture there is an embankment down near the actual opening which provides a second line of defense for somebody who does happen to get in there. That is as good a place to

find bushes and so, on behind the rail, where they normally would not be hit and they do improve the appearance as well as to slow down vehicles that do get that far.

Mr. HUFF. In my opinion, the obtuse angle of approach on the median rail makes it an unsafe area and as a matter of fact I think it is more unsafe than the one on the right.

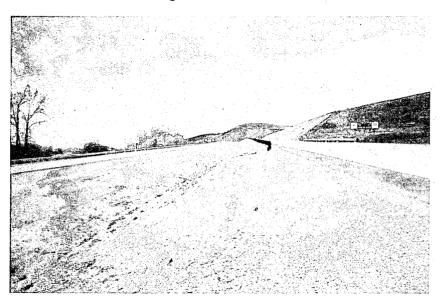
Mr. Skeels. On this one we have here, I don't know the whole situation, of course, but it appears that perhaps that slope could have been modified and not need the guardrail.

Mr. Constandy. It might be a bad picture. I would hate to ride down here at this point where there is no guardrail. It is kind of steep

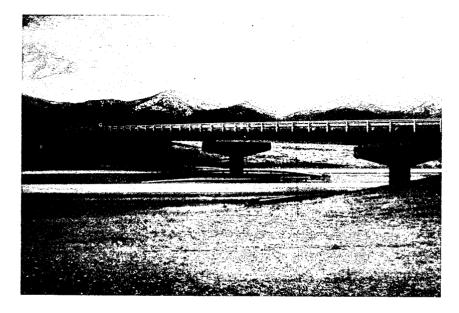
Now I move to a structure to take a look at practices in Montana, and find the guardrail, as you will see, on both sides of the roadway in both directions, center piers and side piers, and this gives you a general view of the installation.

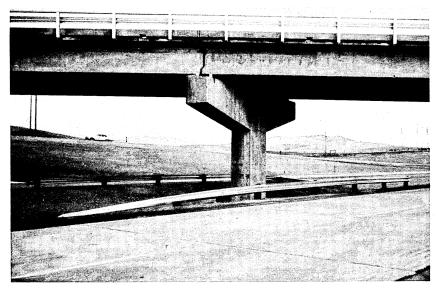
As we move in on it, this is a closeup of the median protection and you will see that the panels are in there with the end posts tightened up to 6-foot-3-inch spacing along in through this area here [indicating], then lengthening out to 12-foot-6-inch spacing down through here. This is perhaps a minimum length, you might say, of guardrail, looking at it from this angle.

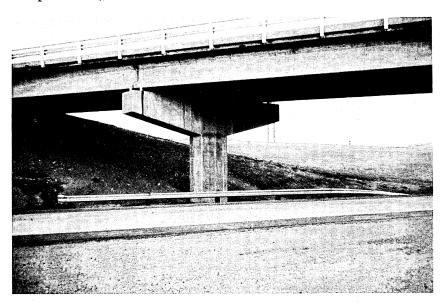
Let me give you another angle on this same structure. Here is the side protection, which is done about the same way.

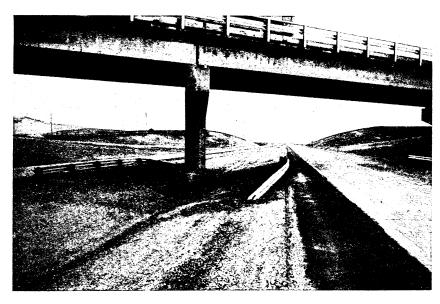
But here we swing around and take a look at the median pier problem, in terms of where that rail is placed. This shot, of course, was taken perhaps a couple of hundred feet away and it is not too difficult to visualize someone getting into the bottom of this bowling alley gutter here that the chairman referred to a little while ago, and ending up in difficulty with that pier.
