## HIGHWAY SAFETY, DESIGN AND OPERATIONS Roadside Hazards

Mr. W. May. Mr. Chairman, today we are going to receive an analysis of the Capital Beltway primarily from a statistical and road-side hazard viewpoint. At a later date in the hearings, we shall receive additional testimony on other aspects of the beltway.

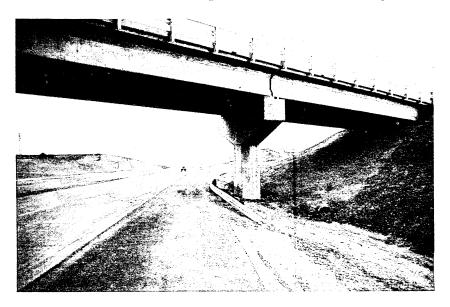
As you look to the right-hand side, you have about the same situation as a couple of hundred feet away. There is not an awful lot of protection here. You have a steep slope here which can turn you back

into the embankment of the rail or possibly wedge you between the

rail and the pier. All of this can be a little uncomfortable.

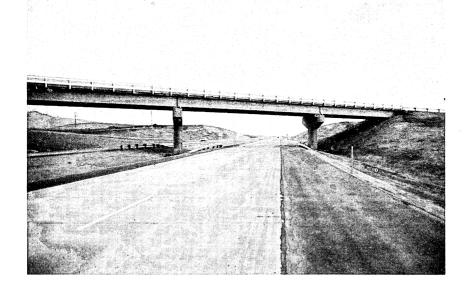
Mr. Huff. In my opinion, it should be anchored on both ends and it should be longer.

Mr. Prisk. Moving along, this again is a far view taken 400 or 500 feet in advance of the structure. I think you can still see these same points stand out rather prominently and suggest that perhaps there has been a bit too little guardrail used at this point.

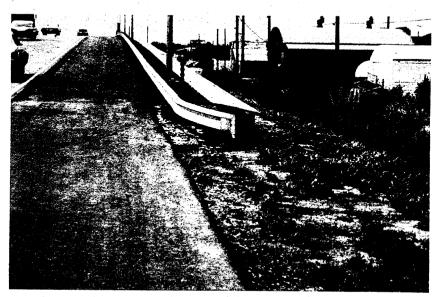
Moving along to the actual application, you see this rather abruptly curved transition into a guardrail section. This is in advance of a slope condition.

Mr. Prisk. This appears to be an extremely short flare, and the treatment here certainly is a rather abrupt flare and is not buried, as you can see.

Mr. Constandy. I notice that there is one post on the end, and by the next post the guardrail is back on a tangent, so the length of that flare is generally 12 feet.

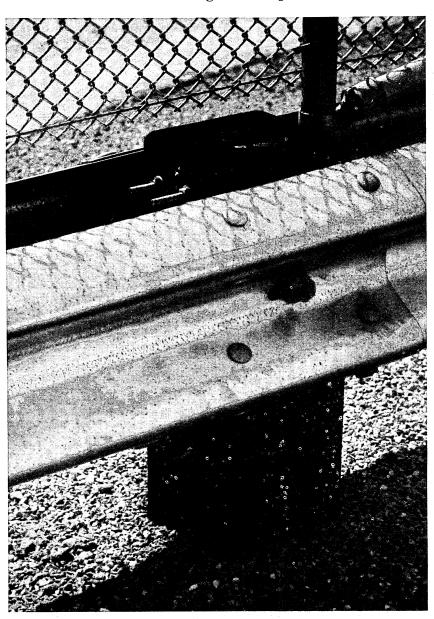
Here is the median barrier where there is an 8 by 8 post, rail bolted directly on, again without washers.

The rail here was set rather low. This is about 26 to 27 inches. The side rail is 24 inches. This is the other side—small washer, nut,

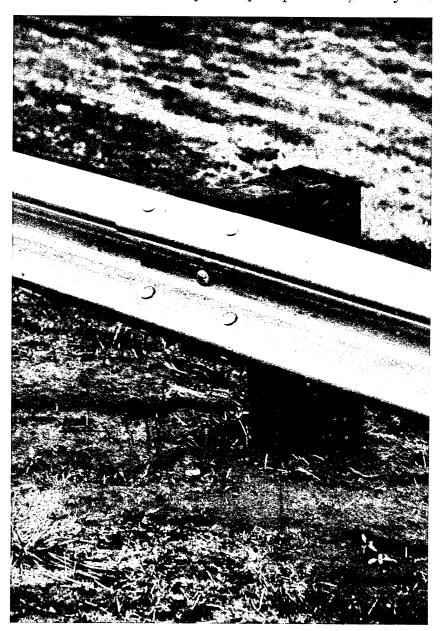
Here, now, we are on the new job, which adjoins slightly to the west, of the work we were just looking at. Here they have blocked out the rail with wood block and at least gained improvement.

Here you do see that muddy area between the edge of the shoulder and the rail, makes you wonder a little bit whether that rail would perform as well as if it had a paved surface coming up to the face of it. When it is soft, certainly the wheel would be down somewhat lower that it would otherwise.

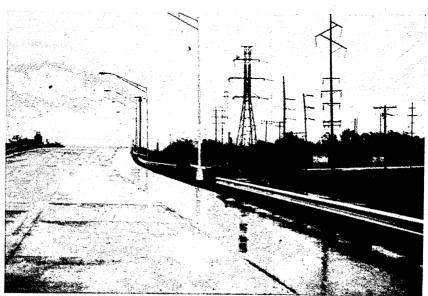
This rail—look at it a little bit farther—here is an installation where there are some light poles involved. The one that you see first, beyond the end of this rail, has a frangible base, transformer base in there. This one is a steel pole and so are the others behind the guardrail.

During the course of the work, the contract was changed to introduce these frangible bases in those places where the light poles were exposed.

One thing that you will notice is that there is a separate guardrail around each post installation and some of the other places, and that, again, begins to bring some concern about the continuity of the rail and desirability of closing up gaps that we see there.

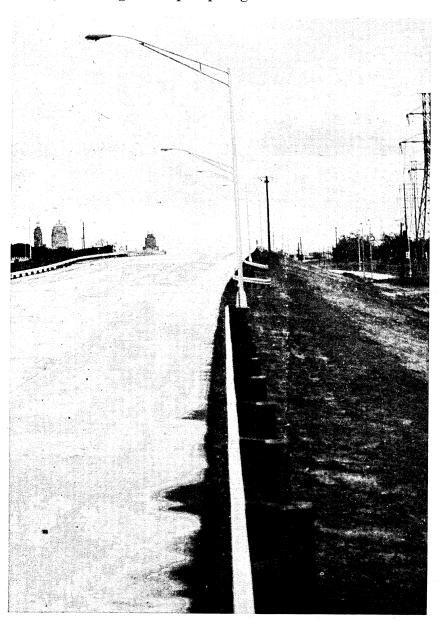
Here you will see, looking at the flare end in some detail, how they

have tightened up on the spacing. Rather an abrupt flare.

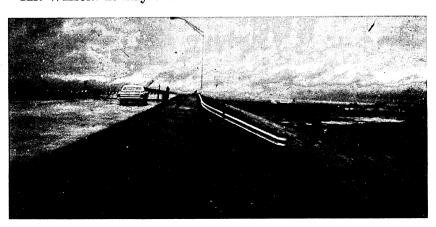
Mr. Prisk. Here now is another view of the guardrail installation on new work, showing the flareback. There is no indication of any rail being buried here at all, carrying on up to this bridge structure. That light pole, of course, would be a steel light pole behind the rail. And here is the way it looks close up. You will find when you get there that you have the light pole mounted on a concrete footing, and some of these footings get very close to projecting in front of the rail. Some of them actually did.

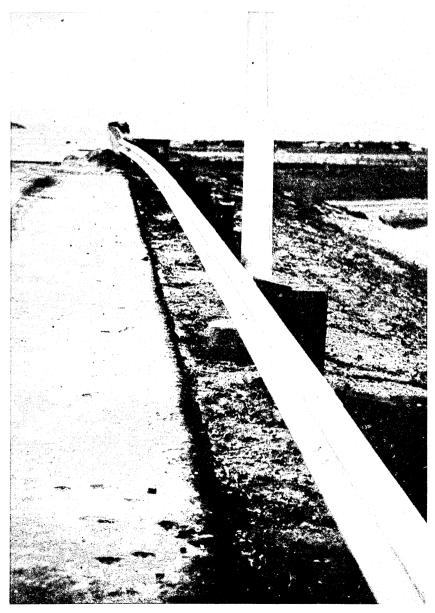
The rail is set, nominally, 2 feet behind the edge of the paved shoulder. It is 2 feet off this line. And, as you move up here to the structure, the rail is then, of course, tied into the traffic side of the parapet rail.

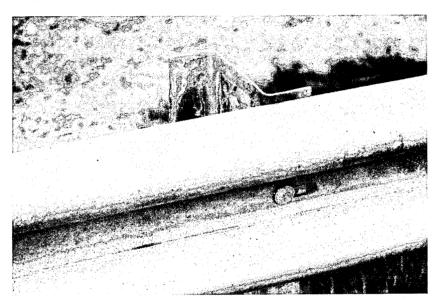
Mr. Skeels. I might make one. We would not consider using this type of post. It certainly—well, I have not run tests on this particular design, but obviously it is a very weak post. The proper performance

of guardrail, or the proper performance of this type of guardrail, is very dependent upon the strength of the post on which it is mounted. As you pointed out, there are other types of guardrail that depend on weak posts, but this type is not; it requires a strong post.

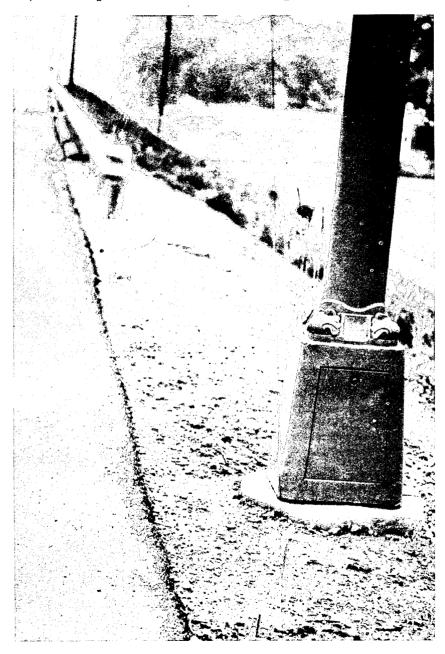
Mr. Prisk. This rail runs about 25 inches high at most locations where it was measured. Here is a section head-on, on the job, just beyond the light pole. As you can see, the light pole was set barely a foot and a half off the edge of the shoulder and the rail about 1 foot off, with no special treatment at all in this particular instance.

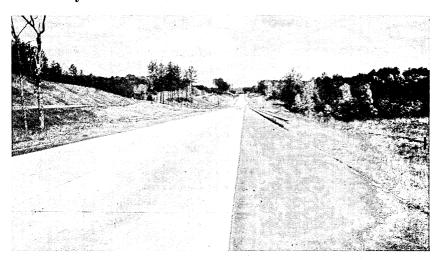
Here is a view seen rather commonly along the job, showing about the way it looks. Again your head-on rail on this side and also on this side [indicating]. This is about 10 feet or 10 feet 6 inches off the edge of the pavement and this is about 9 feet on this side.

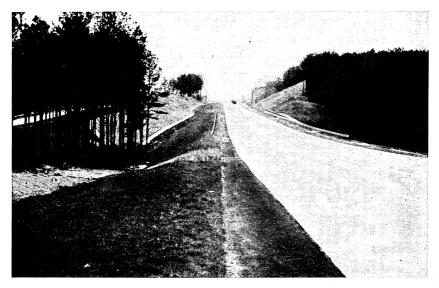
This, again, is a general view showing the median section, separate line and grade, installation of rail here, evidently at a fill height which corresponds to the Georgia standards. This fill here, of course, is not as high, but it apparently meets the height here [indicating]. So meeting the standards here, that section is in. The same thing over on that side.

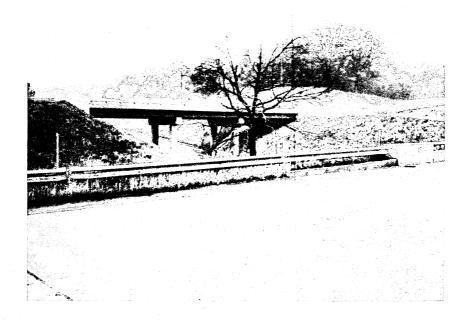
median side you find that the structure is protected by this much advance guardrail—four panels, I guess it is, it would be 50 feet—and starting at this place, they have now added some more. So you have an additional protection beyond what was originally afforded on this project.

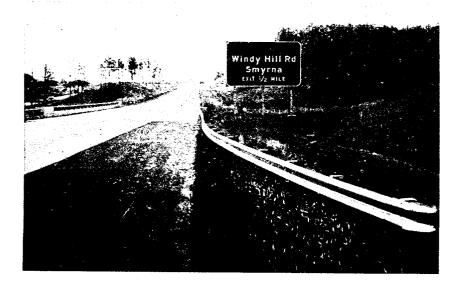
Now we look ahead. Here is what you have. As you go down the sign, you see the blocks in here on the posts, and then the rail is mounted directly on the posts as soon as you get beyond the sign.

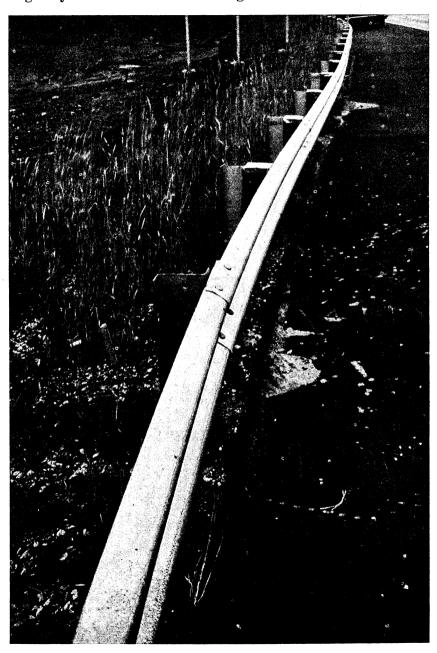
require blocking it out. Subsequently, when they got a contract for the sign, and that included the guardrail, the standards had been improved and, consequently, when they joined the two sections together, they were protecting the motorist from the sign, which has the added feature of the blocked-out beam. As you get away from it, you find this, the older standard without the blocked-out section.

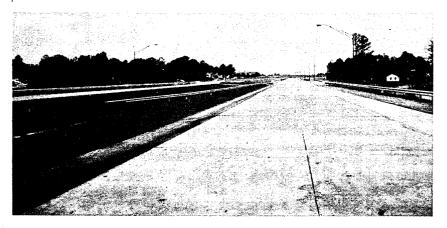
This, now, is on the median side where the rail is taken across the center of the median and buried in the upslope on the other side. It is

quite a long treatment.

There seems to be a good bit of respect around the country, on all of the projects we visited, I would state, for the hazards of this dual bridge, as far as possibility of treating it by rail is concerned. This is one place where the length of rail would seem to be entirely adequate.

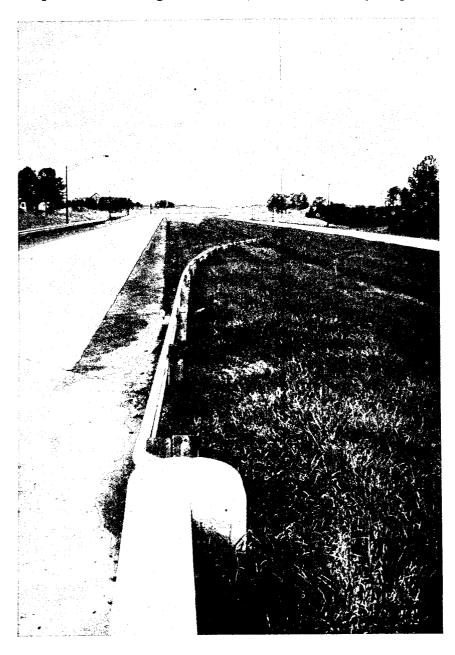
This is looking back from the structure to that rail installation. As you will see, it goes back across the median on a rather easy flare.

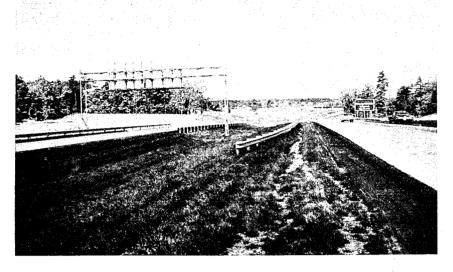
Here is an installation put in around a signpost, sign structure support. And here the treatment is not quite as elaborate, because this comes, oh, possibly 12 feet from the edge of the paved shoulder and does not go on out to the place where you guard that sign support in the same fashion that the bridge itself was treated, the open bridge.

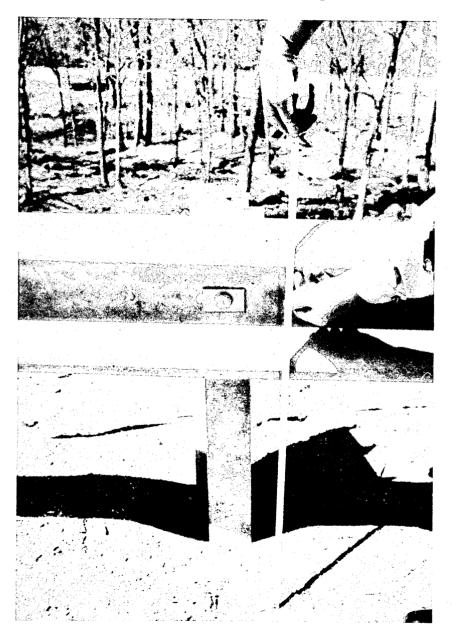
This is the general view of their blocked-out rail, using steel blocks and washers, and everything looks fine. Measuring the top of the rail shows that that is up 31 inches high. This is an edge rail.

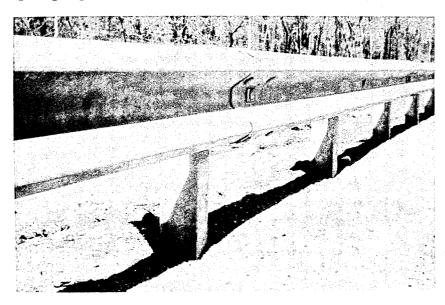
Here is a general view of the same installation, washers all the way through, and this looks pretty good. They have used 6-foot-3-inch spacing on posts.

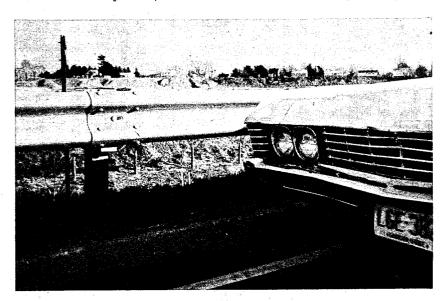
Here, however, is one thing that we did find, that that 31 inches is up on top of a 6-inch curb for a good bit of the project, and compared to a standard American automobile, you will see that the top of the rail is fairly well up on the car, and I daresay that the possibility of getting into those posts might be a little greater. Just what would happen with respect to the curb in front of the rail on the rail's performance is a little hard to conjecture, but I do not think it would help it.

Mr. Skeels. I would like to comment on rail height a little bit. I do not want it to be inferred that the higher the rail is, the better it is. It can get too high. The 31 inches, in my experience, is too high, the danger being when struck with the force involved in collisions, the rail will tend to come off the posts, particularly if washers are not used. If it comes off the post, the car will go under it with the rail going over the top of the car.

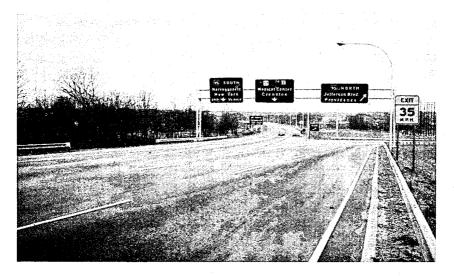
We have one on the right set 2 or  $2\frac{1}{2}$  feet behind the curb and the edge set in about 2 feet from the curb the other way, in this particular case approaching a major gore division between the route taking you to New York and one of the connections into Providence.

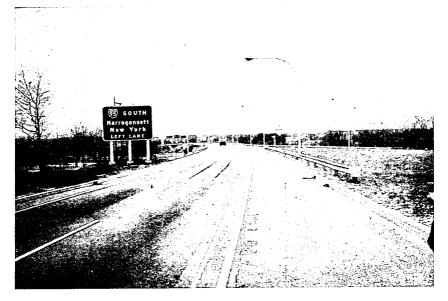
Mr. Prisk. Here is another one. Behind the curb you have a blunt end of rail. In this case these are aluminum poles which, elsewhere along on this project, are left exposed very frequently, but in this case railing is put in there. It is a little difficult, again, to see the reason for that installation.

On the left-hand side, you find the sign that might warrant some shielding, because of the fact there are concrete bases somewhat above ground and very husky upright supports, and there is no railing at that point.

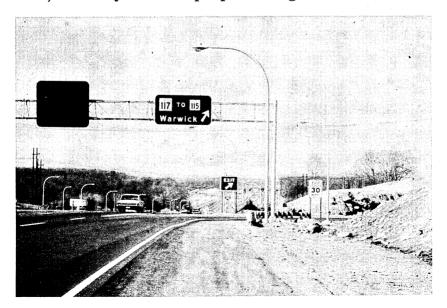
Here is a head-on section, which is extremely short, for one thing, and which has no protection at all. If there is any tendency to run off the inside, I would say this has the prospect of being hit.

You also see several other things in here besides the boulders. There is the light pole, and of course the sign-support structure itself with its

footing.

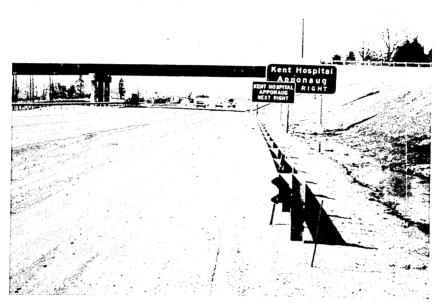
This job, as I said earlier, is not finished. You will see a couple of signs here that say the same thing, "Kent Hospital." Obviously the larger one is the final sign, which has just been installed; the other one just has not been taken down. Nor has the end of the guardrail been yet finished off. A good bit of the rail that we saw is exactly in this condition, exposed end.

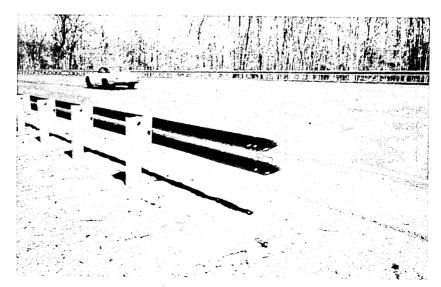
Here is more on the median side.

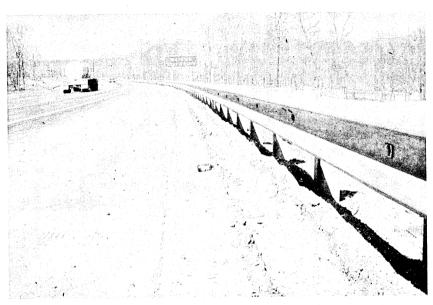
This is a section of the side rail also showing how people get into this area, like it or not. This is shoulder here and this is just dirt, churned up and muddy. Well, muddy certainly in wet weather, as these ruts tend to indicate. And I suspect that the performance of rail with that kind of surface in between cannot be too good.

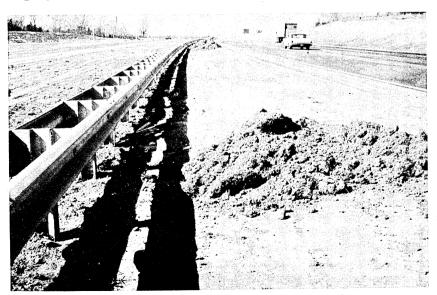
There are washers on this median divider, which runs right down the middle of a fairly wide median, in the process, as you can see, of land-scaping, completing work, finishing work on the median area.

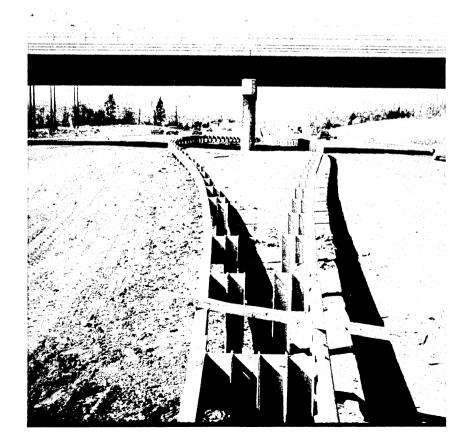
Now, when you come to a structure, this is one of the treatments that we see on this I-95 job. Starting at this point here, you break away from the post [indicating] and install separately blocked-out sections that flare out and go around the pier, and then return to this head on, down in the middle, double section, double backed-out section.

When you look as this, I think you get an impression that cars can easily be thrown off this area here across the roadway itself. The transi-
