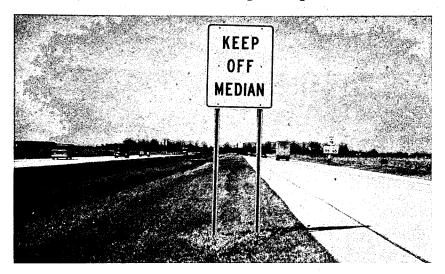
Here is another installation of a sign that we are gradually beginning to think is just about an obsolete message: "Keep off the median."

You cannot talk about it without getting into the subject of messages. But this is at the same general locale as the speed sign that I mentioned in the previous slide. Here is the corner of that auto polish sign off here on the side and it gives you an idea of the dimensions we are talking about again, 2 feet away.

This installation is mounted on a couple of U-channels that are backed up and doubled. They measure as the tape shows 4 inches longitudinally along the road, and there are two of them. This is a pretty

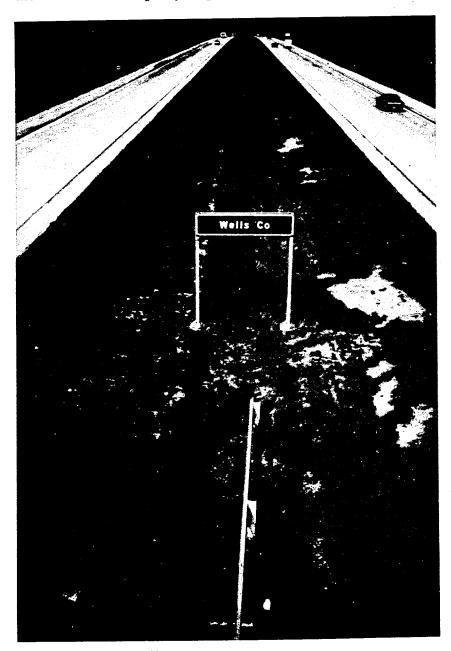
Here is a Wells County sign, erected to show the political boundary. Again, this is questionable. This is an installation on an Interstate highway. How much information that provides that is really of benefit to the motorist is highly questionable in light of the other demands on his skills and on his capacity to operate safely.

This is a sign which I would say is not on a U-channel; it is on an I-beam.

Mr. Constand. It is kind of ironic, as we saw the guardrail on the median divider in the Indiana installation, 50 feet, you people questioned it; it was inadequate. Just in front of it you have two I-beams holding up a sign, which has dubious value. It could just as well be mounted on the bridge, could it not?

certainly would be a contribution of safety to put them there.

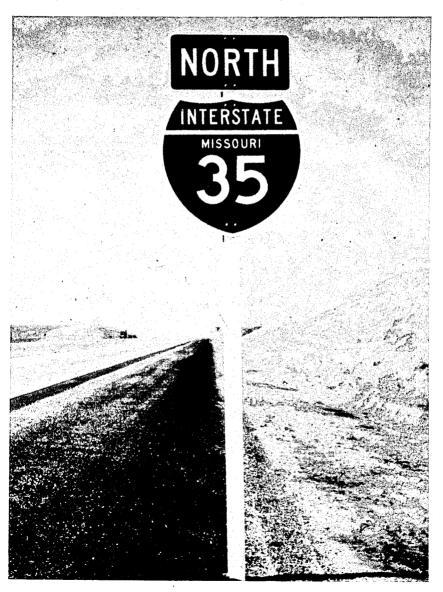
Here, now, in Missouri we find another installation of an Interstate marker, mounted on an I-beam also, I might say.

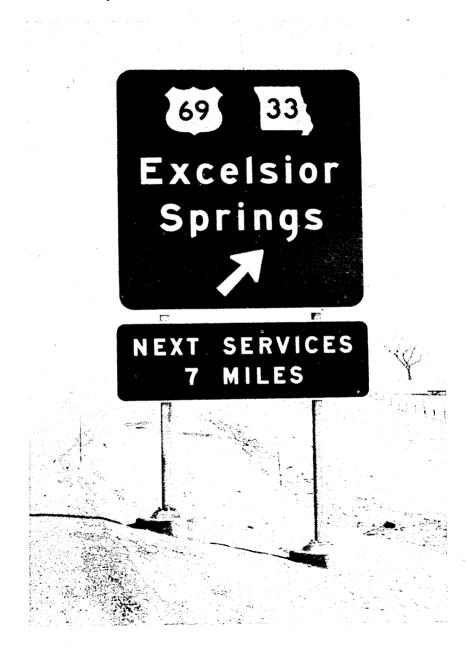
Here is the exit direction sign just in advance of an exit ramp leaving the main lines of the interstate project that we are looking at. Concrete bases again undesirably high, out of the ground, and close to the roadway.

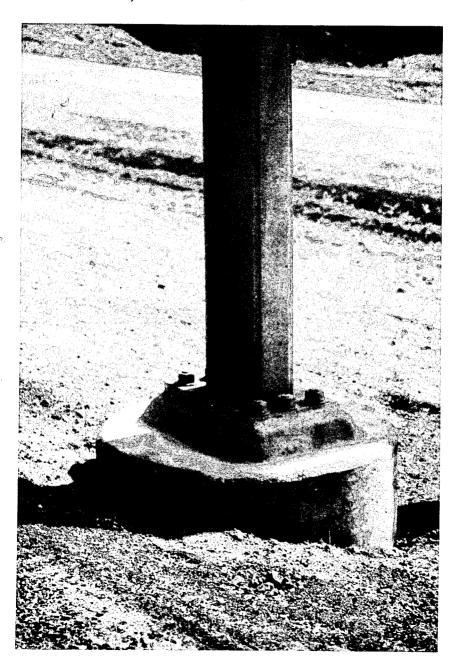
This is that base, close up.
Mr. Zion. Could these signs be put on breakaway posts, too, Mr. Prisk?

Mr. Prisk. Yes, sir.
Mr. Zion. They could be like the light poles?
Mr. Prisk. Yes, sir.

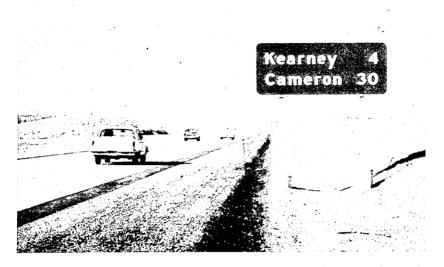
Mr. Prisk. We proceed. Here is another type sign that is useful in orienting the motorist in his distance to destinations. But it need not be up on concrete footings of that size and magnitude. This, again, is the old base problem of getting something in line with the slope.

Mr. RICKER. This illustrates something else. That sign does not have to be at any particular location, and by moving it longitudinally along the roadway it could have been placed behind that cut slope at a relatively safe place; even moving it out slightly and putting it beyond that cut slope would have been protecting it.

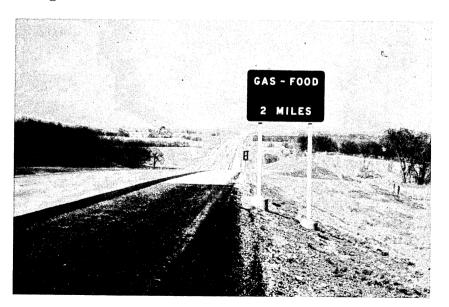
Mr. Prisk. Moving on, here is another similar installation for another purpose, service sign, "Gas, Food" marking, with exposed

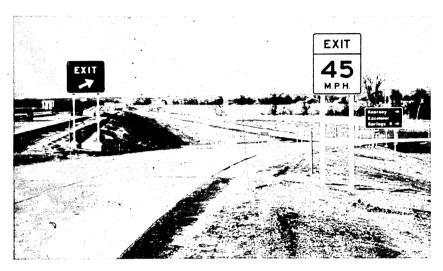
Here is an exit sign with exposed footings. Here is an exit sign, speed sign, on the right-hand side on I-beams. And in this case you will notice that the shoulder is paved to this point and then at this location you drop to a narrow shoulder. So that it would be possible, conceivably, to drive directly into it.

I would also call your attention to almost the forest of signposts down in this area. I cannot help but think that some improvement

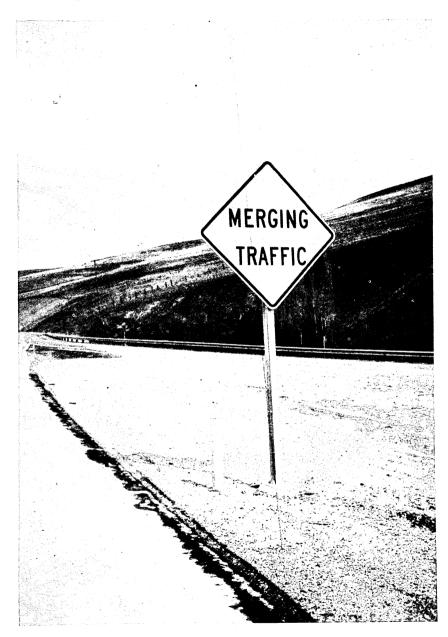
This merging traffic sign is also mounted on a 4-inch ${\bf I}$ -beam on the Montana project.

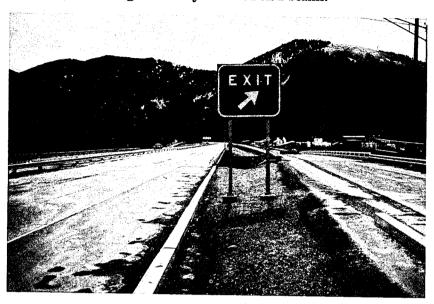
Here is the exit sign similarly mounted on I-beams.

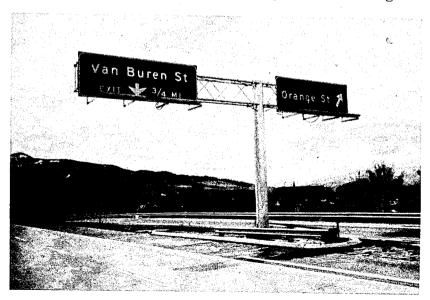
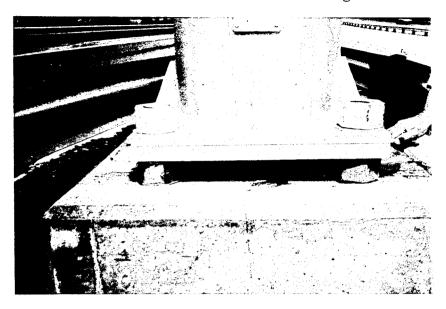
Here is one of the very husky mountings that we saw on an exit from the main line here going into Orange Street.

Mr. Constandy. Missoula?
Mr. Prisk. This is the west side of Missoula, Mont.; outskirts of Missoula. And that particular installation was extremely impressive. You see the gore condition where you have the approach roadways nicely divided, curbing outlines it, extremely short section of guard-

rail here, 12.5 feet either side. And then that pole in the middle. I would like to take some estimates of the audience as to how large that is.

I estimated it was 18 inches and when I measured it, I found it was 24 inches in diameter, and then measuring the base, I found that that base the pole is welded to is 32 inches by 32 inches by 3 inches thick. Those nuts that you see are 5 inches across.

This is a tremendous thing. And there it sits on a concrete base.

I think the best point that was made in summary of this situation is the fact that it need not be there at all and would better serve the motorists if it were mounted at a position a couple hundred feet upstream, back toward the camera, so the drivers would have that information somewhat earlier, and that this gore itself could actually be fully clear.

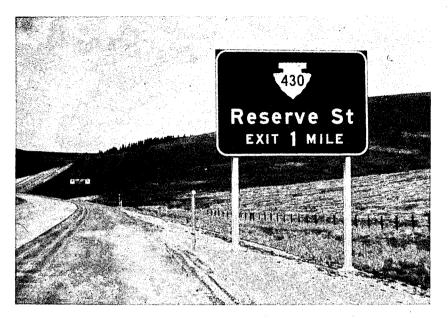
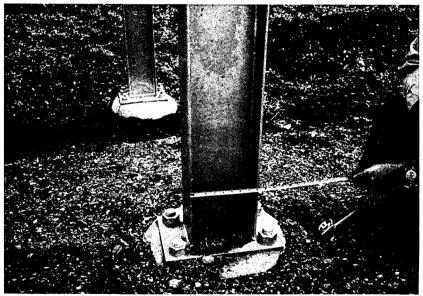
We move along on the Montana project, going west, getting into a more rural section. We find the exit sign for Reserve Street the next installation. This is mounted on two I-beams, as they are shown here.

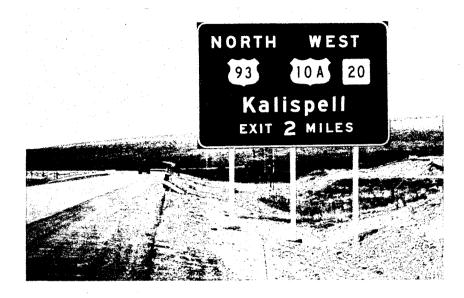
Here is the 2-mile exit sign for the next major interchange, the Kalispell Interchange; and this is mounted on three 10-inch I-beams.

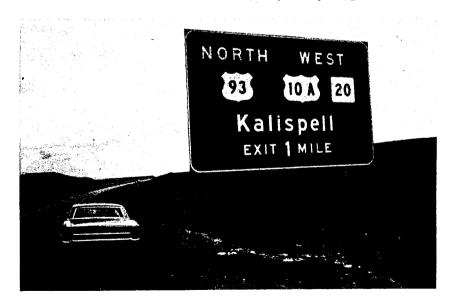
Here is the 1-mile exit sign, the same design as the previous one, but mounted on three 10-inch I-beams, very heavy support.

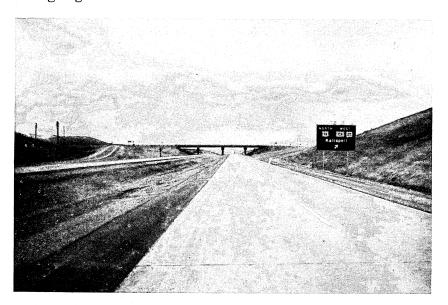
Here then is the exit direction sign, just ahead of the interchange. You will notice a rather abrupt deceleration lane, perhaps too short, particularly in this kind of open country; but, in any event, this is the signing that we find there.

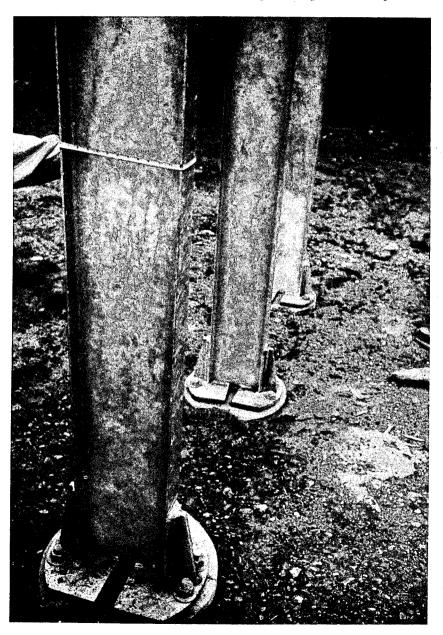
We move along now to the Georgia job, and this Windy Hill sign is also supported on three I-beam mounts. These measure 12 inches. This is a very light section beam, but is is 12 inches. There are three of them.

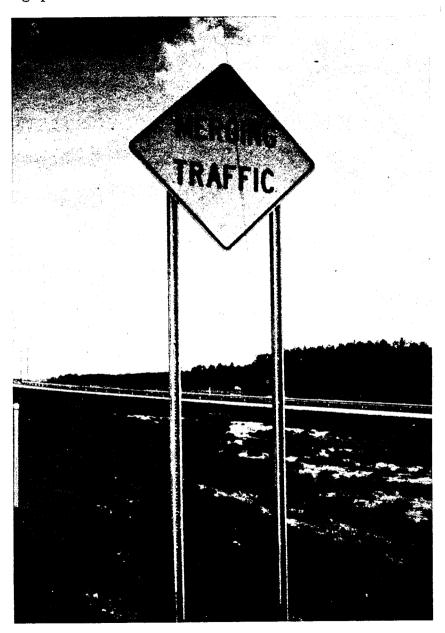
The merging traffic sign used on the Georgia project mounted on a high pair of channels.

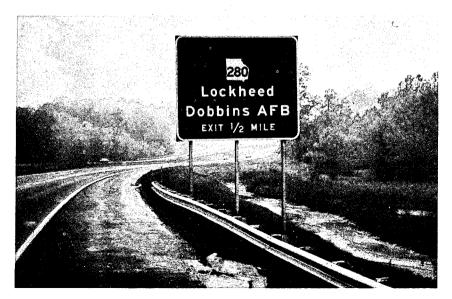
You go from this sign to the sign you see, through the legs of this sign, in the background. That sign says a half mile. Instead of saying Dobbins and Lockheed, this says Lockheed and Dobbins. This violates the principle of good signing practice, which maintains continuity in signing messages.

Mr. Constandy. I think it is worth pointing out, too, that the exit here is also closed, although none of the signs in advance have reflected that.

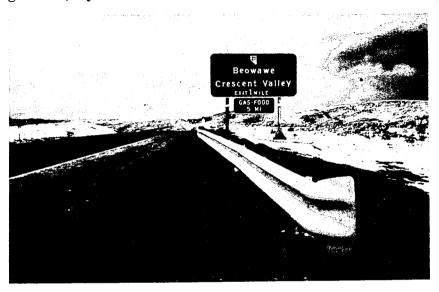
Here is the installation just ahead of the one interchange that we had to look at in Nevada. This is the 1-mile sign. It is mounted on heavy supports, but in this case it is pretty well protected by the advance guardrail, as you see.

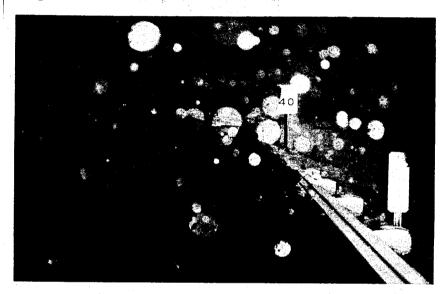
Here is a shot of a smaller sign, also taken under adverse conditions,

not protected.

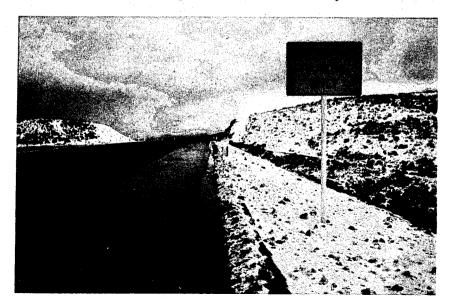
Here is another sign, "Emergency parking only," perhaps of a class that ought to be looked at again in terms of its necessity.

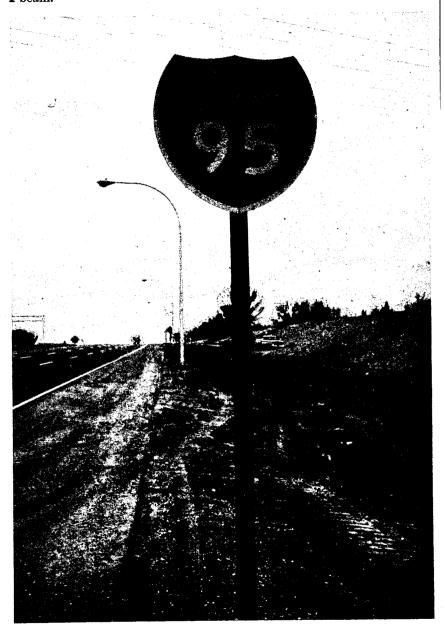
We move now to Rhode Island. Here we find that the interstate marker is accommodated on a wood post, 4 by 4 instead of a 4-inch I-beam.

These posts would go down much more easily and with far less violent consequences as far as a collision is concerned. The same thing is used, doubled up, two of them, for speed limit signs.

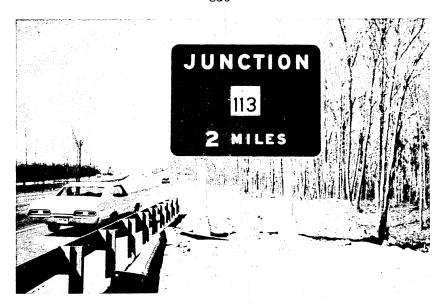
When we come to direction type signs, advance guide signs, there are mounted now, as you can see, two aluminum poles here. The third one remains to be placed on this base to back up the center of it. I think you tend to look at this and wonder if that would not be quite adequate without the third one, but in case you think that three may

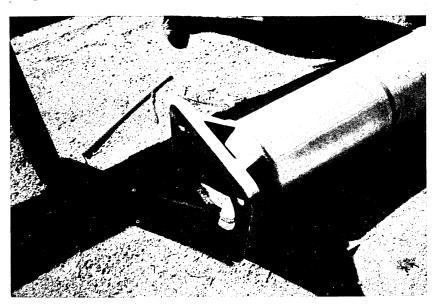
be too much—here is one with four. Again I am not too sure whether this is not more support than that sign needs. It is an extremely large sign—no question about it.

Mr. Prisk. That will be a future message when other exits are open, so we were advised when visiting the project. This is not a completed sign, as far as the project is concerned, because some of the exits are not yet open.

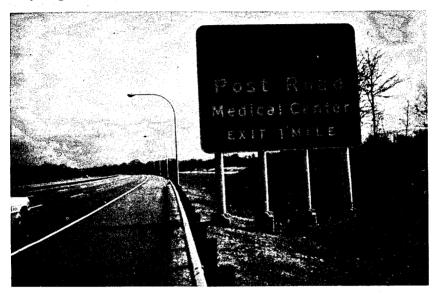
Mr. Constand. Could you show that base in the last slide? (Slide.) In speaking with the people from the department here, they mentioned that base is frangible and the pole is aluminum. It was their opinion that if struck it would not cause the car to stop violently. However, it is also very heavy. I was not able to lift up this end of the sign. Their opinion is that the post is not as lethal as it looks.

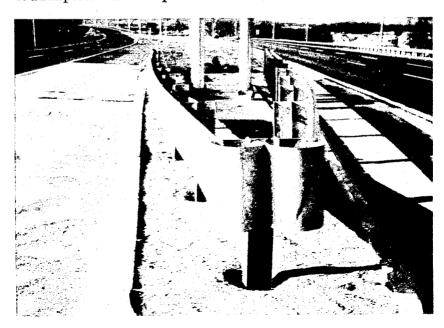
Signing does present a problem when you have as many as four

signs with that much message copy to understand.

As you come in close at that point, this is the way the actual sign base looks in the gore area. There are two posts there, actually two bridges, if you remember, one over the right road and one over the left. This is to be replaced by a single structure, single support, which will cover the entire roadway.

Mr. Constand. As Mr. Marcello mentioned, they recognize the hazard that exists here themselves, and it was his intention to have both of those sign bridges taken down and one longer one put over both roadways, and the elimination of the sign structure and the

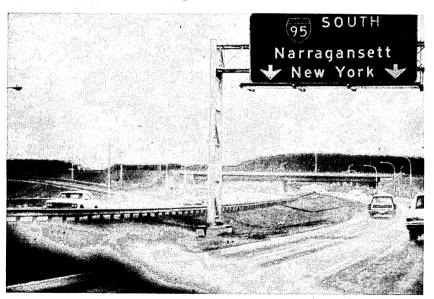
Mr. Prisk. No. These were primarily for the two signs on each one. Moving now to the next one, south on 95, Narragansett-New York, we see an exposed sign structure support. This is in the median. I think I showed a picture rather similiar to this yesterday, or day before yesterday, as we looked at the guardrail.

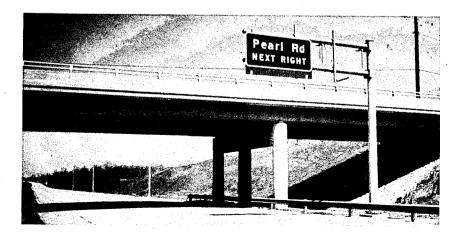
Here is an installation made almost at the structure, a cantilevered design, good design, behind the rail, nicely protected as far as that is

concerned, but you immediately seize on the thought here that that sign might be mounted on the surface of the structure itself, and that

this installation and support could be done away with.

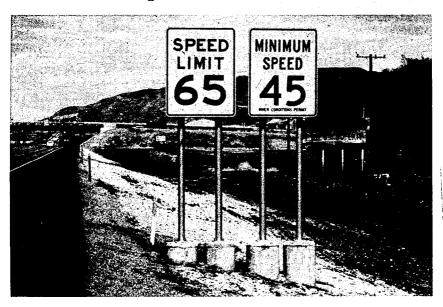
They are up, indicating this is not uniformly controlled to keep these bases down to the ground level.

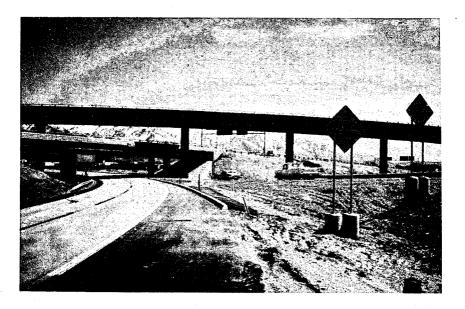
We were not surprised by that previous one; we were here, because here our cylinders are concrete, bigger than you can put in a barrel, extending above ground, and on the outside of a curve. There are signs of cars running off into this area, and this would not make anyone feel too easy about leaving that type of installation in place very long.

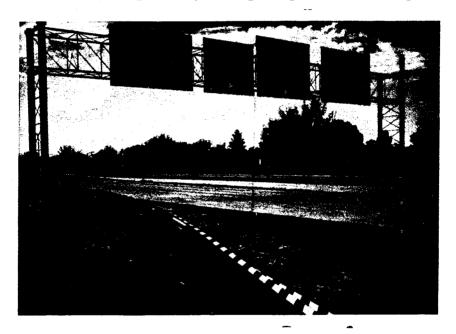
Continuing in Utah you see this situation, the typical exit sign installed at this point. Clearly this is the kind of place where the breakaway design has its best application. With the breakaway sign, I dare say the entire area could be cleared up of this hardware, as the British call it; namely, the guardrail, posts. All these could be taken out.

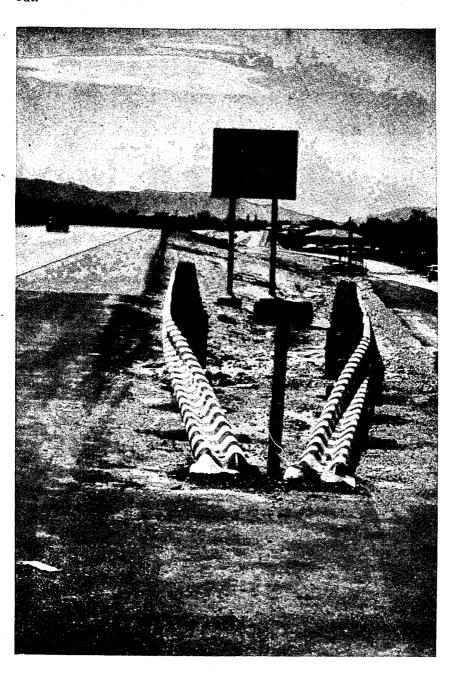
This is the back of that same installation, showing the concrete footings above ground.

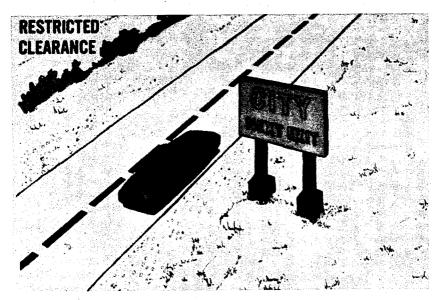
Mr. Prisk. These are indicative of typical signs that exist all too often, some of which we have seen in actual photographs: heavy footings, whole installations in a restricted clearance area.

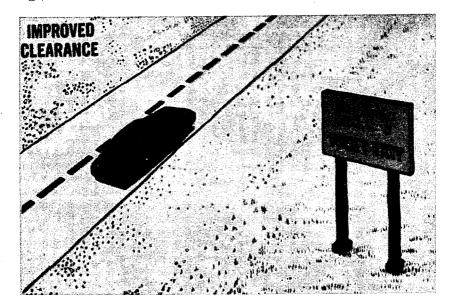
One easy way of course is simply to move these out. I think perhaps the most remarkable thing you might do sometime as you drive the Interstate System is to look at the signs that could be moved. We attempted to do this, and in a 30-mile section, out of 150 signs that were observed, it appeared that more than 100 of them could be moved 20 to 30 feet off the edge of the pavement without any loss of effectiveness.

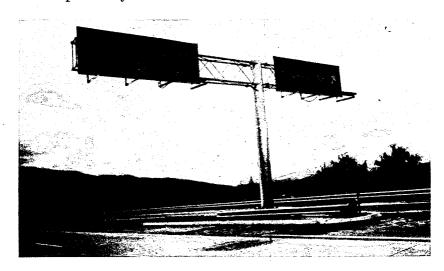
Mr. Prisk. Moving back to our favorite sign, which you saw a moment ago, this gore I think speaks for itself, after what we have said about it previously.

There are not too many things in here that are necessary. It could be entirely cleared by an advance sign bridge 200 feet to the right of the picture, and the rest of the gore is fairly flat, negotiable, traversable by car.

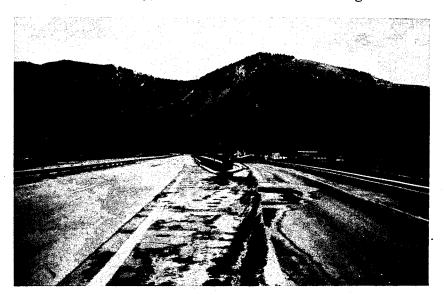
You move up on this one and you come on into the gore here. You have conditions in this gore that are tied up with what we were talking about earlier today, about where there are twin bridges.

So in the gore this presents really a double hazard.

You have these two 6-inch I-beams on the exit sign. Following the practice in this State you also have the additional hazard of the hole between the bridges. This is in Montana, I should say.

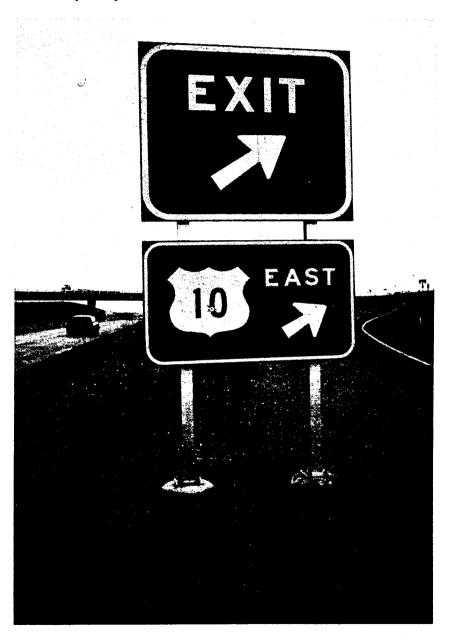
Moving up on the gore you begin to see the signing at that point, and the relatively flat area beyond it.

But very heavy signposts, I-beams, concrete footings which are necessarily heavy.

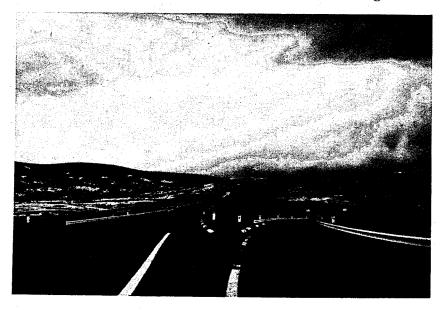
Transferring ourselves to Nevada and the project there, this is the way the gore looks at that point. Here they have supported the exit sign on a single I-beam. This is outlined with a black and white curb to give better visibility both day and night, and this does seem to assist at that place.

You also have the advantage of these delineation units that run down through here, and I think you need to remember that these gore areas

need to be highly visible both at night as well as in the daytime, but the gore itself, with the removal of this obstruction, would not be an unreasonable place to run into.

Mr. Skeels. I would like to point out, that guardrail in the background should also be ramped, because it is very apt to get hit.

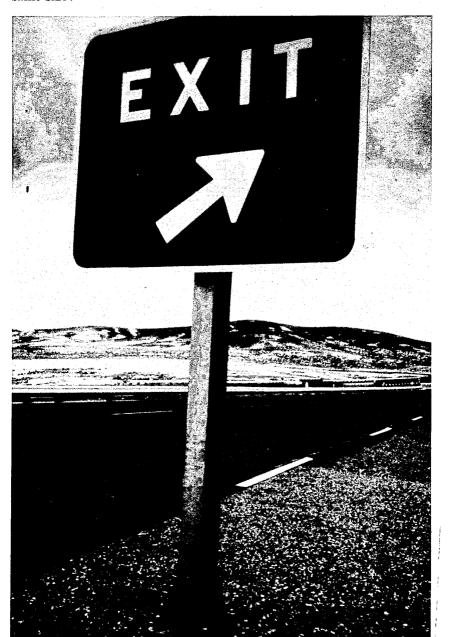
This is a closeup of that exit sign giving you a little better idea of the fact that this is mounted on an I-beam support. As I say, in some cases States are using two 6-inch I-beams; in this case a single one. The variability in this practice is quite remarkable.

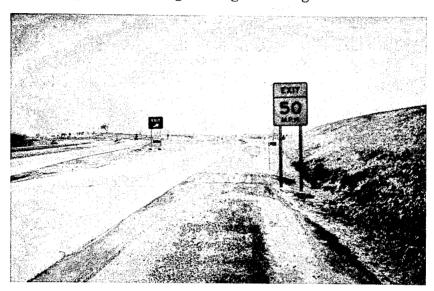
To move on down to that gore, we find the exit sign here with rather heavy concrete footings sticking out of the ground.

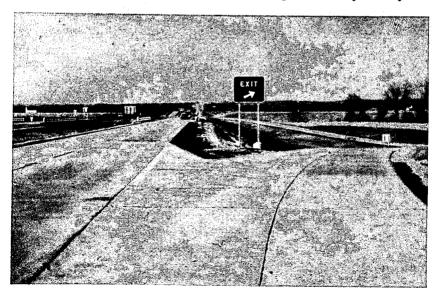
And here we are—again the place here where the grading of the interchange probably could not be accommodated to make this a real safe place to run into, but it does not look like you have too good a chance of getting in there with those footings in the way as they are.

Mr. Prisk. This is certainly one thing that should be considered. There are some efforts being made to develop impact attenuation barriers to use in just such situations as this. The Bureau of Public Roads has a mockup now of a barrier that will accept a reasonable amount of impact where you have to guard against collision with some fixed object that cannot possibly be removed, or against a situation of dropping into a hole, such as you have here. But I think your point is well taken, it is time to back up and take another look if that situation does exist.

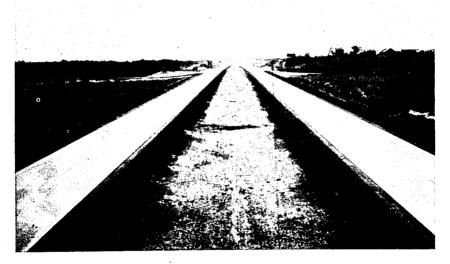
Here is a gore coming toward you, on camera, in this area, again indicating relatively flat land that lays there. Oftentimes not too much consideration has been given to filling in places of this sort; but with some consideration of that in advance, it would be possible to provide a reasonable runoff area along in this section between the two roadways.

It might be of some interest to the committee to know that Road Research Laboratory in England has come up with a series of tests very recently that have shown that gravel, about three-fourths of an inch round, laid to a depth of 18 inches will stop a car within reasonable deceleration limits and actually will hold the car in there. So that still another possibility is to load this up with a gravel runoff track that would be used for that purpose.

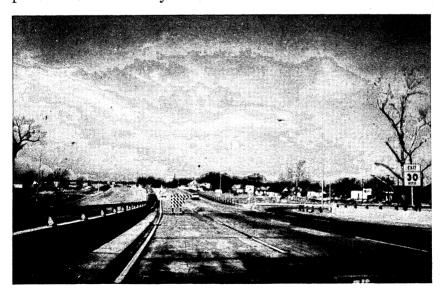
This is one that is undesirable from the standpoint of the curb and certainly the rail, not to mention the sign installation; that is temporary. The fear that I would have in looking at this would be that they would replace this with a 6-inch I-beam.

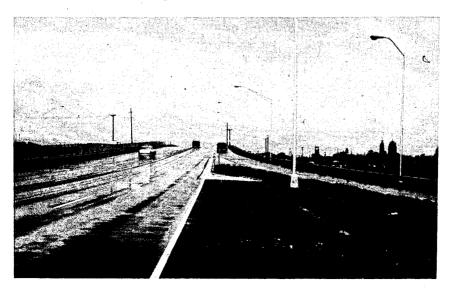
Mr. Skeels. This is perhaps an example of the very serious gore problems, one on an elevated structure in which you have to have a railing behind it and you have to get into that railing in some manner. In this case the large block of concrete is pretty short and pretty vertical. I am sure Mr. Prisk will have more to say about this.

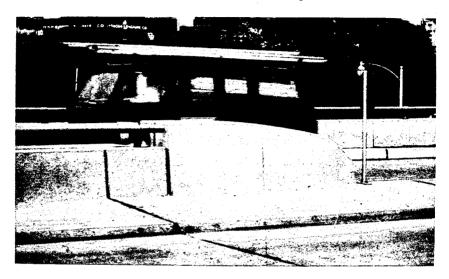
Mr. Prisk. There is another view of it here. This is about the way it looks. This is what I am sure is a hazard marker, and that, in fact, would be a very considerable hazard.

This is a prow-type design here, which does come on down close to the roadway level, but there is not very much streamline to it. And

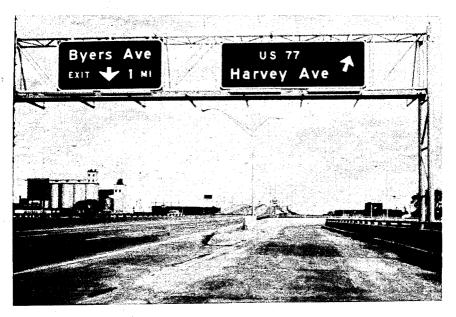
Here is a view of another one at a somewhat greater distance. There is a little bit of advance notice out here in terms of some lane mark-

ings and a little island out in front. Otherwise you do not have much notice of that hazard.

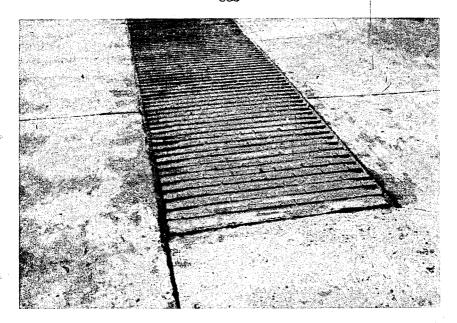
I recall measuring this at about 80 feet, and at the end of that 80 feet is the usual curb such as we just saw on the urban project, and then, of course, your gore is beyond here.

I would only point out that 80 feet at 60 miles an hour would be traversed in less than a second and hardly is enough notice—or given at

If you could just transfer this whole thing a little farther in advance, it might do some good. At that point I fail to see this is going to help anybody very much.

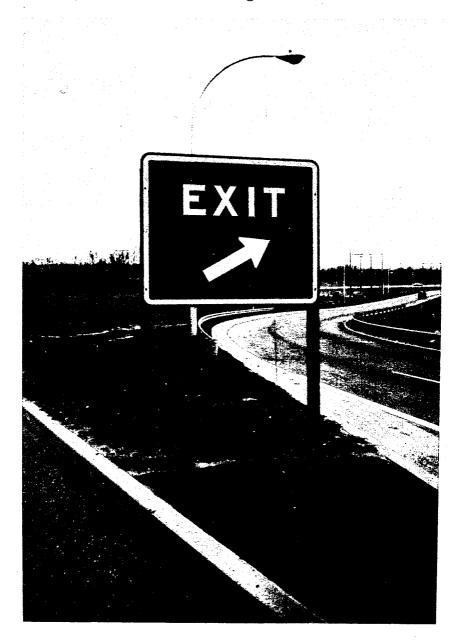
Here is an exit sign in Rhode Island and a gore beyond, which again is quite traversable. If you think of riding in there too far, you might concern yourself about that rail and get that down at the end.

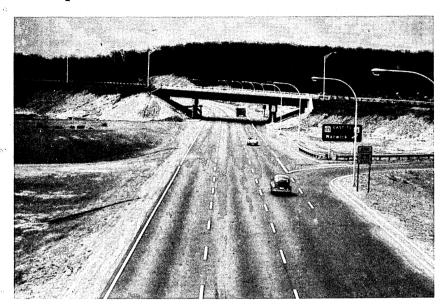
Here is still another gore where there is a very abrupt takeoff, 25mile-an-hour curve to enter that, and there is need for additional material to fill this depression if that gore is preserved.

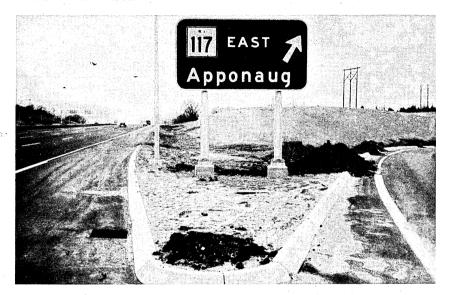
This is another gore situation which we saw where there is a curb here outlining the gore, and for the life of me I cannot see reasons for curbs in this kind of a situation.

The footings are high. These are concrete footings, these blocks you see, topped by aluminum poles, which will snap all right if you can get up to them. But possibly when the final grading is done here, as someone suggested this morning, this will be brought up to grade, so that you will not have anything except aluminum poles to contend with.

I think I still would feel a little more comfortable with a true break-

away slip joint in there.

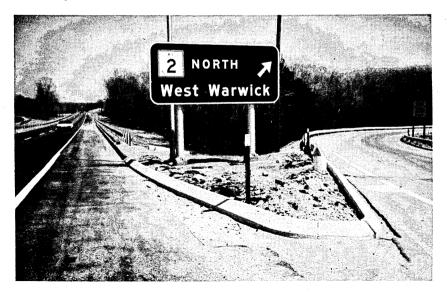
This is another view of a similar situation. We do have a guardrail difficultly in here. This job is still in the cleanup stage. But you can

see that it is not totally outside the range of possibility of running through here, taking the sign out and running through here and coming to rest down below without getting into any great difficulties

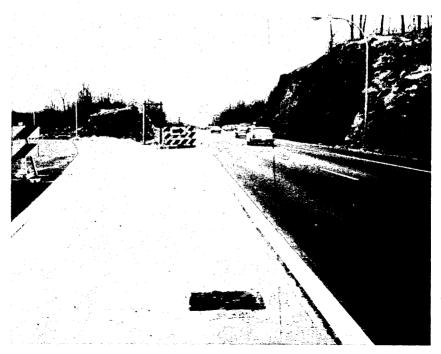
There is another use of concrete wedge between two asphalt pavements. This is a rather rough gore, if you move on into it, because this is rock in here and, of course, rock in the vicinity in general.

The question rises again as to just how much of this you can remove.

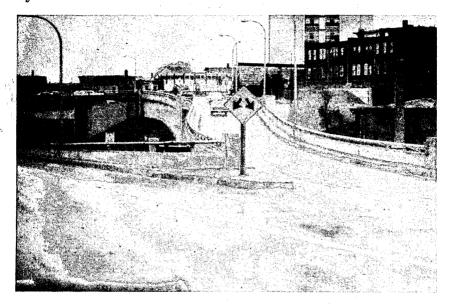
Some of these are pictures now on the north side of Providence, also on I-95, showing some of the things you can get into in urban conditions where you have walls to contend with and vertical curbs are the rule of the day. This is overworked obviously. Still on our Interstate System.

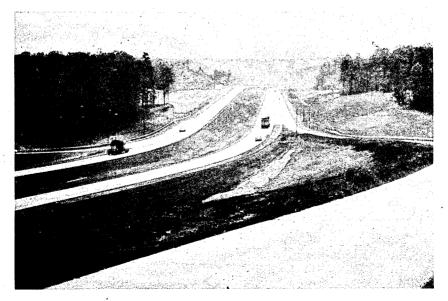
Now we come back to conditions in Georgia, and the thing I wanted to illustrate here is the very good alinement, vertical and grading in between these two roadways. Excellent opportunity. The car at this elevated position has to see traffic on the main line in order to make its merge down at this point. [Indicating.]

Also it is worthy calling attention to that very excellent acceleration

lane. It gives you plenty of opportunity.

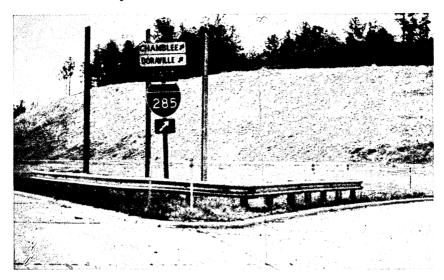
And here, then, at the end of the project, we have this kind of situation where they are getting ready to put up a three-masted sign to replace this Interstate 285 marking, which designates a beltway around the city. A guardrail has been put around the gore area, which constitutes a substantial obstruction.

There will be a large sign put up here without the breakaway design.

It too will be a very substantial traffic hazard.

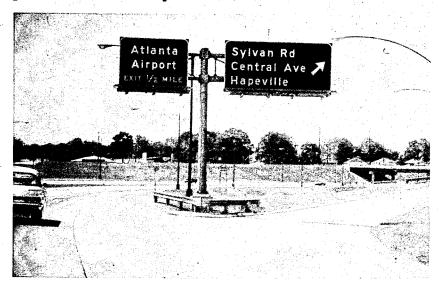
This is the condition headed for the Atlanta Airport, where you have a heavy concrete base here, very short section of guardrail, with two ends to hit. Otherwise, as you can see, it is fairly free and level terrain between the two roadways.

With the removal of that sign, the upright posts, the guardrail, the erection of the bridge a couple hundred feet in advance, this gore

problem would be entirely solved.

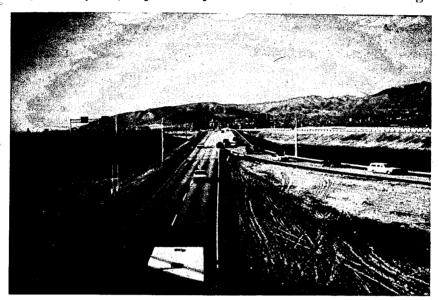
Mr. Prisk. This is a gore, also in Salt Lake City, outlined with a very short section of guardrail, up to this point [indicating]. You can see the cars can traverse this. There are marks all over the place. And they not only can, they do. They run off here and run down through

here [indicating] no reason. There is nothing down there. So obviously these are just drivers who were approaching the camera position, missed the road on one side or another, and then corrected their action by crossing the gore in order to get back to the road where they wanted to run.

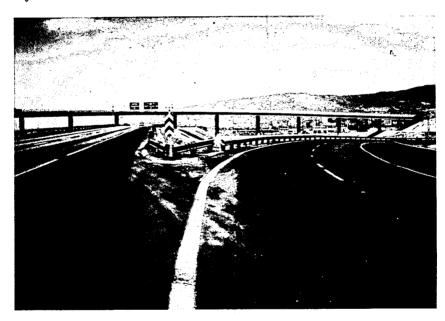
This again is I-15 here. The gore we were just looking at is over the hill. This turn takes you onto 80 going into Salt Lake City, so this is

Mr. Constand. I would like to ask you to keep this in mind, too; because as we approached this, it became apparent that many of the cars, a goodly percentage of them were going up this shoulder area believing it to be a lane. Of course, it is not; it is a shoulder. So we went up to the bridge, up where the arrow points and looked back this way [indicating], and took a series of pictures there. And again, not surprising, there were a number of cars that narrowly missed the guardrail, gore, but then continued on their way. And they have the duplication of the same problem at the narrow bridge right here at the crest of a hill. The shoulder is reduced for the bridge and it is not carried across the bridge full width, so you have another problem of the vehicles almost striking the bridge parapet.

This was pointed out; it is probably the most dangerous situation we saw.

Mr. RICKER. Perhaps this is the time to comment that it has been found useful to stripe that gore area; in other words, where the shoulder is beginning, to put diagonal paint marks about 2 feet wide across that entire area in which you see traffic out there. It does work. It keeps people out of there.

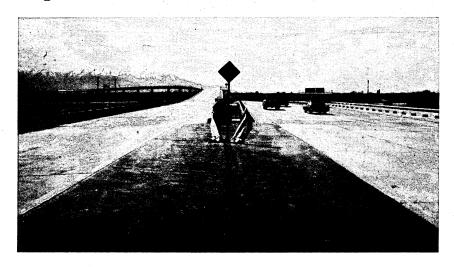
Here is still another one, another gore with a dual bridge just beyond. So again we contend with not only the hardware that is in the gore, but the possibility of dropping into a space between the two bridges.

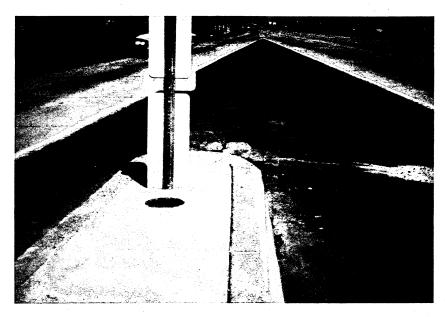
This is another one on the same Utah project and in this case that

asphalt wedge is doing a very good job of keeping people away.

In the immediate foreground, however, you do have to contend with the curb, which is raised about 6 inches at that point, almost vertical; and if that is struck, you can be in trouble.

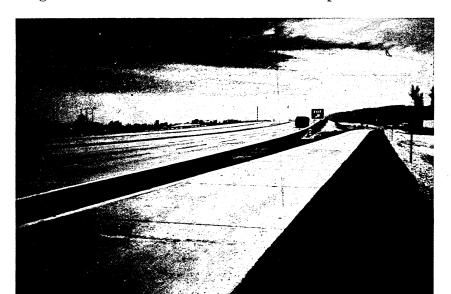
Here is a gore. As you get a little ways away from the city conditions where there is relatively easy terrain to follow, a little grading and treatment in that gore installation, breakaway sign for the exit marking, and removal of the guardrail would probably make it quite safe. Again I call attention to the desirable contrast in pavements.

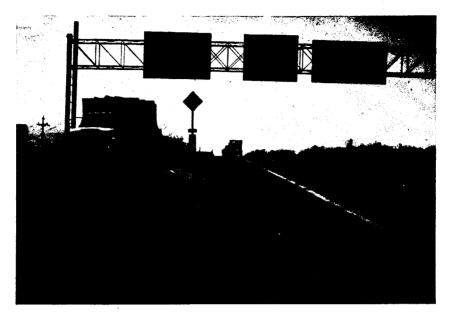
Here is one where the entire platform was raised up, again on a curb, a hazard marker up there, diamond marker, simply to reflectorize at night.

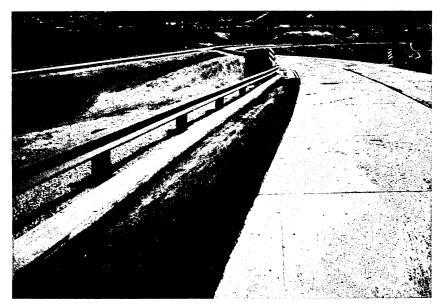
Here the curb is in front of the rail. This also is in the Salt Lake City project. I am disappointed this is not out here [indicating]. In this case I do not know. This is on an approach to a structure. There may be some reason for it.

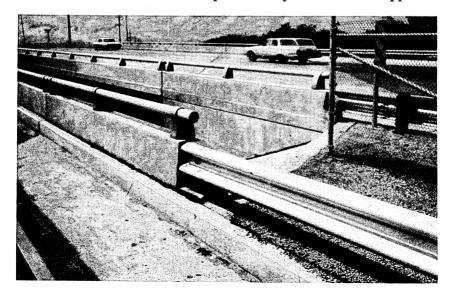
Here again is a dual bridge situation and the curb here about 4 or 5 inches wide, and entirely satisfactory as far as collision conditions are concerned. It lines up reasonably well with the approach

rail at this point. However, back here, the rail fades back behind the curb and the rail would not perform as well back in this area as it does up here [indicating].

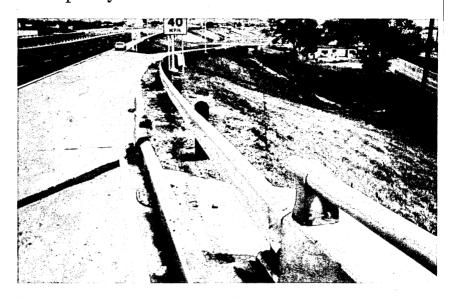
Here is the curb so far in front of the rail that it would be a serious handicap to any effective service out of that rail.

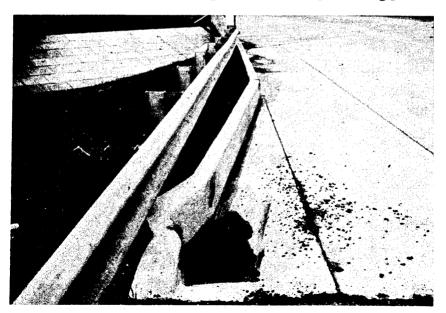
Here is the situation in Missouri, now, where we find the very definite tendency to continue that bridge curb in the same line as it was on the bridge, even though the rail was pulled back here. [Indicating.]

You must remember, of course, that these things are built at different times. Undoubtedly the structure was built many months ahead of the guardrail installation. But if these were planned together, they could be made to conform.

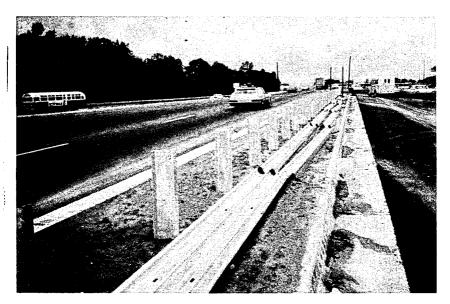
And here we have a situation I think worthy of calling your attention to: a brand new job here, this is south of Atlanta off the subject project, but the one that we saw en route to the airport. A curb in front of a median barrier, double sided barrier, can hardly help that barrier to perform as effectively as it would if you paved over the barrier flush on both sides. So I think this is a case where money was spent for curb and gutter—as I recall, the price of this was \$3.20 a lineal foot for curbing and gutter along here—and I do not think we bought any safety with that.

Yes. I think this a case where some money was spent unnecessarily.

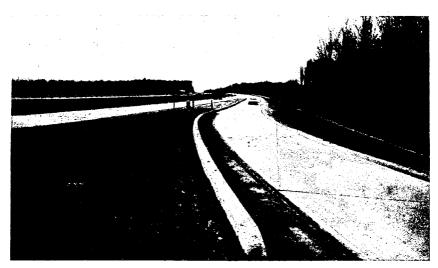
Here it is shown as it starts. It has a little taper here, reaches its height very quickly, and is continued down here to a point where it reaches the edge of this shoulder.

This curb is not thought to be much more really than a visual guide to traffic using that entrance ramp. I personally am not impressed with having curb at that location.

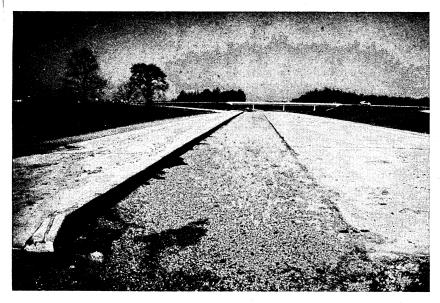
This is the use of curb in a similar fashion on another entrance ramp, on the same project, on a section not yet open. This is the end near where it joins the through lane.

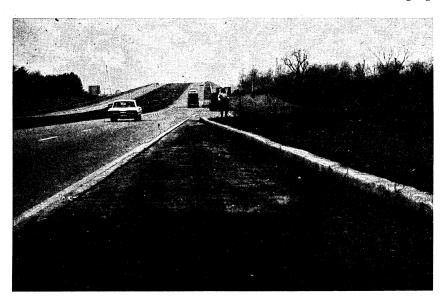
And this is a similar or additional type of curb situation. This is in Indiana where cars are unable, as they approach the entrance ramp, to have use of the full shoulder. You see the shoulder continuing up

there in the distance, but the shoulder is cut off at this point [indicating] from about where the camera shot is taken.

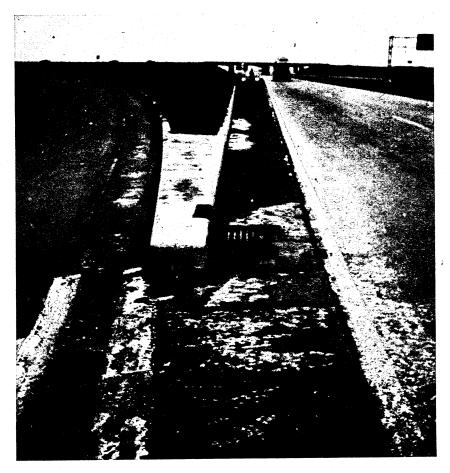
Mr. PRISK. This is a closeup picture on the Indiana project. This, as I say, is the older work. There is only about a foot-and-a-half or 2-foot clearance at this point. [Indicating.] This is the entrance ramp, and this is the throughway.

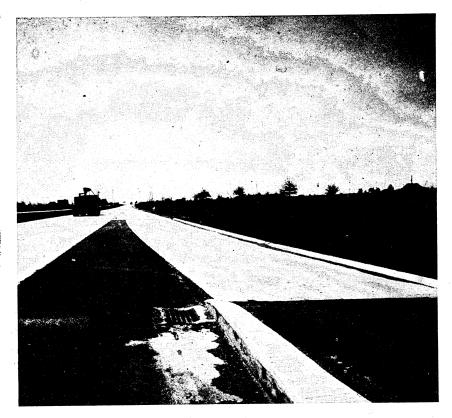
Here is the work as it stands today on the new job, which is certainly better from the standpoint of clearance; because instead of having 2 feet from here to the curb, you have the full shoulder width. Drainage is dropped here and taken over into this low spot.

The curb has the same disadvantage here, I would say, as I remarked

on Ohio.

Another thing that is noticeable here and I think significant is the fact there is a curb on the outer edge of the entrance ramp. This is not regarded as a good feature, because it tends to confine the entrance movement to the point where the drivers are prone to stop in this area unless there is immediate opportunity to enter the traffic in the through lanes.

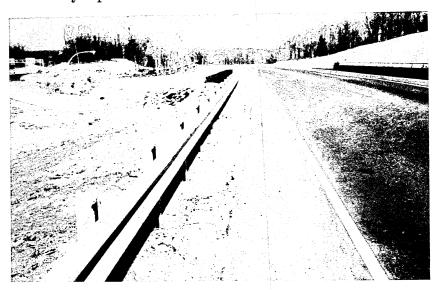
Here we are in Rhode Island with granite or precast concrete curb coming across these bridges, pretty much as though you had a sidewalk situation. There are no pedestrians permitted in this area. In fact, there are signs right in this vicinity prohibiting pedestrians from coming into the interstate section at all. So the curb at this point is quite an unnecessary imposition on the free flow of traffic.

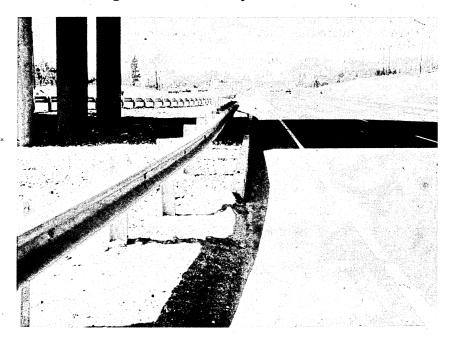
This is a similar situation on an undercrossing, with the curb well in front of the guardrail structure by 2 or 3 feet.

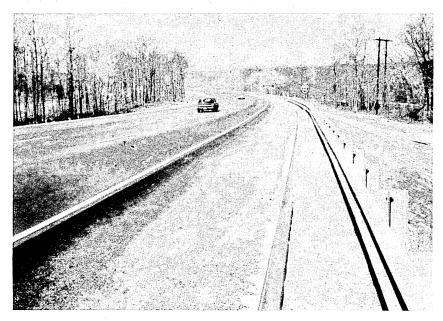
This is an asphalt curb, again used so as to provide a walkway immediately in front of the guardrail, and perhaps as much as 2 or $2\frac{1}{2}$ feet wide.

With that curb not there, of course, you might lack the drainage control that would be necessary. From an operational viewpoint, it would seem you could go ahead and do without the curb on this kind of grade. It is almost flat.

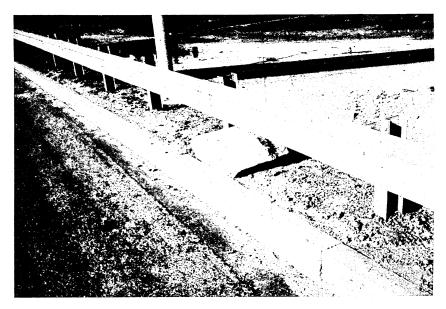
Here is an interesting shot, a little curb left over here, laid in front

of the railing.

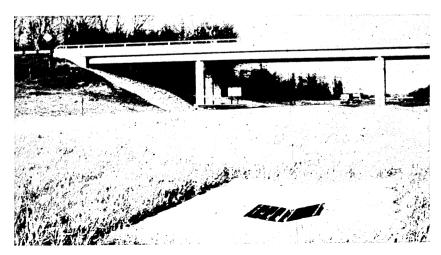
Now to look at some of the conditions that we saw. This is on an Ohio project, interstate, where the median is built flush with surrounding ground.

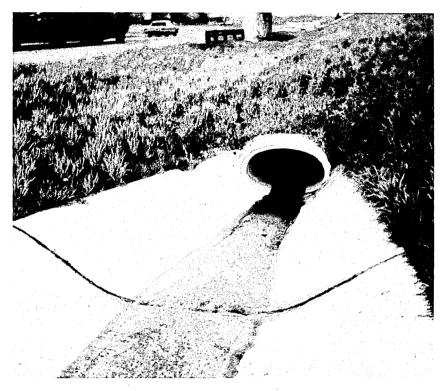
Here is a drainage feature at an interstate separation in Ohio where some obstruction is offered at the roadside.

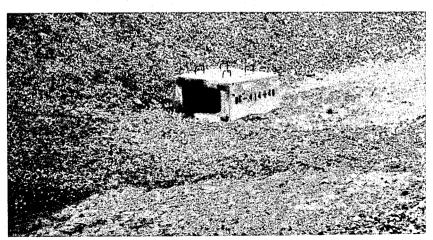
Here now in Nevada we find an exposed median drain built well above the surrounding surface. This is truly an obstruction to any traffic in that area.

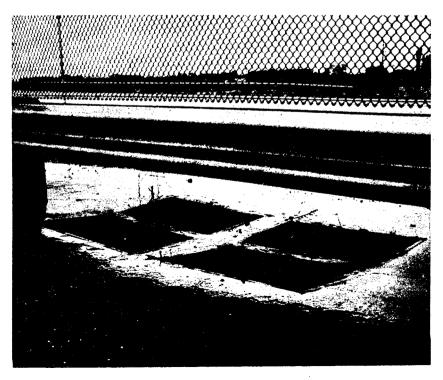
Here now in Oklahoma is a paved median with a surface drain. It serves very nicely to handle drainage and offers no obstruction to traffic flow.

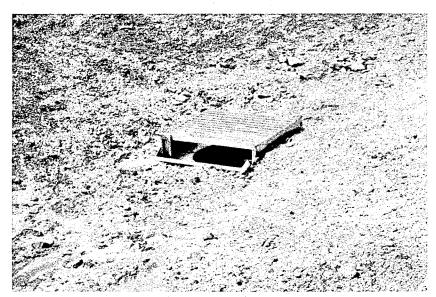
Here is one in Montana which does project above the roadway surface in the median.

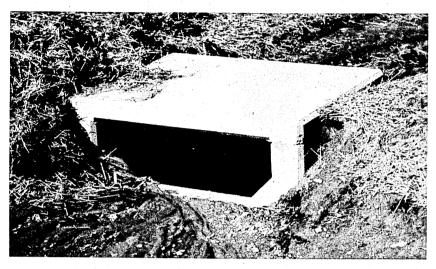
Here we are in Missouri, with a drop inlet in the median, again raised above the surrounding terrain, level of the terrain. This would constitute quite a hazard if hit.

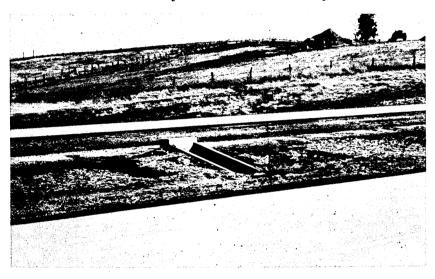
Mr. Prisk. This is entirely needless and unnecessary concrete.

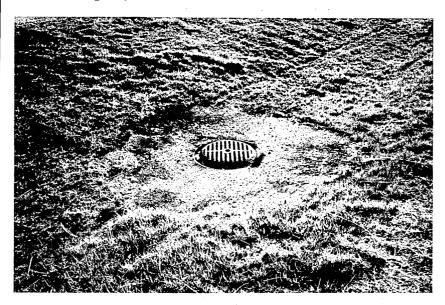
Moving now to Rhode Island, we find in the median this sort of a drop inlet with a circular grate, paved areas around it, which seems to be functioning very well.

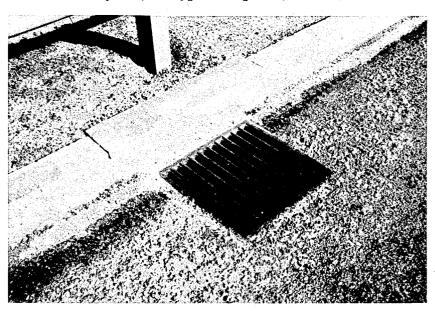
This is entirely safe, this type of drop inlet, here shown at the curb.

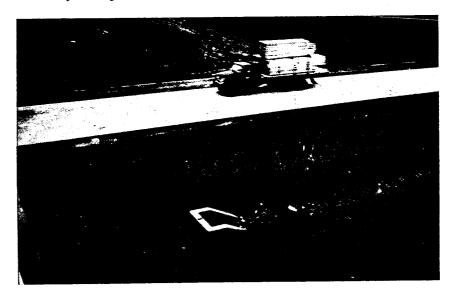
Here is the type of median drain, and an obstruction at the same time, seen on the Georgia project. This is going through a grade separation structure. And although the headwall has been cut off, there still does remain here a less than desirable facility for drainage, from the safety standpoint.

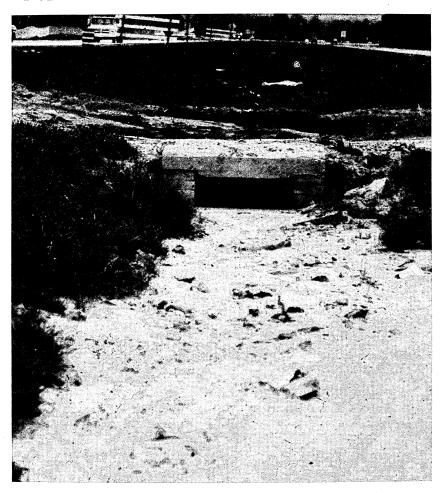
This is another type of inlet on that Georgia project where there is a vertical rise here, very obviously three or four bricks high, a tabletop type of median inlet raised above the surface.

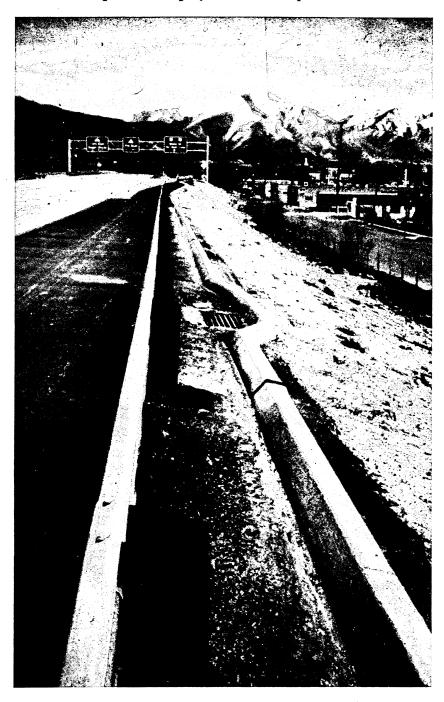
In Utah, on Interstate 80, we found drains of this type, and this curb that we saw yesterday, I think does tend to control the drainage. With these drop inlets that project seems to be quite well served.
