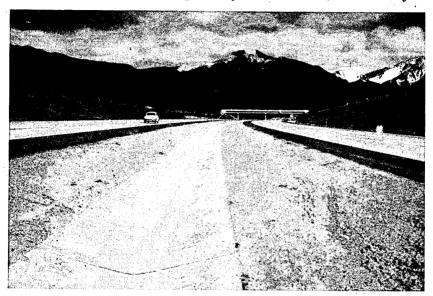
The median drainage is handled in a concrete paved ditch of this sort. Aside from the fact this has a rather sharp V at the bottom, I think it might be regarded as satisfactory.

A rounded bottom would probably be more safe, functionally.

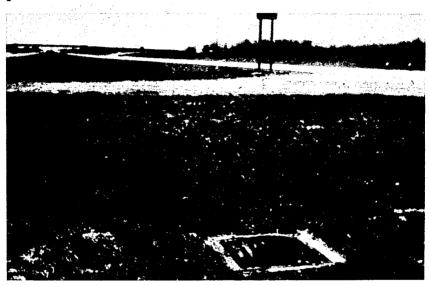
Here is the Indiana project, again showing a drain almost completely flush. Beyond it, however, is an undesirable feature of this median dam that we too often find on Interstate projects; the grate itself is quite harmless.

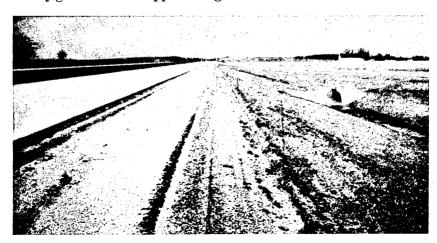
Also in Indiana we found pipes used under the roadway to drain the adjoining land and to handle natural water courses in the area. These are rather large pipes, and as you will see here, they are left open without any guard as far as approaching traffic is concerned.

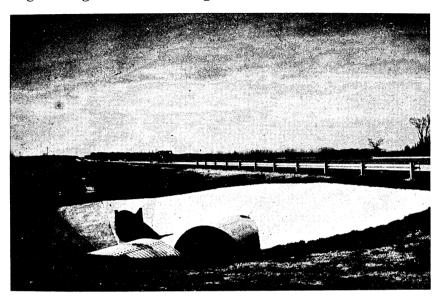
When you come to a major junction where there is a drainage along the highway as well as this cross drainage, very large pipes, some of them running up to 6 to 8 feet in diameter, are brought together in this large drainage sink to handle surges in the waterflow.

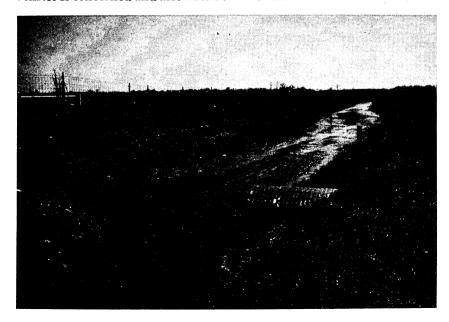
This gives you an idea of the Indiana project in terms of the amount of water that does, in fact, drain from adjoining land and collect along the project. You see cars in the upper right-hand corner of the picture. If they went out of control on this slope I expect the water itself could be a very serious hazard as far as the mobility of the vehicle is concerned and also in the event of an overturn.

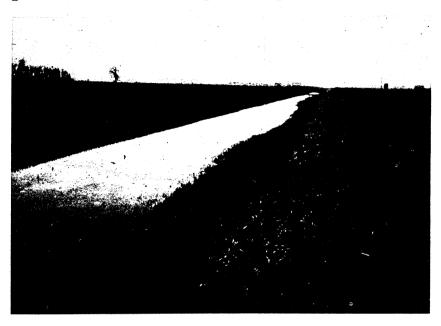
More of this same water condition. The water, I think, must be regarded as a hazard itself. The slopes here are good.

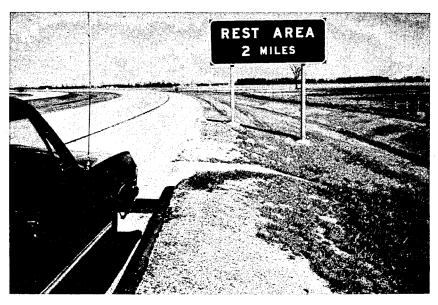
And here is an interesting drainage condition, also found on that project, where there is a ditch paved down the slope which, of course, is not unnatural, but up at the top there is a drop inlet at the same point, which [slide] going back to the previous slide for a moment, the outlet is at this point [slide] so you have two places for water to go immediately in front of that automobile.

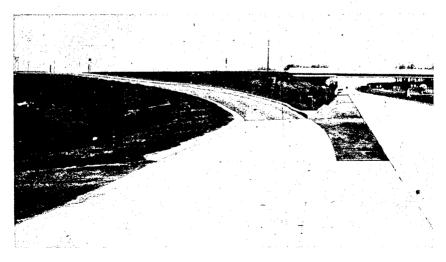
Here we come again to a consideration of shoulders on the Indiana project that has just been opened a few months. In this case, the

shoulder goes directly into the acceleration lane. And there are no shoulders, as you will see, on the ramps. This is an undesirable feature to omit shoulders from ramps. A shoulder does pick up, as you get to

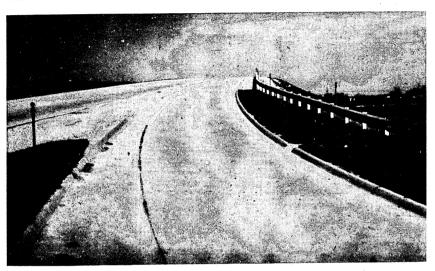
In this instance, a very unusual installation of guardrail which is shown here on the Indiana project, you see curbs that control movement of the entering traffic and the guardrail is pulled in here so that this shoulder, which normally starts here [indicating] and would run on up to the structure on top of the grade, is bisected by the guardrail installation.

Mr. Constandy. So half of the shoulder is behind the guardrail? Mr. Prisk. That is true.

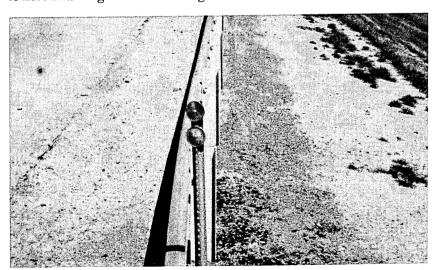
Here is a view close up so that you can see the shoulder paved out to here and the guardrail running down the middle.

Mr. Constandy. Yes. That leads into a bridge that does not carry a shoulder across it. Is that not correct?

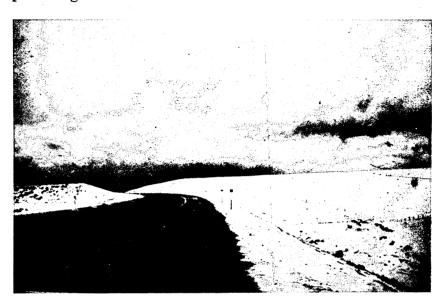
Now as we move into Nevada, we find this shoulder condition, which is very desirable from the standpoint of its appearance and for delineation purposes. These are the travel lanes, the black lanes; the shiny surface out here is the shoulder surface. From that standpoint, it does provide a good aid for traffic.

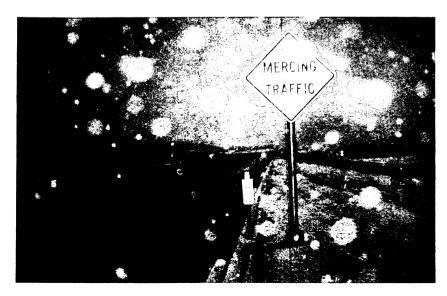
This is the same condition under poor weather conditions during a snowstorm. Again, along here you have this asphalt curb for drainage control.

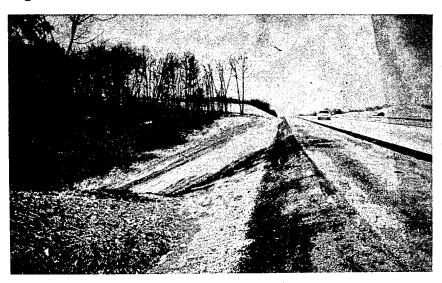
This is the type shoulder that they have. Not any too stable. We understand some additional work is to be done on this shoulder, and certainly is needed, because it is soft now, easily pressed in just walk-

ing on the shoulder.

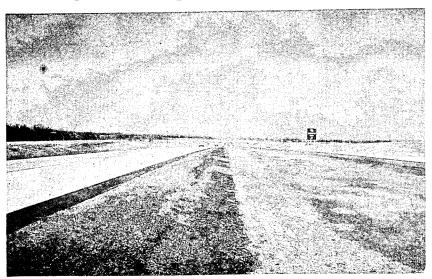
Another view of this same shoulder on the median side, showing perhaps a little bit more transverse slope than is desirable. A shoulder should have a relatively light slope from the edge of the pavement over to this point. [Indicating.]

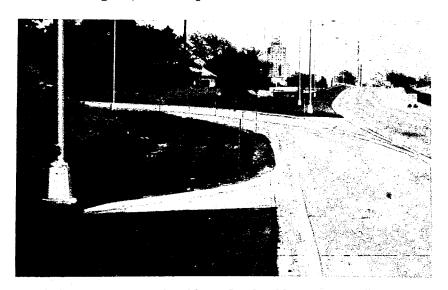
Here is the Oklahoma City project, which has the feature that we saw in Indiana, no shoulders on the ramp at all, both sides curbed. Of course, this is an urban section, perhaps a little more reason for that condition being found here. But we do have the shoulder through this area [indicating] which is cut off at this point, grass, and, in fact, the light pole is installed at that place.

It is a matter of discontinuity of the shoulder. I think it is certainly undesirable. Motorists should always have a moving travel lane with a shoulder alongside, wherever possible.

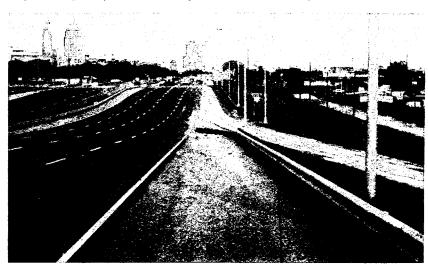
This is another example of how the shoulder gets cut off, and that, of course, shields the entrance movement, but at the same time it does make for an obstruction in the shoulder.

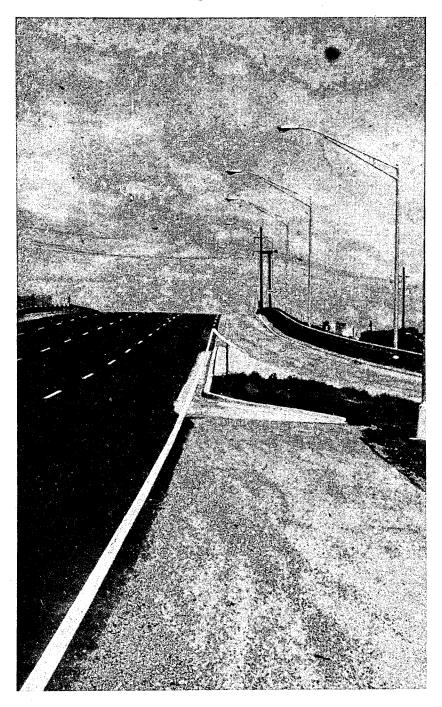
Mr. Prisk. Here is a closeup of that obstruction. As you move up and over all of the intersecting streets, this is curbed at this point.

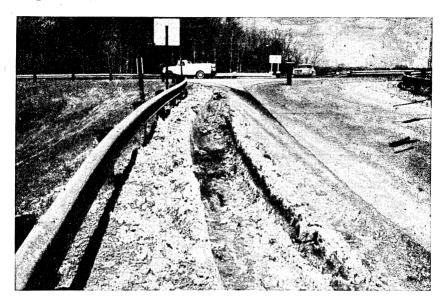
Here is the kind of condition we have in Ohio on one of the entrance ramps where, with weather conditions, this soil is rutted out very bad-

ly. And this is not a traversable shoulder. This is a ramp, of course, here [indicating].

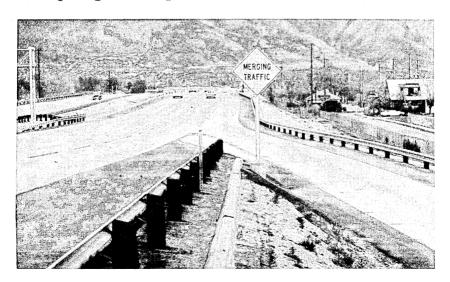
In Utah, you have somewhat the same condition that we saw in Oklahoma City. This is Salt Lake City here, and here is the shoulder interrupted again at that point.

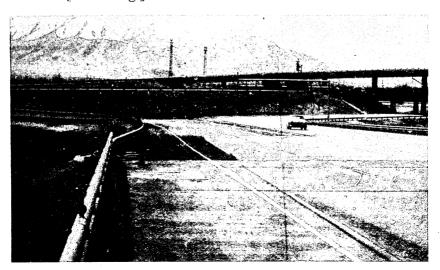
Proceeding north on I-15, with Salt Lake City to our right, you have a choice of turning off here to go into Salt Lake City on Interstate 80 or continuing north toward Ogden, Utah, on Interstate 16. This, in fact, is the shoulder [indicating] of this approach roadway that we have been on. You will see cars that move on right up through this, what appears to be the shoulder area.

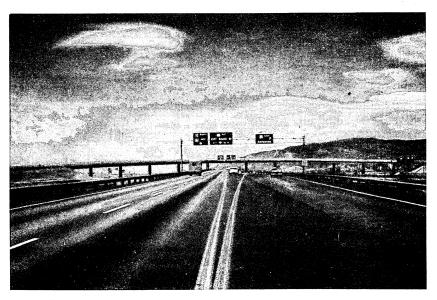
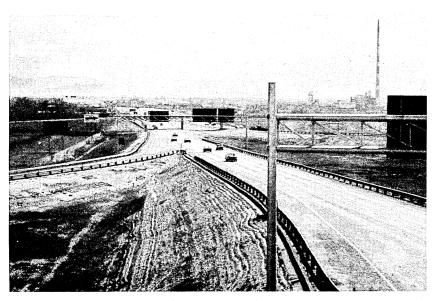
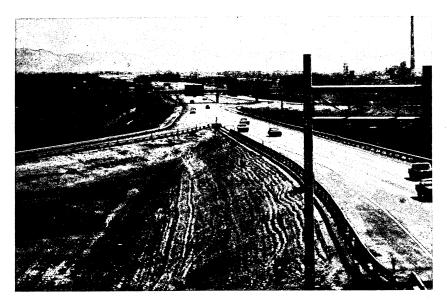
Here is a view of this same place, and this is this shoulder condition. And if you will just watch the red car as he moves from this place (slide) as he comes ahead, he progresses here (slide) and through here.

Mr. Constandy. Of course, it is the one next to him we were concerned with, but the red one is easy to see. The car riding the shoulder, restricted shoulder, going over the bridge.

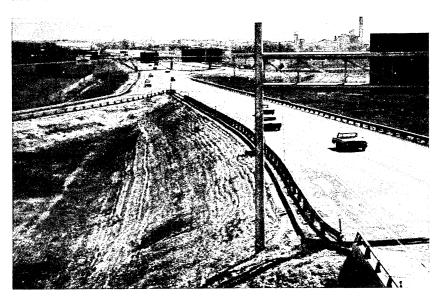
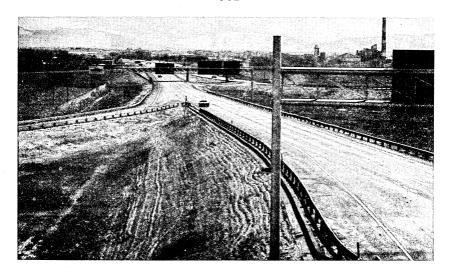
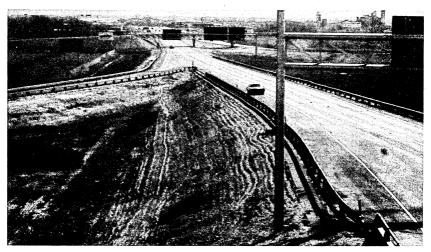
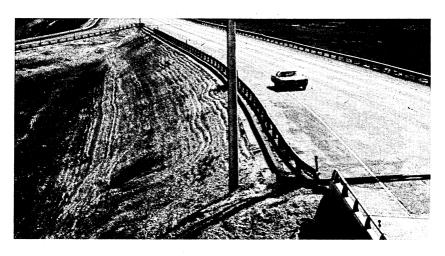
Going on ahead, here another one comes up on that shoulder in the same fashion as the first shot we saw. Watch his progress.

He comes on up the shoulder. You see what happens to the shoulder here. It narrows down at the structure and if he were to continue on the shoulder, he would find himelf in some trouble.

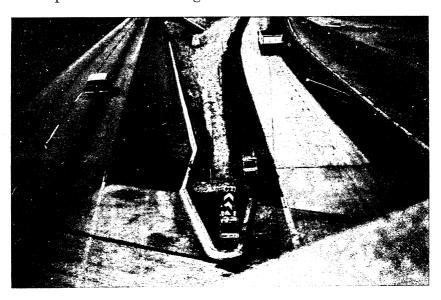
As you go immediately under the structure where those pictures were taken, this is the condition that you run into: curb gore at this point not too traversable down through here. [Indicating.] That is the off-ramp and this is I-15 straight north. That concludes this series.

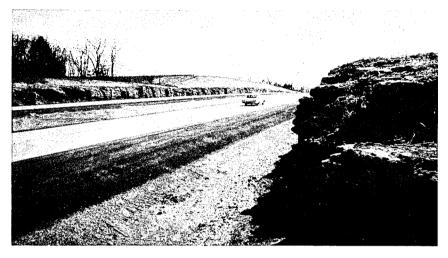
A special situation, of course, introduces itself if you find rock alongside, and in the severe cases here this has been cut back to 20 or 25 feet from the pavement edge, still stands there, somewhat of a hazard.

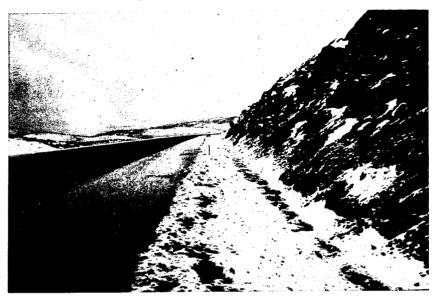
And here, as you enter a rock section, you get into a more severe, much more severe slope, and to a degree much more severe hazard.

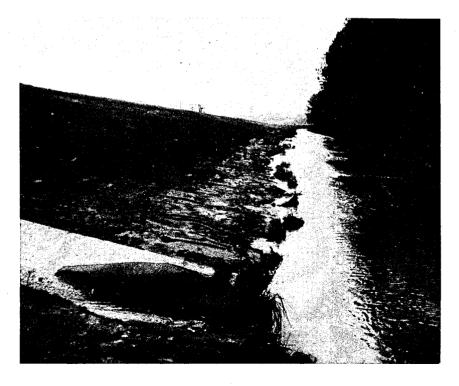
On the roadside slopes are moderately good, but you find conditions of this sort where water is dammed up.

And you have, although with a fairly good slope here, quite a pond at the bottom. When these are wet, without being properly covered with vegetation, this becomes very hazardous to negotiate.

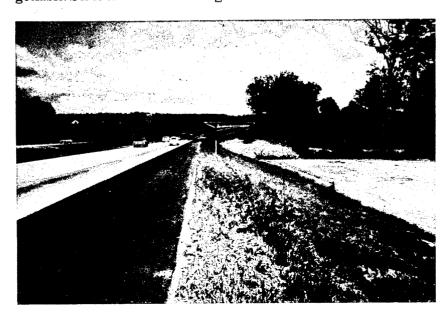
Occasionally on projects of this sort, as we did here in Georgia, we find mounds of dirt that are left in areas where it could so well, with a little bit of attention, be moved to adjoining sections to ease slopes. Slopes themselves right in this area were probably about 2 to 1 or so.

Nearby sources of material and modern earthmoving equipment make it possible to distribute soil in such a way as to make slopes ne-

gotiable. Some of that sort of thing was done here.

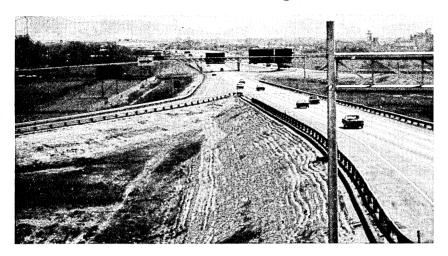
Going through to Utah, one of these gores that you looked at, it would be a good place to have some extra dirt down in here, and these slopes being—if they were a little bit flatter, this guardrail could well have been eliminated, and this would be a negotiable area.

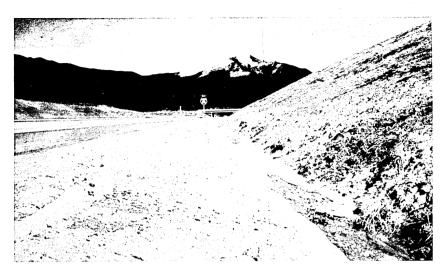
This is still another view of that side slope condition that we were looking at a moment ago.

Slopes here are such that if the dirt were readily available, right-ofway is setting back in here, and this could have been perhaps eased off to the advantage of anyone that might move on that side slope condition.

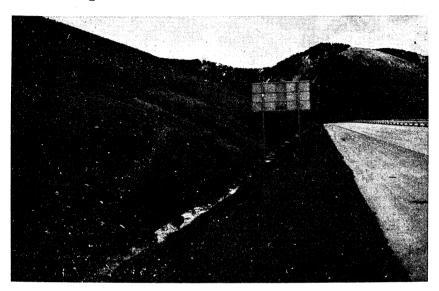
I am not quite sure why we have that. This is a man taking some of his porkers home, a nice flat slope.

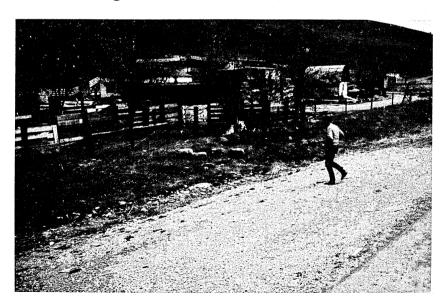
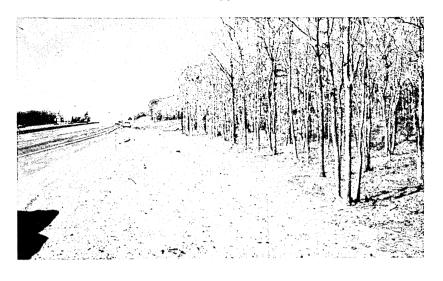
This is in Rhode Island. Your slopes, of course, are very easy here. They are fairly flat. The trees are the hazard. [Slide.] Here you have rocks coming through the surface of the earth—this happens in New England—as well as the trees. [Slide.] And more of the same.

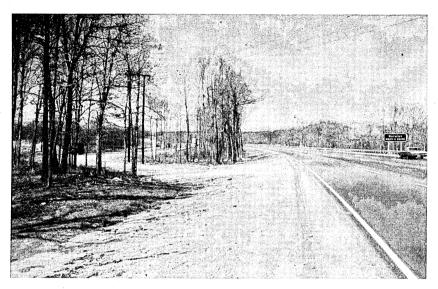
Here we have trees very recently planted and rather too close to the pavement, if I might say so.

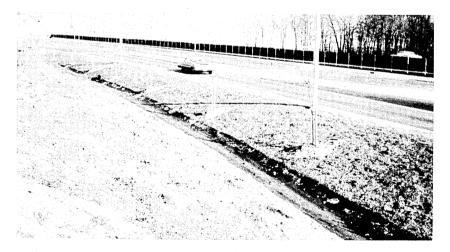
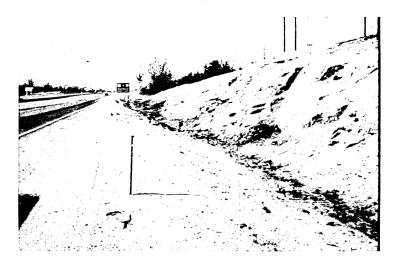
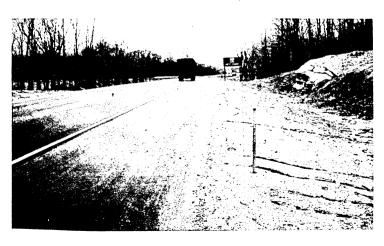
Here there is rock adjoining the roadside, and these slopes really ought to have some protection. It is hard to imagine how this can go on without ultimately proving to be a hazard. [Slide.] Here too is more of the same rock. [Slide.] Still more. [Slide.] And still more. There was an accident in this general vicinity.

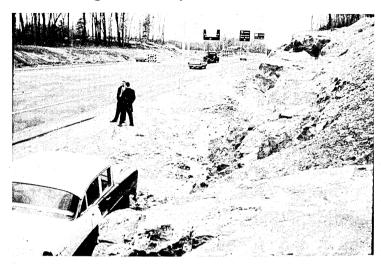
And here is a case where they cut the rock back in a slope plane, which leaves the rock with a relatively smooth surface as against the natural rock that we find in other places.

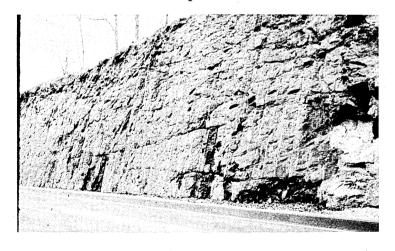
This is some landscaping that was done on the project, just north of Providence, on I-95. A great deal of money and effort went into design and construction of attractive roadside at this point.
