#### 1.12.5 Impact Attitude Determination

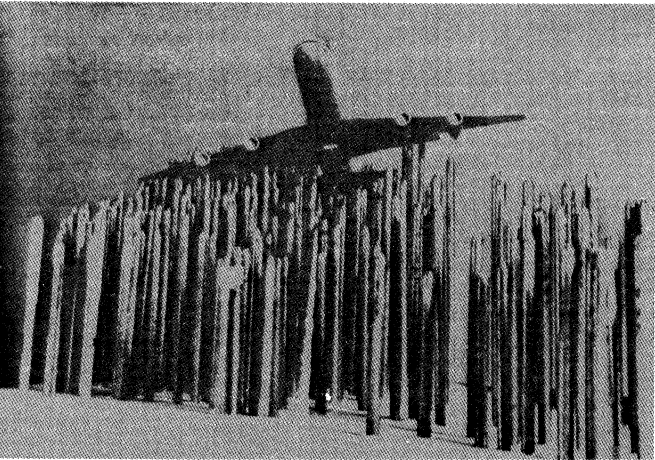
*Figure 1.14. Reconstruction of Impact Attitude*

Using analytical plotters, three dimensional measurements were made of 378 trees which had been cut by the aircraft prior to ground impact (See Figure 1.13.). A 1/100 scale model of the tree-cut zone was then constructed, and a detailed 1/100 scale die cast model of a Douglas DC-8-63 aircraft was mated to the tree pattern (See Figure 1.14.). Flaps were placed on the model at an 18-degree configuration to match post-crash investigation findings. By accurately measuring the orientation of the aircraft model in the tree pattern at increments along its flight path, the attitude of the aircraft and the flight path angle were determined. Measurements indicated that the aircraft first contacted the tree canopy in a seven-degree right bank, nine-degree pitch (the angle between the longitudinal axis of the fuselage and the horizontal), and a 10-degree yaw right attitude, on a descending, 12-degree flight path angle (the angle between the flight path and the horizontal).

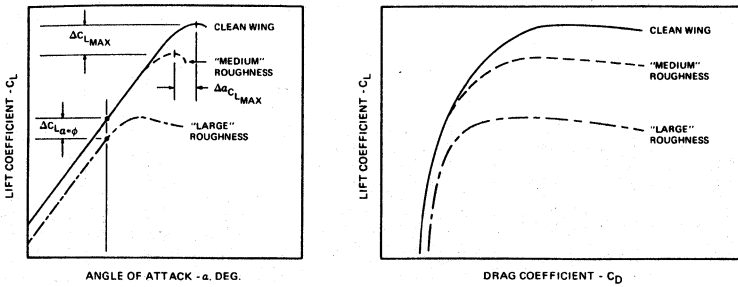
Figure 1.15. Typical Effect of Surface Roughness at the Leading Edge on Aerodynamic Characteristics

Considerable research has been conducted into the effects of ice contamination on airfoil performance. As a result of this research, it is accepted that, in general, ice accretion on the leading edge or upper surface of an aircraft wing results in an increase in stalling speed, decrease in the stall angle of attack, and rapid drag increase near the stall. (See Figure 1.15.)

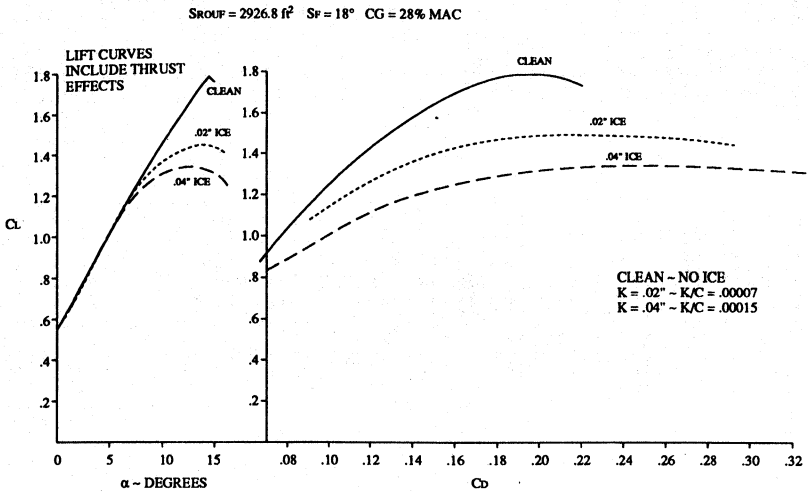
Figure 1.17. Model DC-8-63 Effect of Wing Upper Surface Distributed Roughness on Aircraft Lift and Drag

The lift penalty which results from closed wing slot doors is a 0.2 reduction in maximum coefficient of lift. Ground spoiler deployment results in a 0.4 reduction in coefficient of lift at zero degrees angle of attack. This reduction increases as angle of attack increases. Douglas Aircraft Co. was unable to provide exact data for higher angles of attack. With respect to ice contamination, Douglas Aircraft Co. supplied information which indicated that, with wings contaminated by surface roughness elements of 0.04 inches, maximum coefficient of lift would be reduced by about 25 per cent. The coefficient of drag at or beyond the stall angle of attack (which would be a lower than normal angle) would increase by greater than 100 per cent relative to an uncontaminated wing operating at the same angle of attack, below the stall. (See Figure 1.17.)

Unlike the Boeing 737, the Douglas DC-8-63 is not equipped with wing leading edge devices. Douglas Aircraft Co. confirmed that the performance degradation experienced by the DC-8-63 with small amounts of contamination is significantly greater than that encountered by other aircraft types equipped with leading edge devices. Information provided by the Douglas Aircraft Co. indicated that significant reduction in the maximum coefficient of lift and significant increase in the coefficient of drag would be experienced with surface roughness elements of 0.04 inches. (See Figure 1.17.)

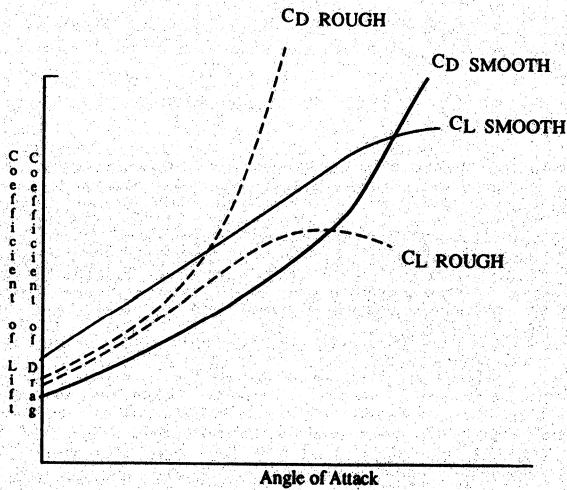
*Lift and Drag Effects of Wing Contamination*

The most significant effect of snow or ice on the wing surface is its influence on the smooth flow of air over the surface contour. Changes in the contour shape and roughness of the surface will cause the airflow to begin to separate from the wing at a lower angle of attack than normal and cause a reduction in the lift which will normally be developed by a wing at a given angle of attack and a given airspeed (see figure below). Both the maximum lift which can be developed and the angle of attack at which it will be developed will be reduced significantly. Stall buffet and stall will be encountered at higher than normal airspeeds.
