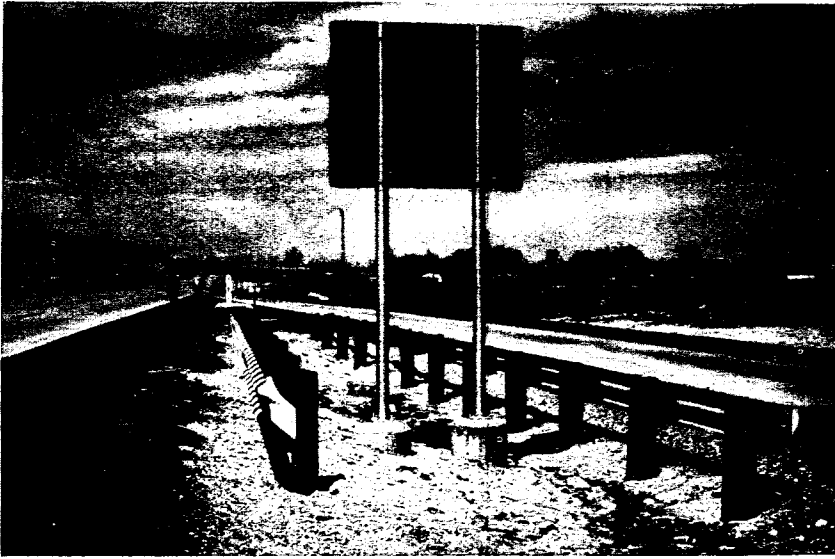
This is the back of that same installation, showing the concrete footings above ground.

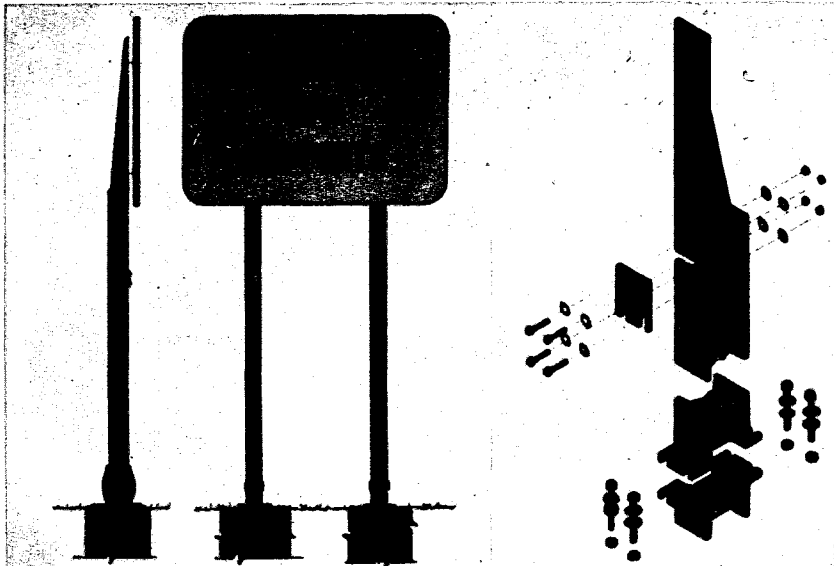
For the benefit of those who are not too well acquainted with break-away sign supports, this is a drawing prepared at Texas Transportation Institute, illustrating the details of the joint at the base of the sign, right at this point which shears off.

The one up here is in fact a hinge arrangement on the traffic side of the I-beam, which causes the I-beam to break and break around the hinge just below the sign surface itself—you saw the pictures
