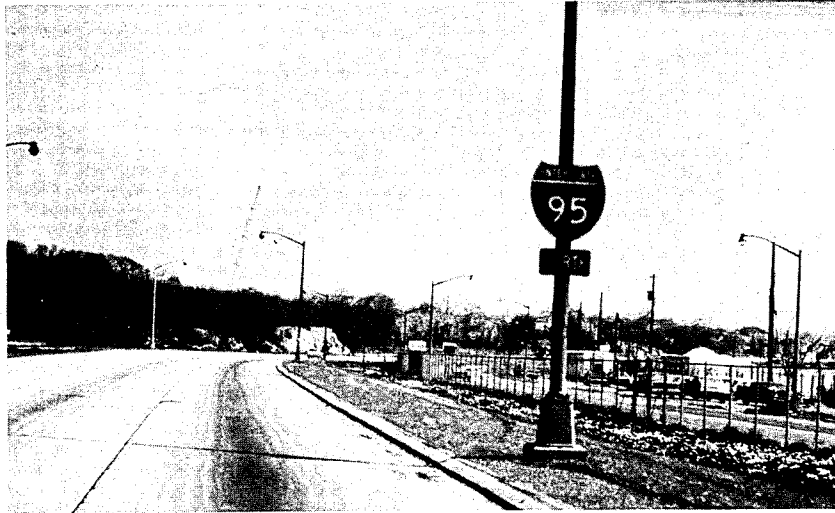
Here is the same sign mounted on the right on a pole, eliminating all maintenance and putting it in a more favorable position, a little higher, and at no extra cost.

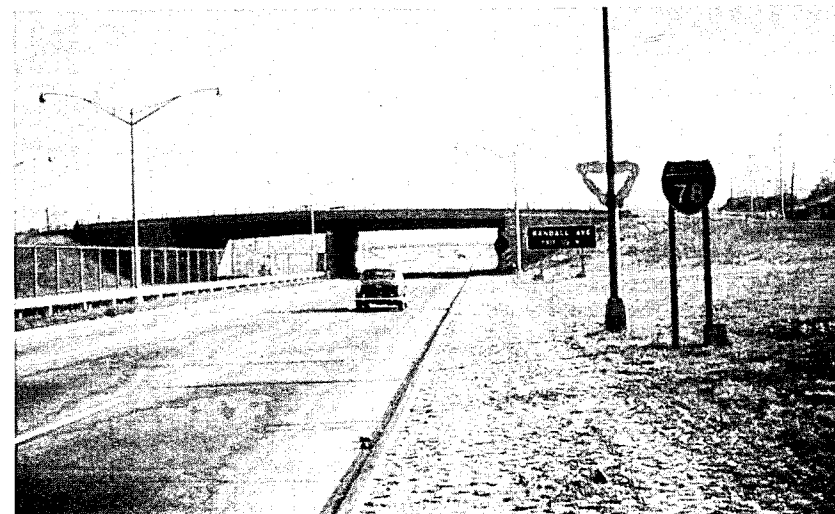
Now, these are not small poles. They may look small; they are 2½-by 3-inch angle irons. If you hit them, you may get into serious trouble.
