Mr. Blatnik. Time is running out on us. Mr. Linko, would you proceed with your presentation?

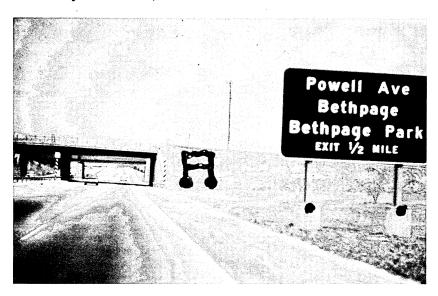
Here you see two concrete stanchions that must be 2½ feet in diameter and about 2 or 3 feet high, capable of wiping out any car. There is no good reason for the sign to be at this location. They put in a second hazard close to where one already exists—the roadsides are

saturated with this type.

As you see, it says "one-half mile." A little further you see a natural hazard, a bridge abutment and embankment. I feel the better place to put this would be at the bridge. I cannot understand why they put it in

here. If anyone hits that, he is finished.

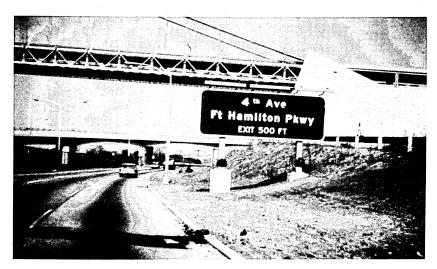
Here is another one, right in the shoulder. (Slide.)
