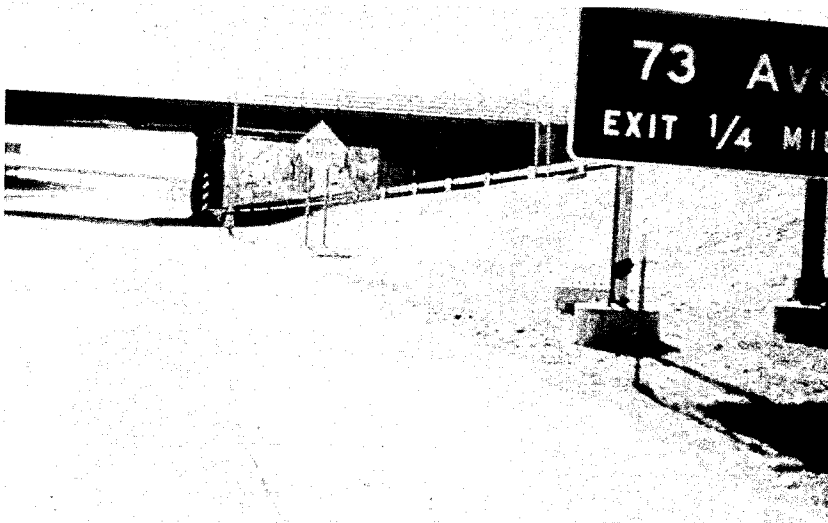
You can see, this sign could have been attached to the bridge. Again it is unprotected.

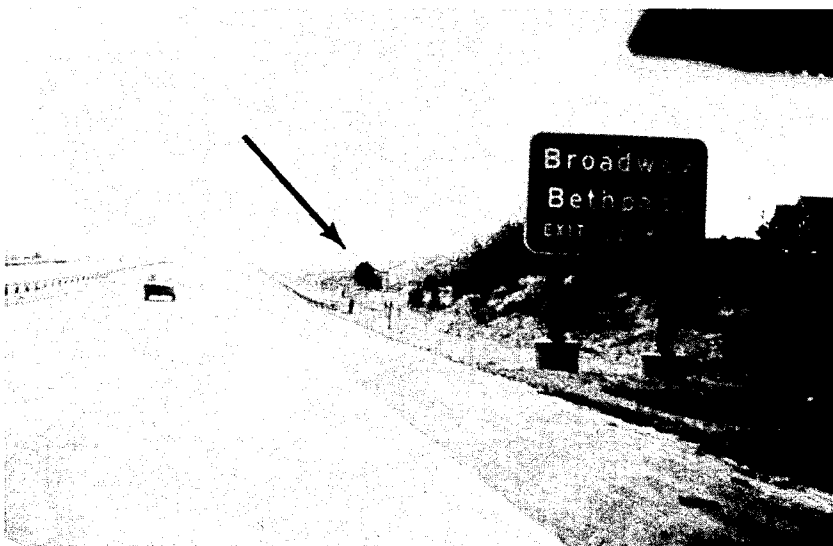
Here is a half mile sign. Nobody is going to notice the difference if it is changed 40 to 50 feet. We could have completely done away with this hazard by putting it behind the existing guardrail (arrow).
