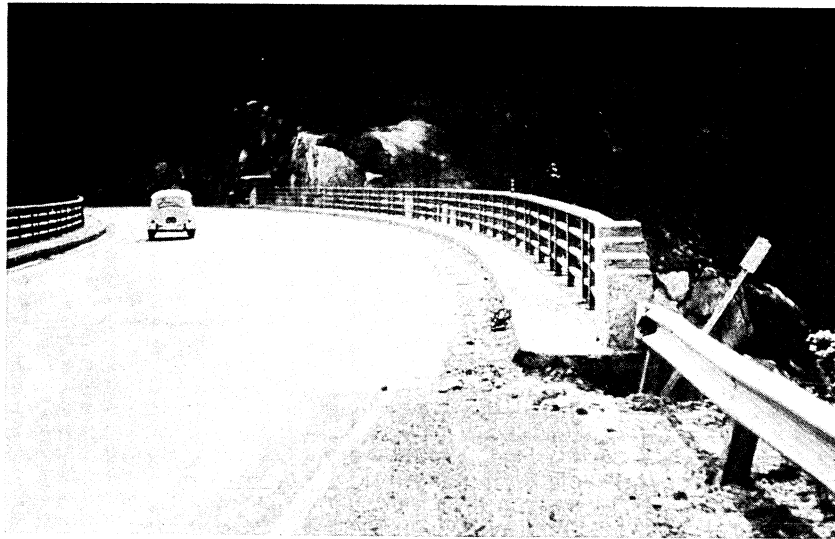
strength of that connection, you see. And all our highways in New York City are deficient in this way.

Now this is a picture I took 8 months prior to an accident. I saw someone was chipping away on this thing already.

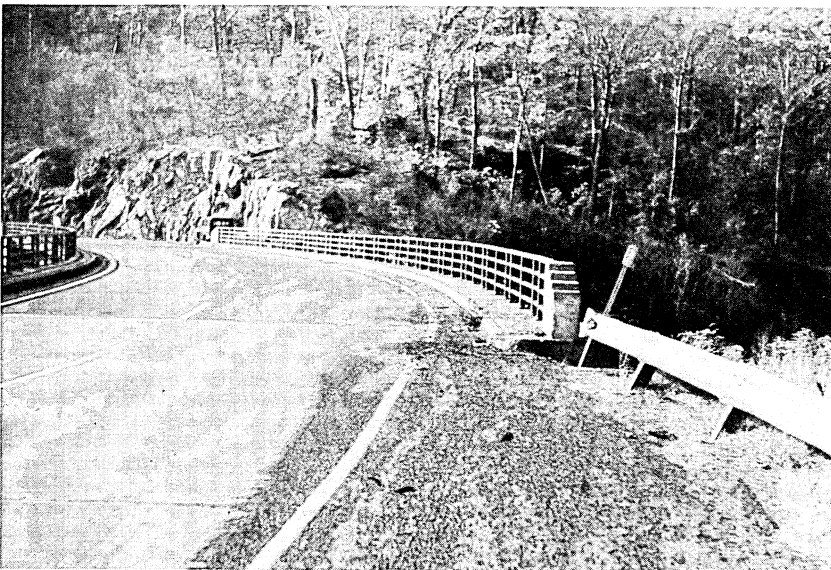
Here is the same scene. Three people died here.

Four days later, another person died here, in the exact location. They failed to do anything about the situation, so I wrote a letter to our Governor pointing out the deficiency.
