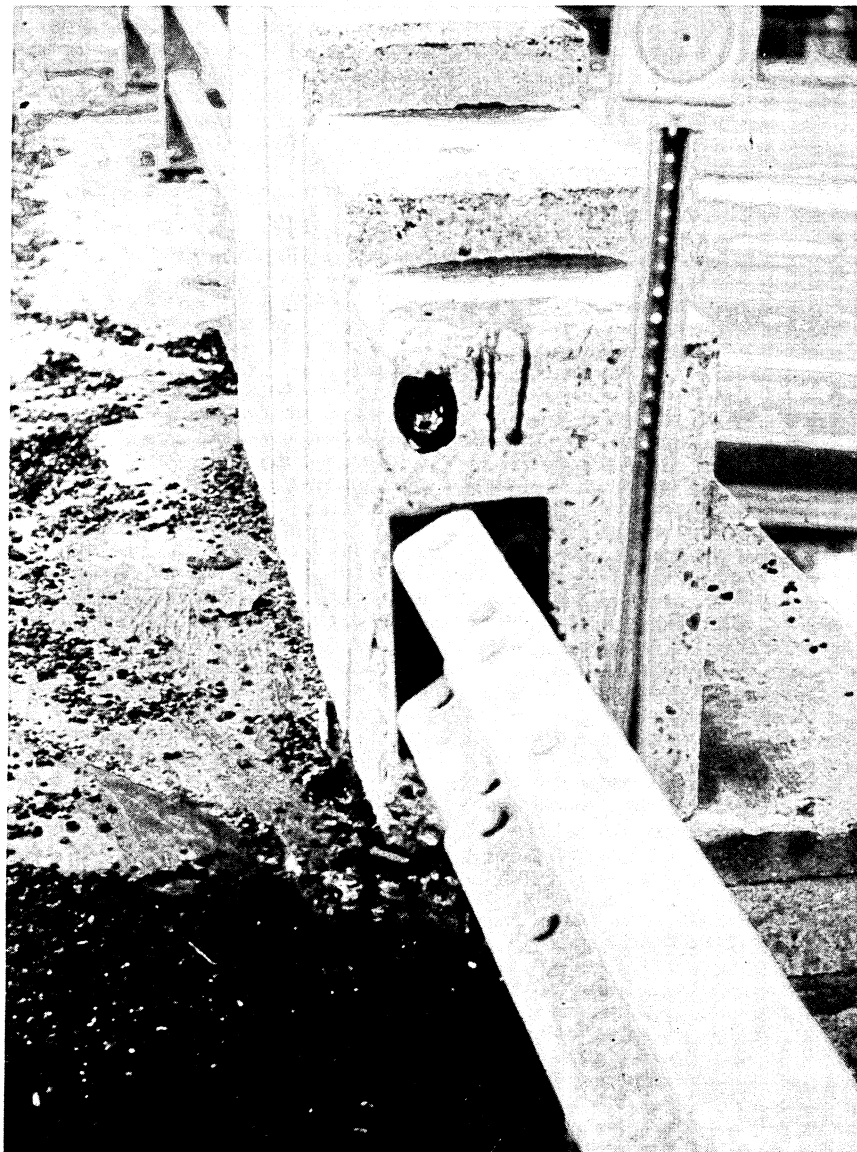
The answer to this particular place where the people got killed was that they shoved another guardrail in there and they thought their responsibility was over. This is when I wrote a letter to the Governor. I went to this particular place after they repaired it and I shook this guardrail and it moved 6 inches back and forth. You can see where the mark is at the base of that I-beam, you can see a big hole there, and that part could be pushed back and forth also.

Mr. CLEVELAND. Is that curb in the previous slide at the base of the bridge abutment—the base of the bridge—that curb looks like 5 or 6 inches. Is that a hazard also?

Mr. LINKO. Yes; that is a hazard and it has been chopping up our cars. I noticed that after I wrote a letter to the Governor.
