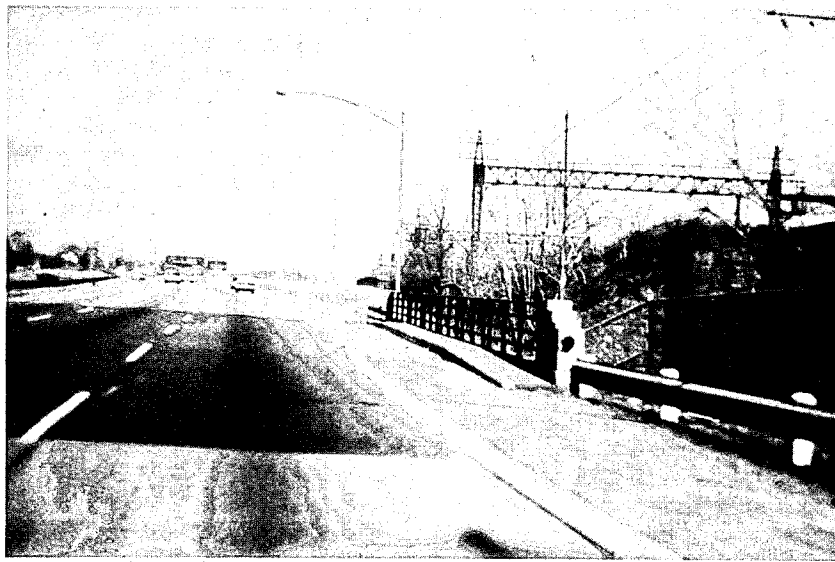
Mr. LINKO. Here is a case where they removed the high curb, but the guardrail is set behind the bridge abutment, you see.

Now you have the material to do the job properly, but it is not installed properly, so all these unnecessary accidents at these points are really not necessary.

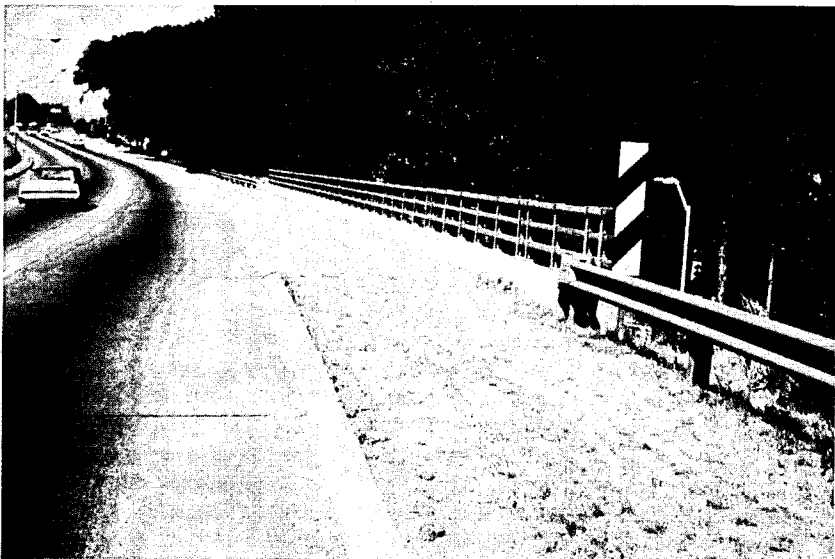
Now here you see the guardrail set in front of the curb allowing you to go right through.
