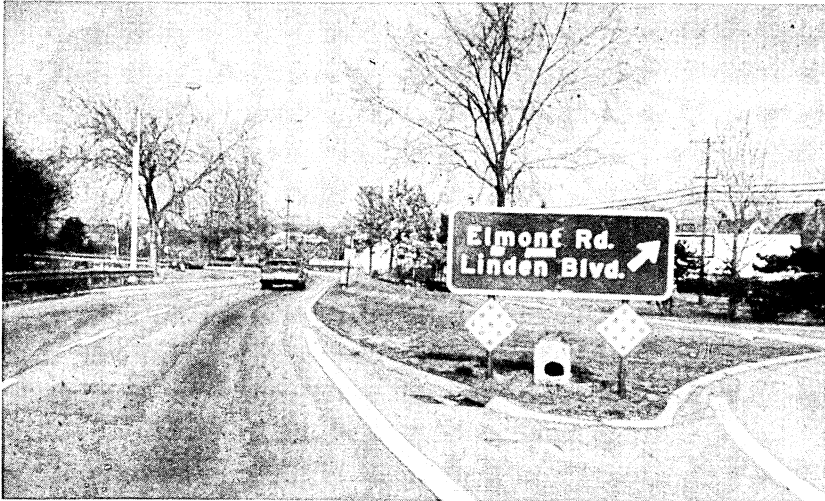
Mr. LINKO. Here also you see a new sign just installed and there is a concrete stanchion there between the legs. Nobody thinks of removing it. This is an easy-knock-down sign. It (the stanchion) is not serving any purpose at all.

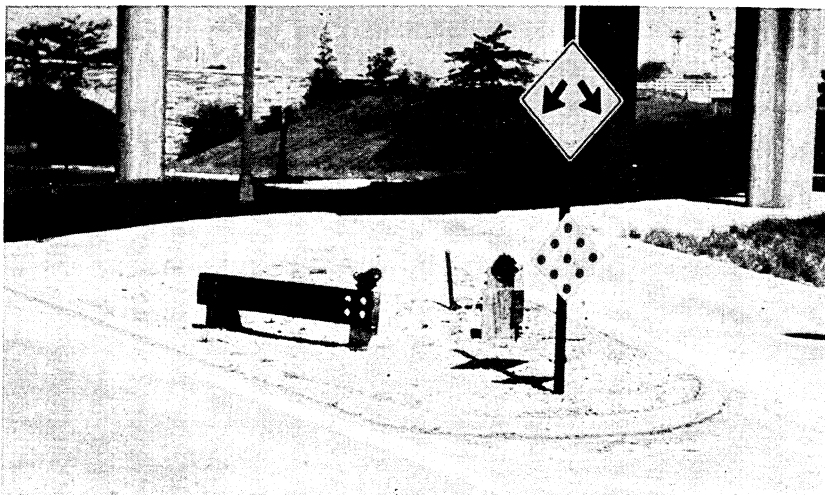
Here also you see a sign knocked down two 2 years ago and the stanchions are still there. A small sign has since been put in.
