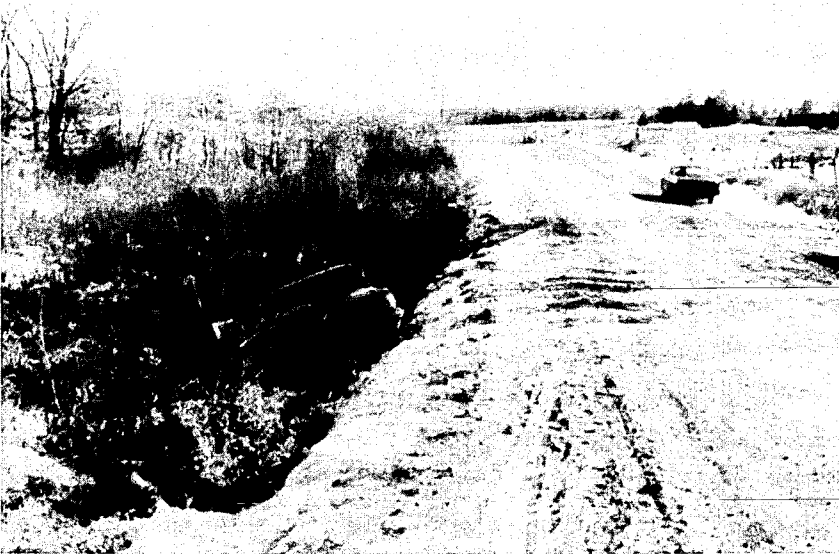
As he came around the curve, he slid off and went into the ditch along the road edge.

Notice here there is no shoulder to this roadway, and notice the very deep drainage ditch along the road edge.

The ironic part of this thing is the fact that this is a nonfunctional drainage ditch, its function having been lost by a subdivision that is to the left, and in the background with service drives, making this ditch just a deep ditch.

He went off into the ditch as you can see, and struck with the left front fender in that area, causing the door to pop open. He was ejected and was killed.

Now, we have a problem with automotive design in that the car door opened; but the important thing is that had this been a relatively flat area, he could have made his mistake—I am not making any excuse for the vehicle, but even with his mistake, he could have survived this accident.
