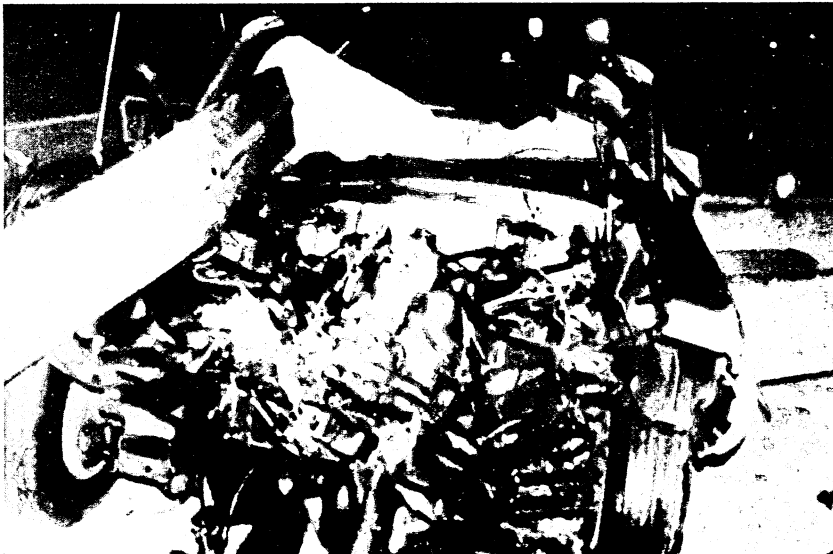
This is the front view of the car.
