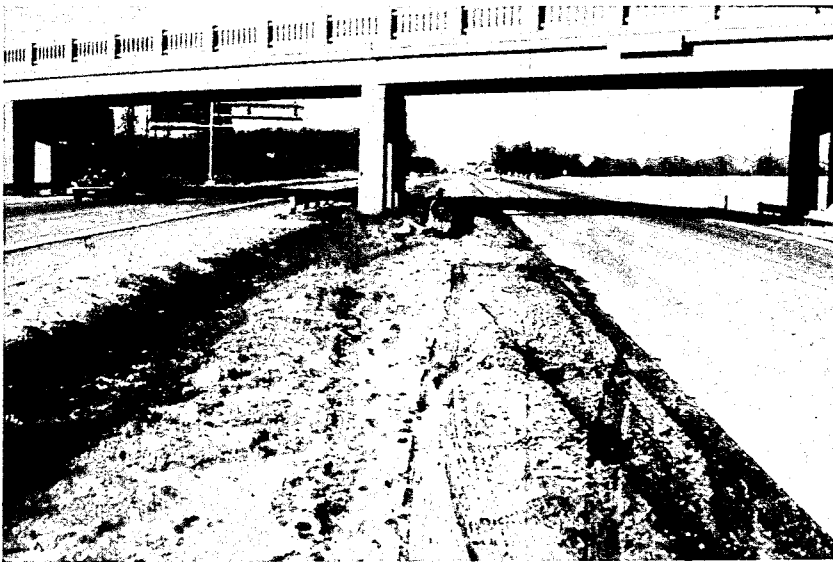
This is another accident on I-94. Notice that in some instances in this area, we do put signs up on the overpass railing.

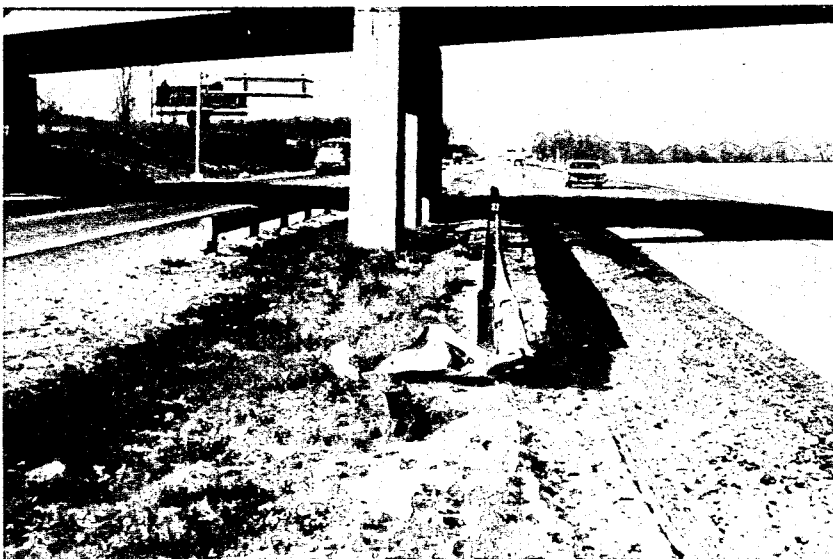
This man was traveling at about 80 miles an hour one night when he hit the end of this guardrail, but his car jumped up on the guardrail. The guardrail then led him on the collision course to these bridge piers.

See how he damaged the end of the guardrails.
