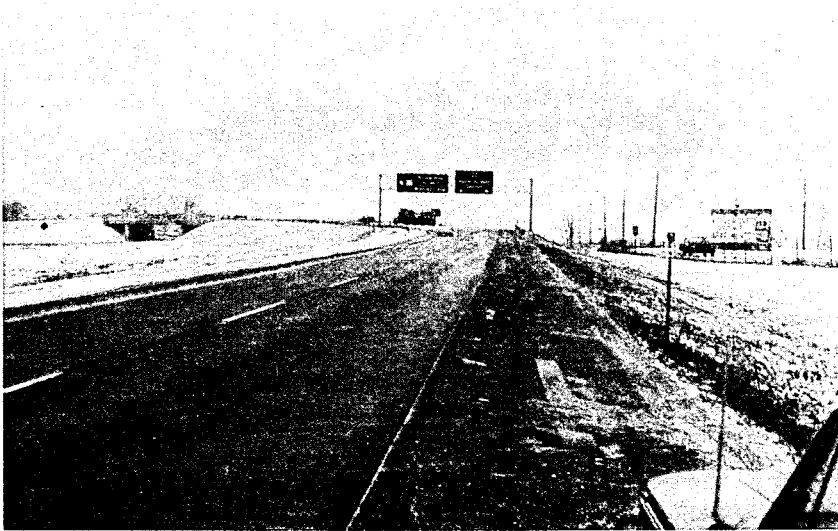
This is an expressway turnoff well marked, heavily signed. There is inadequate guardrail around the base of the signpost. But 1 day the individual did make this turn, a 17-year-old young man driving his parents in a brand new car, and he swung a little wide. You cannot

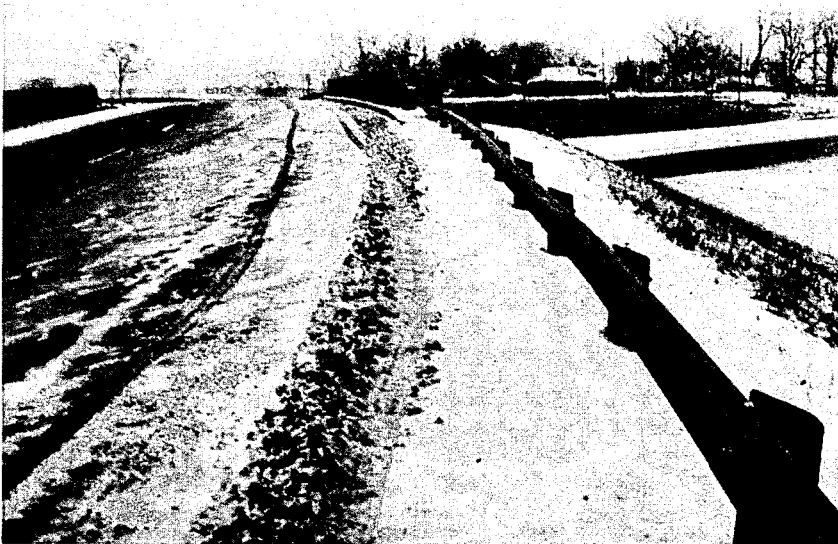
really see it, but the road edge is right here [indicating], along here. He swung wide and got into this area
