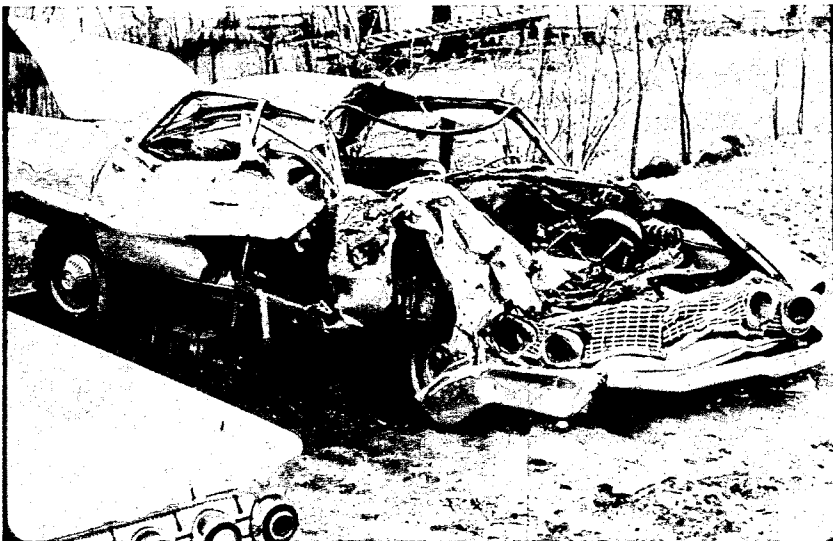
This is what the car looked like.

One of the concepts that has been advocated for an area like this is: Is it really necessary for drainage ditches that pass beneath expressway system to remain open? Why not enclose them for 30, 40, or possibly 50 feet away from the road edge? So that if this, for example, had been covered over and this individual had gone into the area, he would not have had the strong deceleration forces applied to the vehicle to cause it to flip over and for him to be killed.

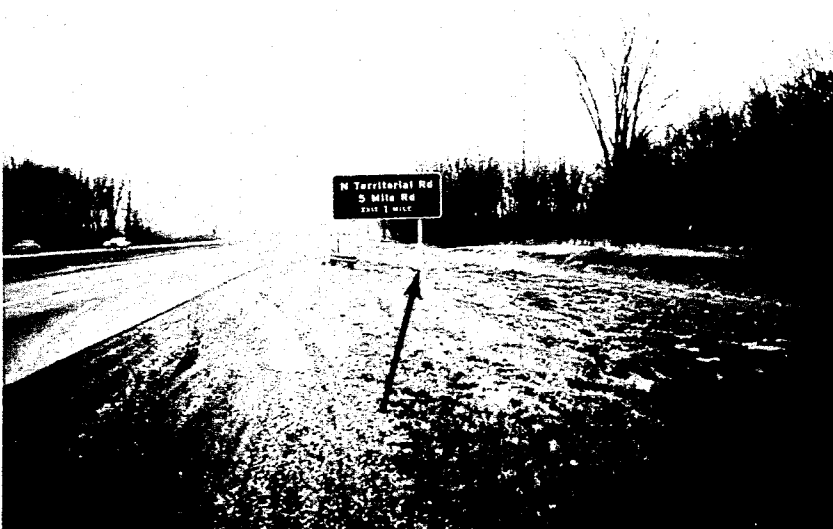
Now, here we see a typical sign on the expressway system, at least in Michigan. These are 8-inch I-beams, support posts, imbedded firmly in concrete; and look at the guardrail we have adjacent to it.
