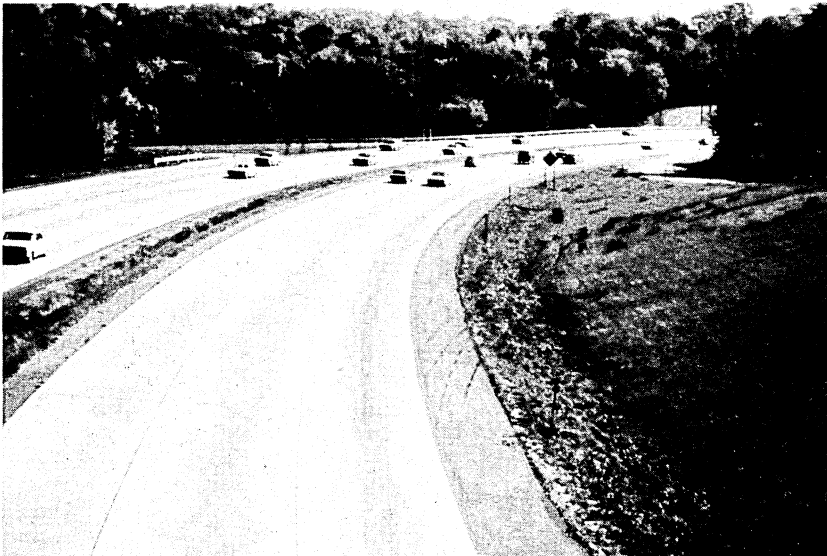
This is a good design on your right. You can see tire marks where a truck ran through there. He pulled over to the right-hand side, and that is the best place for him when he loses control of his truck or car. He recovered and had a second chance.
