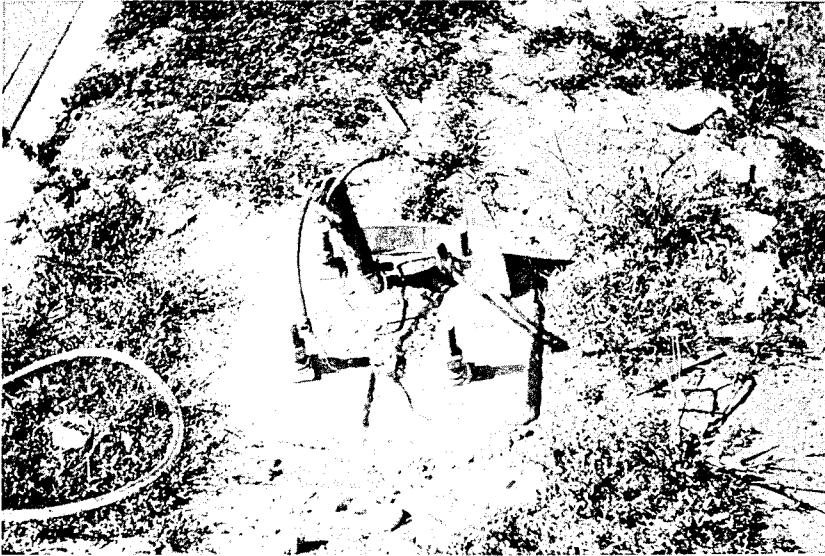
Here is a place where somebody snapped it off, and the aluminum shattered and there is a minimum of damage to your car. I feel we should consider this as standard equipment. In fact, we should make a standard on minimum shearoff on all poles along the highways. This way no unnecessary damage should be caused to an automobile. It is not more costly.

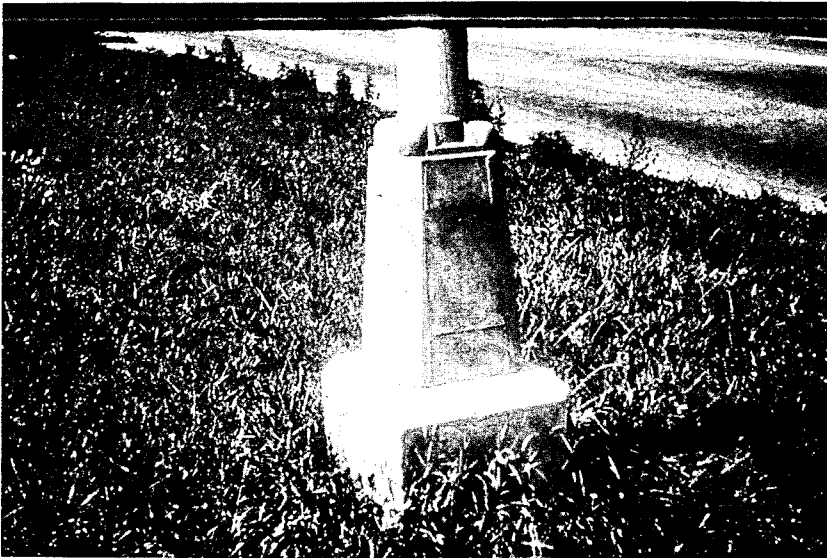
Here you see them defeating the purpose. They put a big concrete stanchion underneath these things.

Mr. W. MAY. This is an aluminum breakaway light pole put on a concrete pedestal?
